- 1. Hazardous Building Materials Assessment (Preconstruction) 1635 Dundas Street East, Whitby, Ontario**

Re: Revised Hazardous Building Materials Assessment (Preconstruction)

Region of Durham (Client) retained Pinchin Ltd. (Pinchin) to conduct a hazardous building materials assessment of Sunnycrest Nursing Home located at 1635 Dundas Street East, Whitby, Ontario.

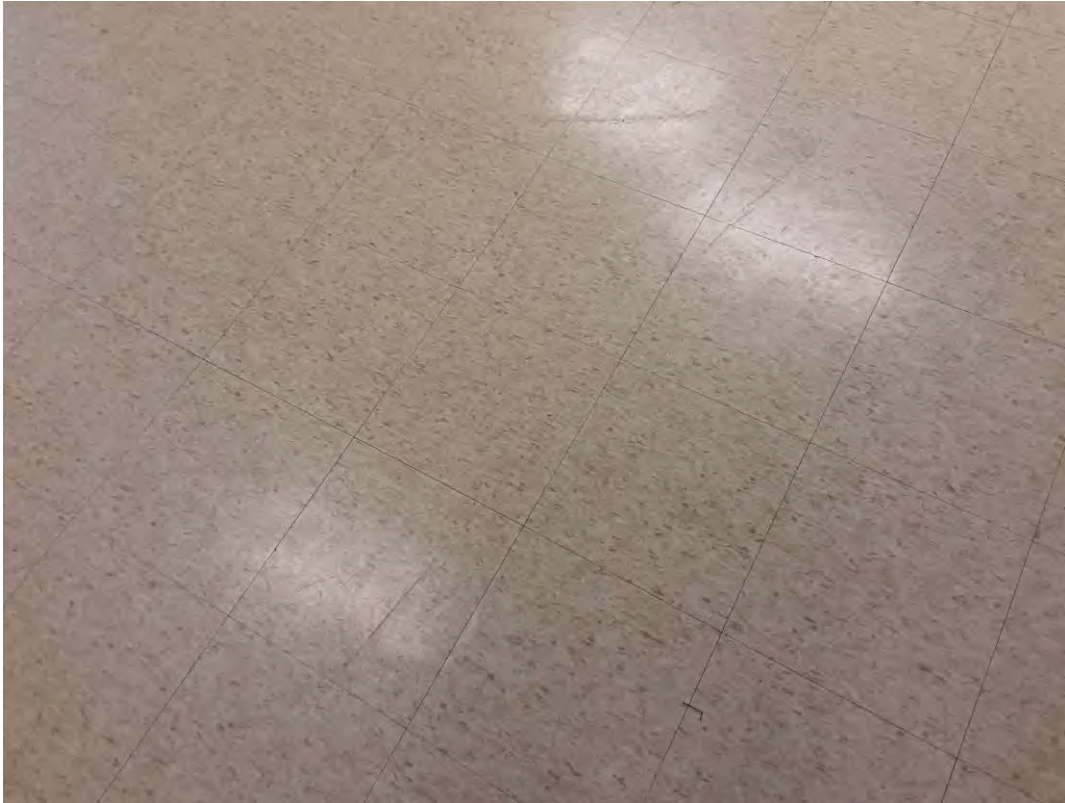
S0001A (None), Floor, All, Vinyl Floor Tile and Mastic, Lobby (Location #: 4)

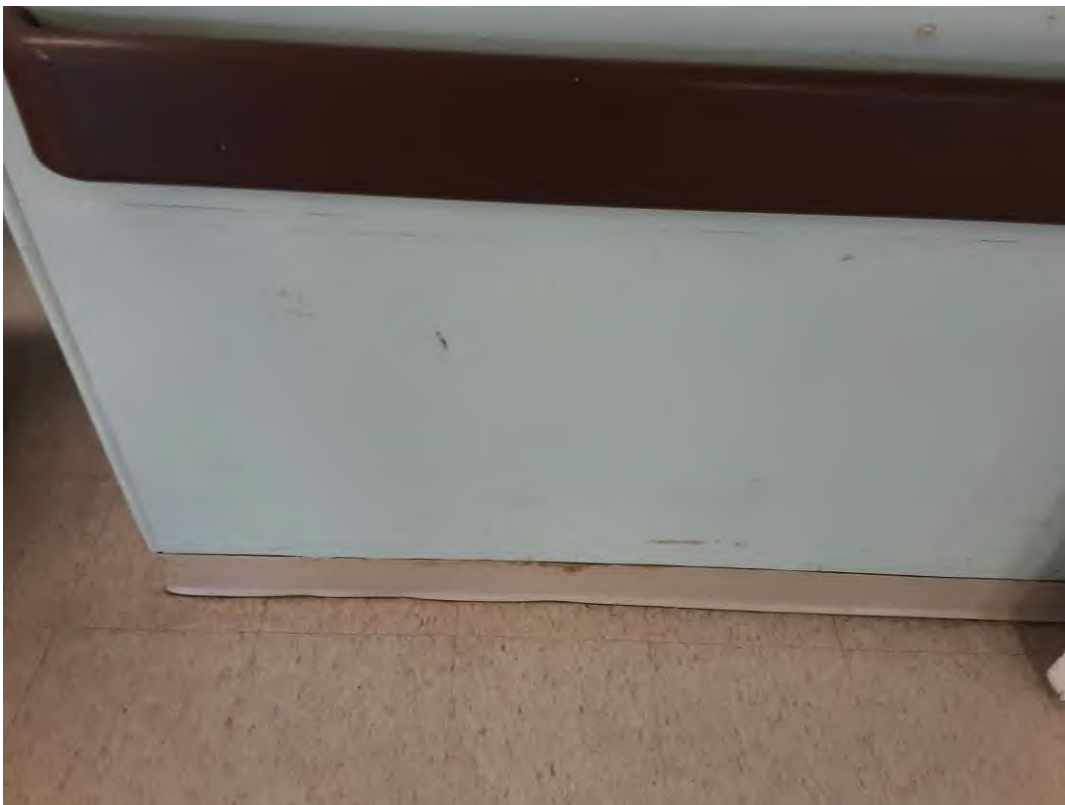
S0002A (None), Wall, Base, Adhesive/mastic, Lobby (Location #: 4)

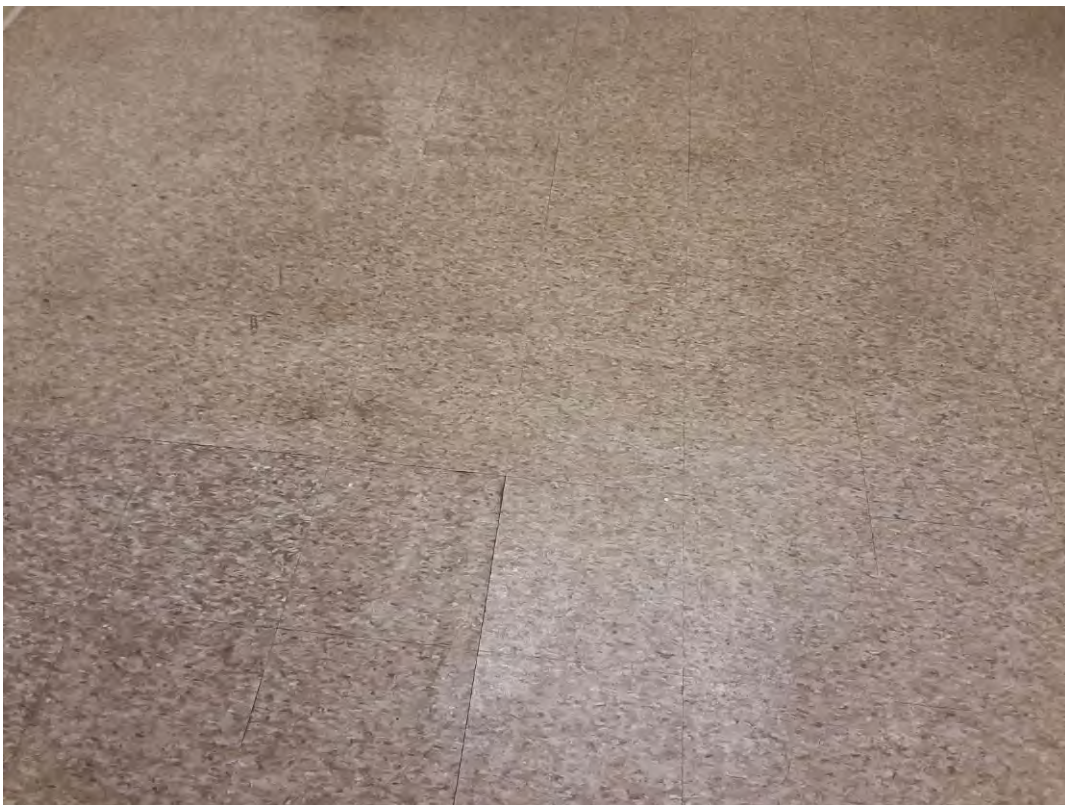
V0003 (None), Floor, Vinyl Floor Tile and Mastic, Main Office (Location #: 5)

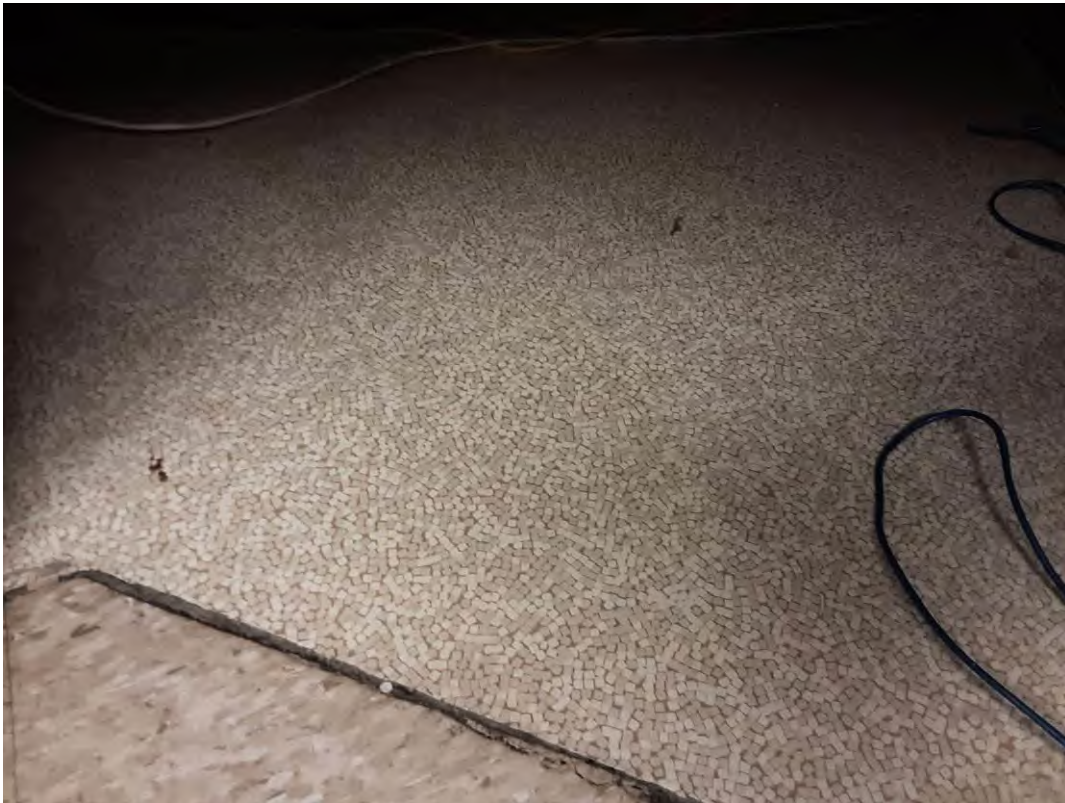
S0004A (Confirmed Asbestos), Floor, Vinyl Sheet Flooring, Lobby (Location #: 4)

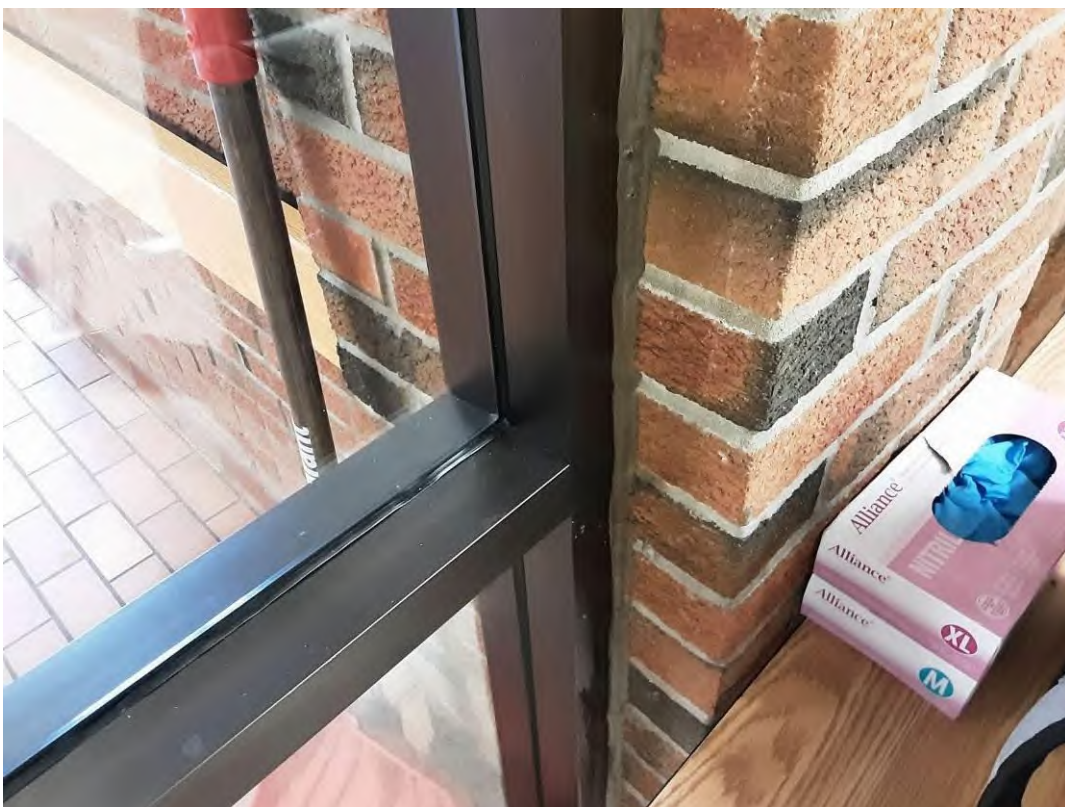
S0005A (None), Other, Door, Caulking, Lobby (Location #: 4)

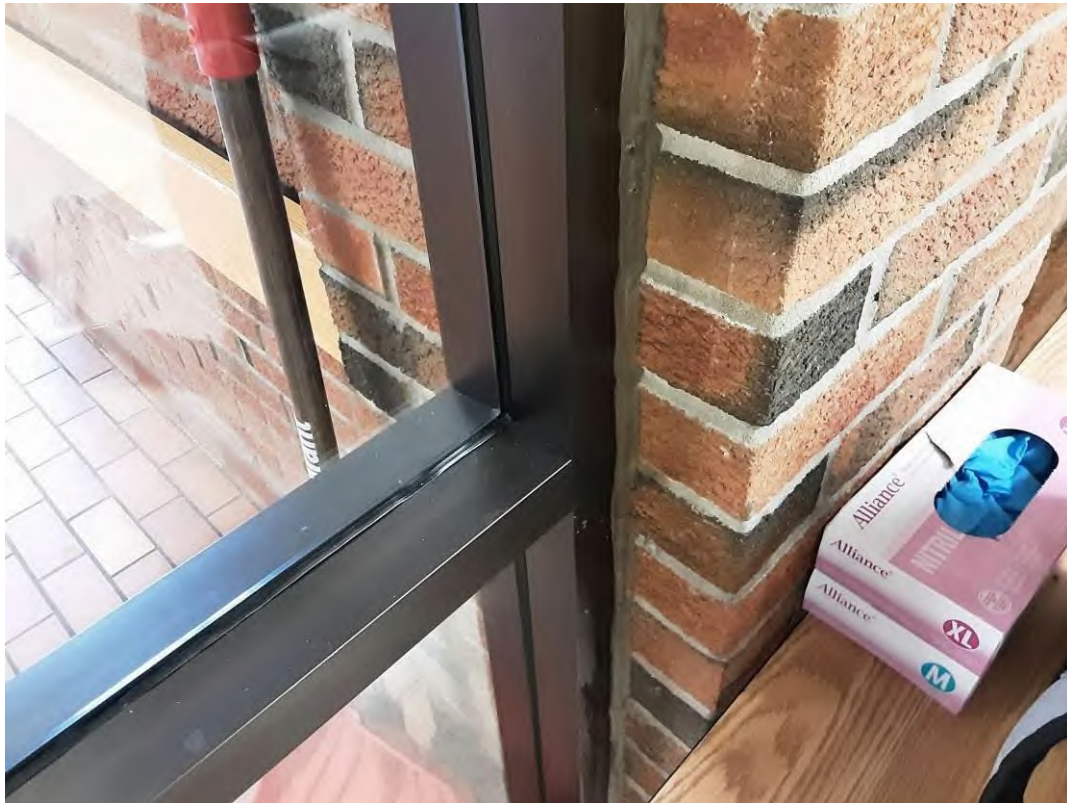
S0005A (None), Other, Door, Caulking, Lobby (Location #: 4)

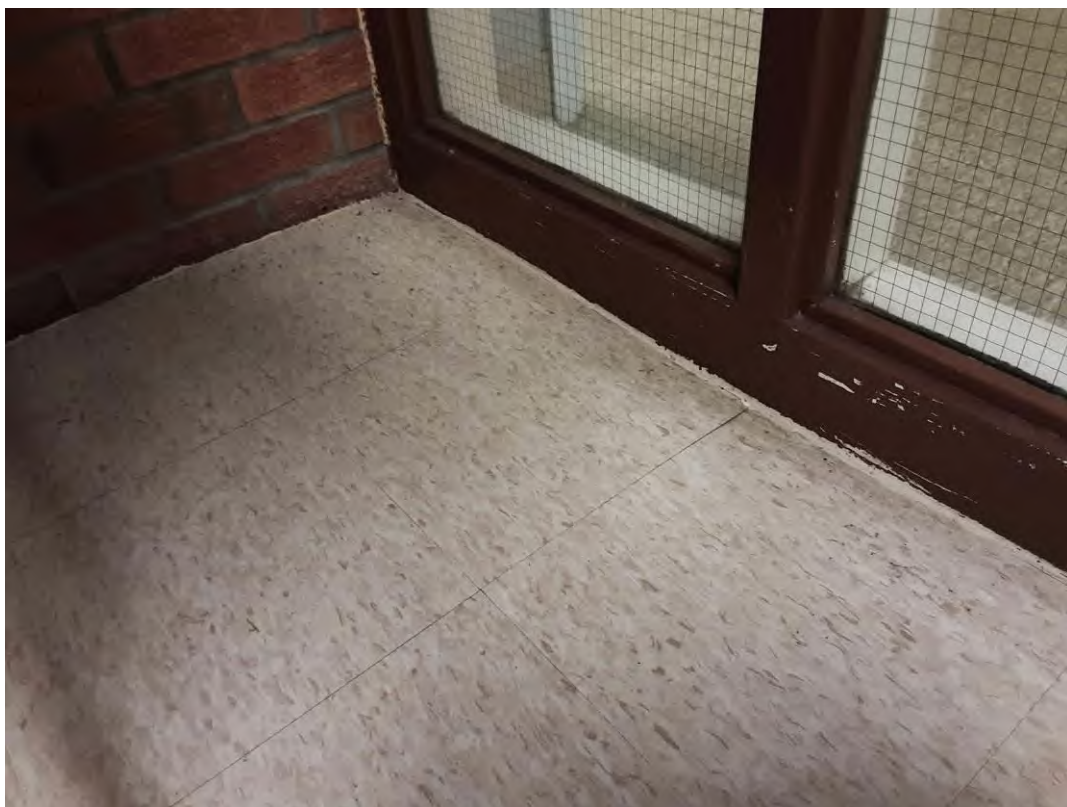
S0006A (None), Wall, Base, Caulking, Lobby (Location #: 4)

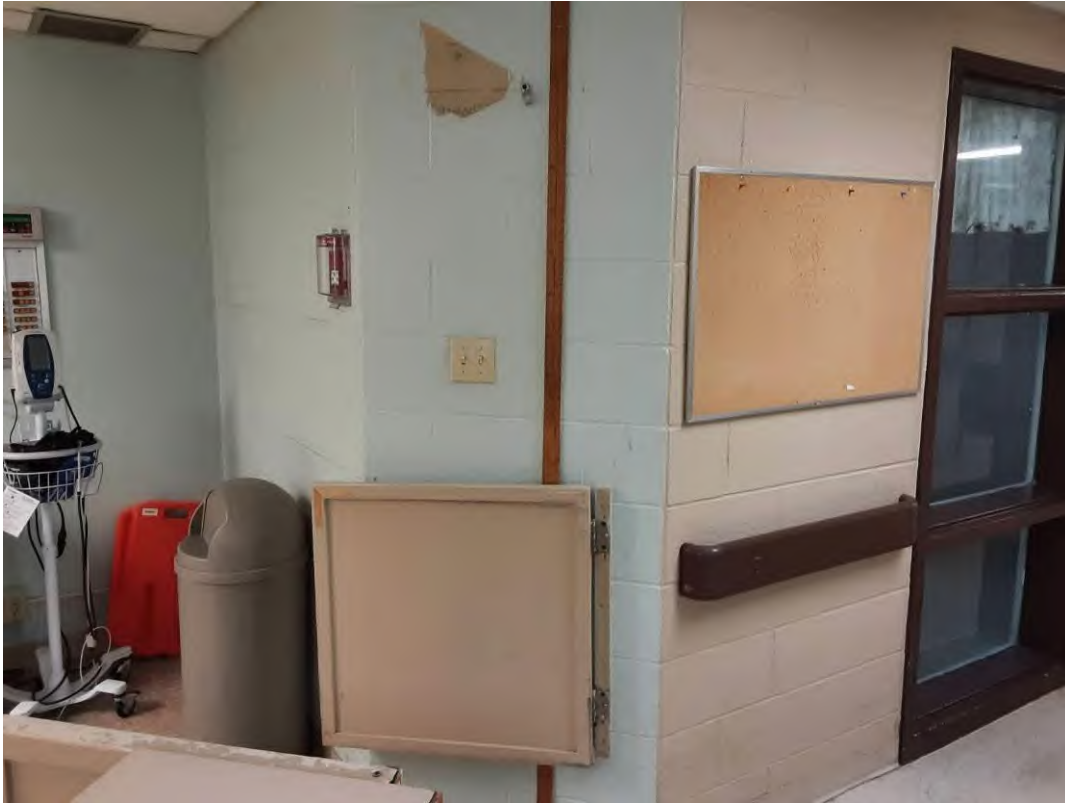
S0007A (None), Wall, Paint, Lobby (Location #: 4)

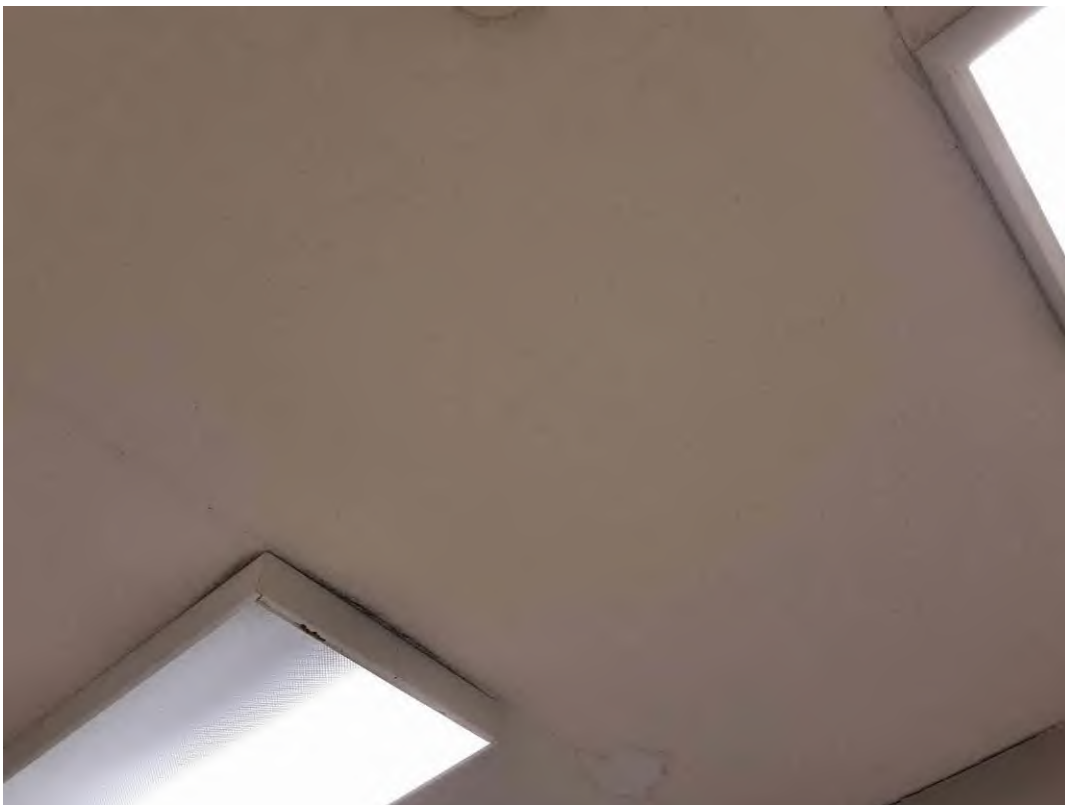
S0008A (None), Ceiling, All, Texture Coat, Main Office (Location #: 5)

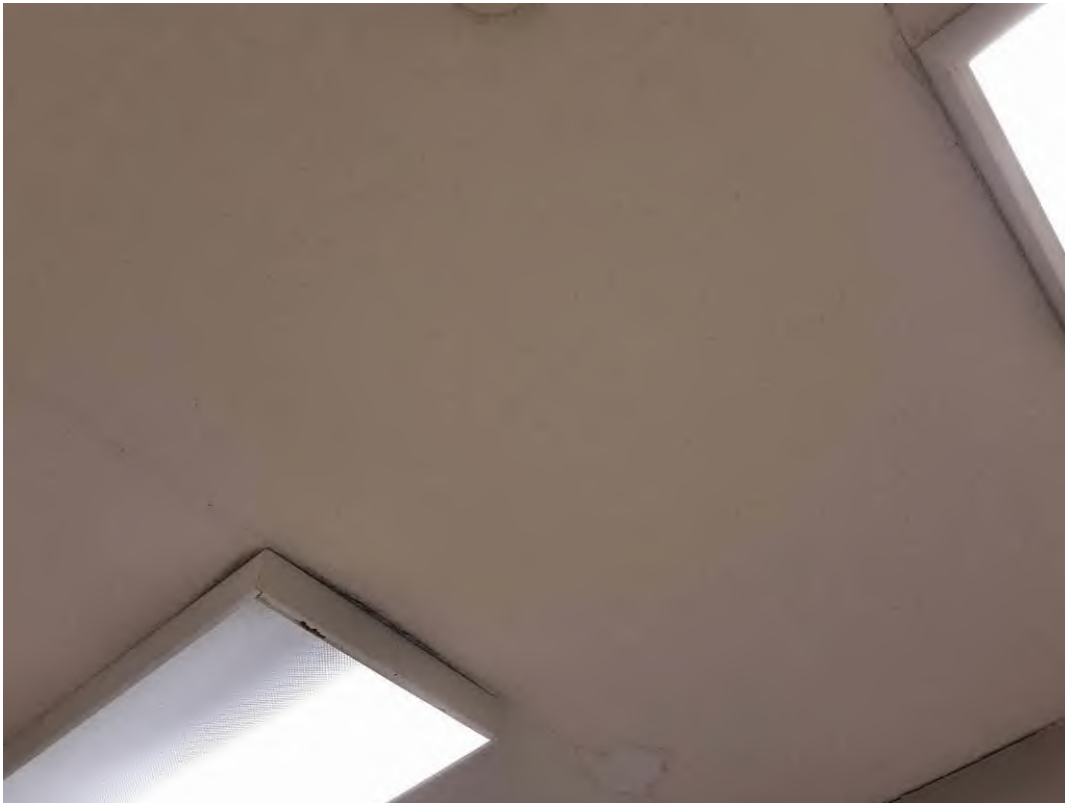
S0008A (None), Ceiling, All, Texture Coat, Main Office (Location #: 5)

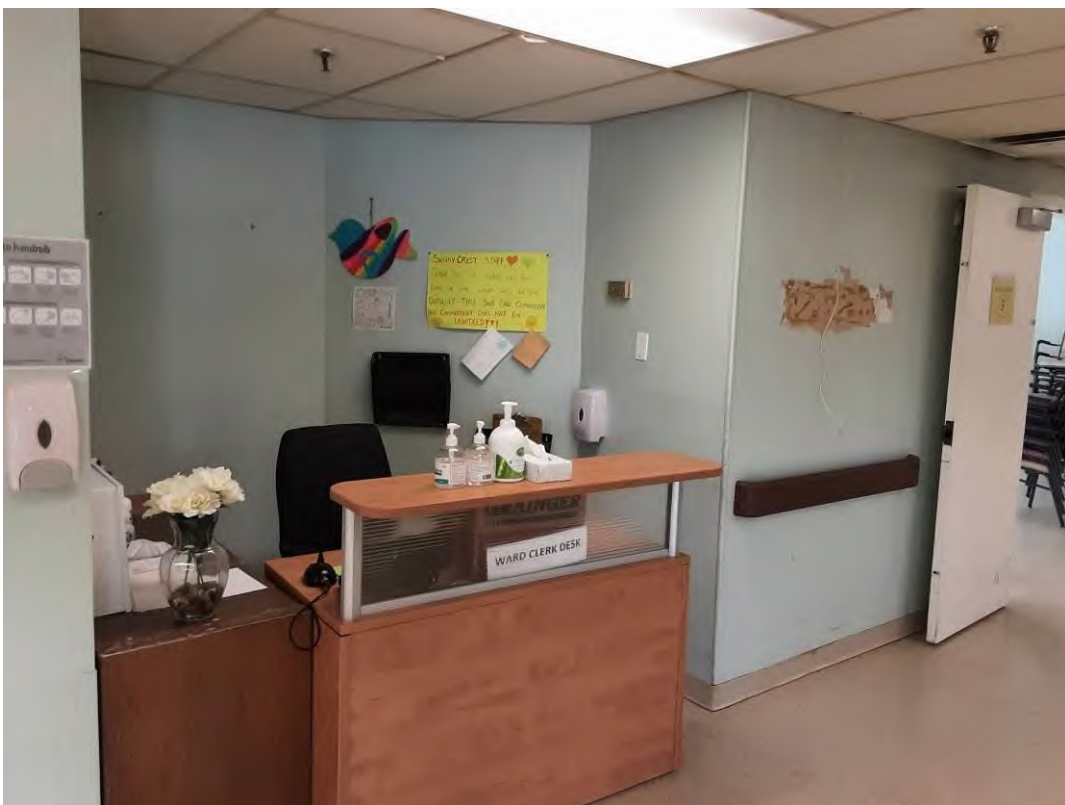
V0009 (Confirmed Asbestos), Wall, All, Drywall and joint compound, Lobby (Location #: 4)

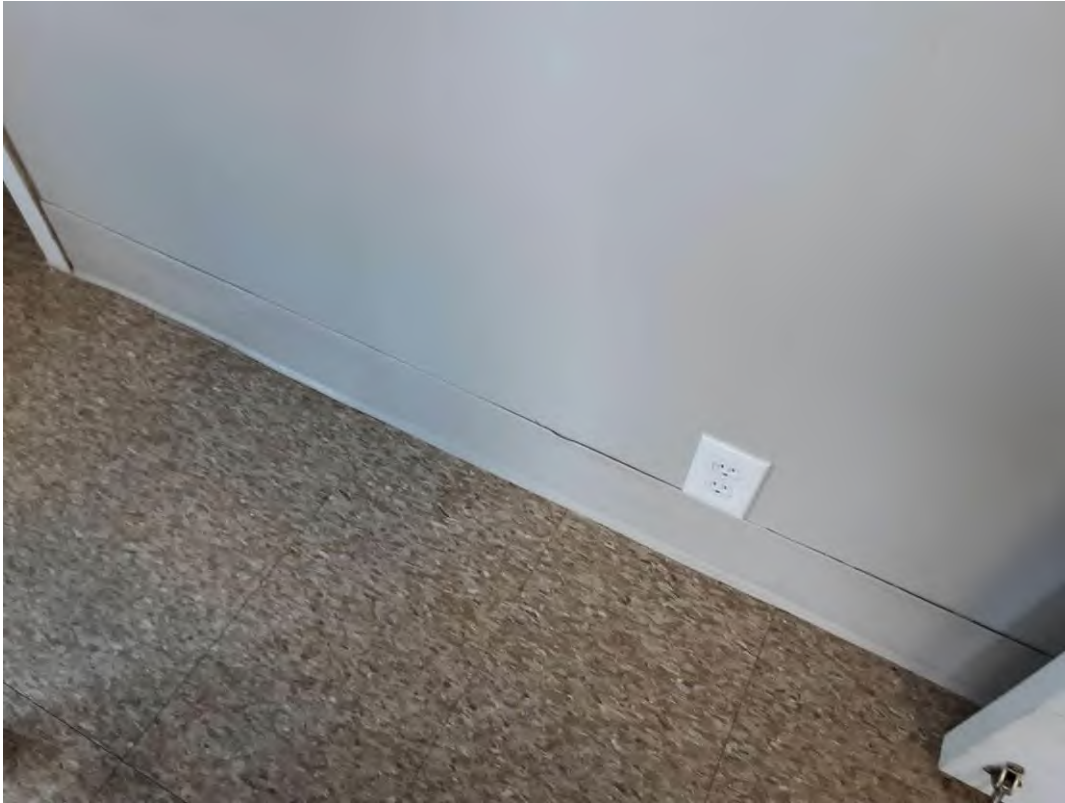
S0010A (None), Wall, Base, Adhesive/mastic, Meeting Room (Location #: 7)

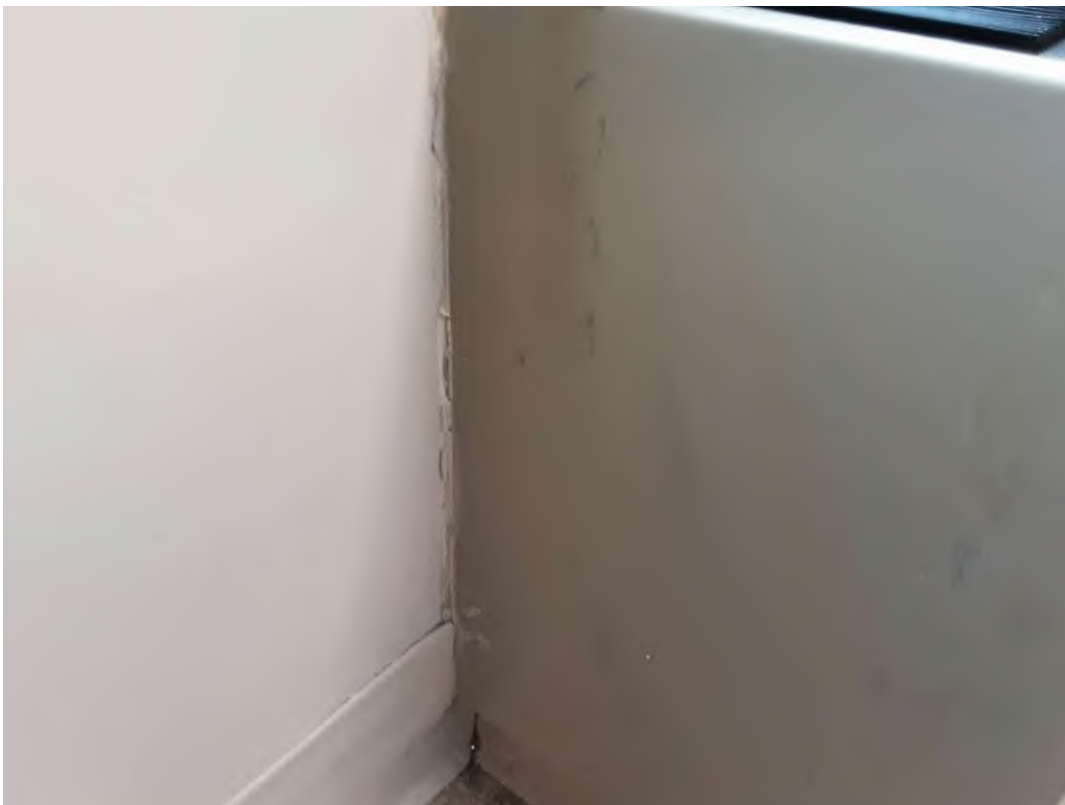
S0011A (None), Other, Radiator, Caulking, Meeting Room (Location #: 7)

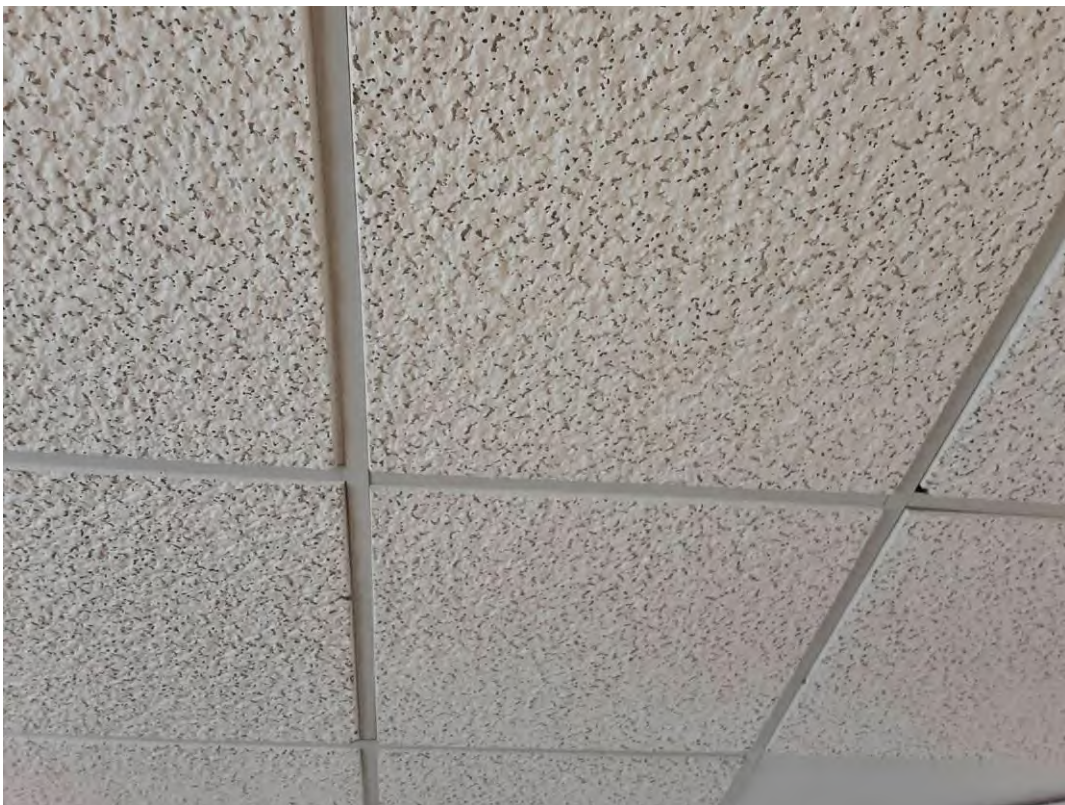
S0013A (None), Ceiling, All, Ceiling Tiles (lay-in), Office (Location #: 10)

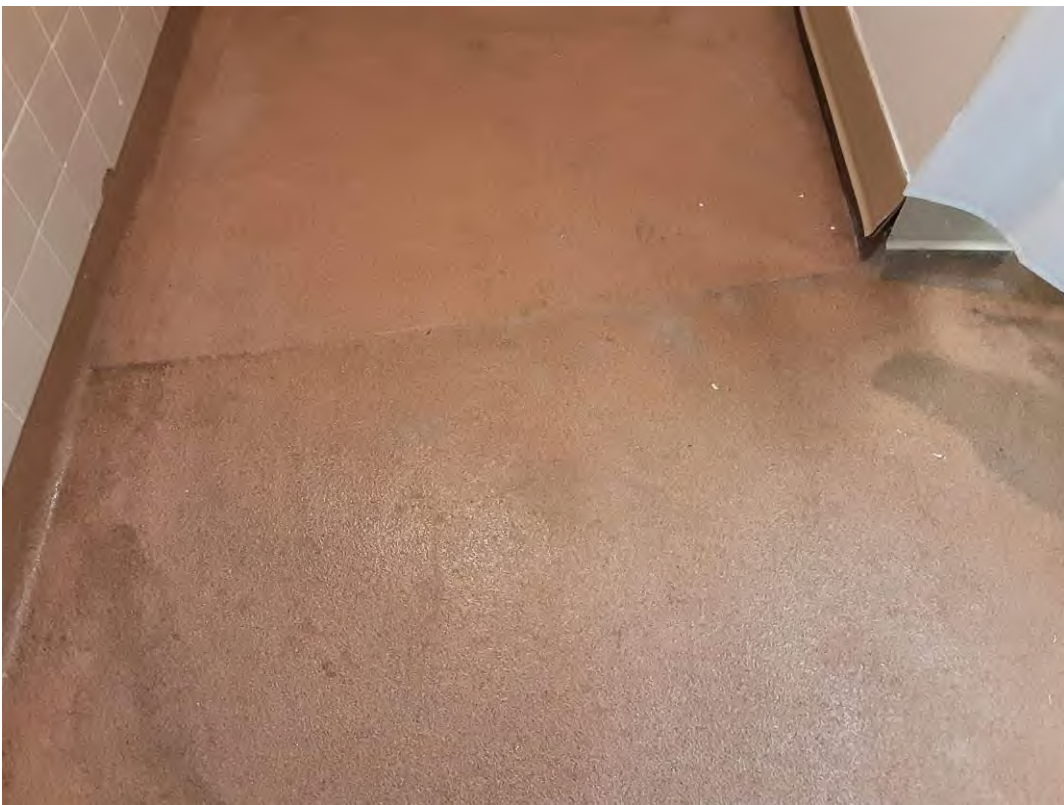
S0015A (None), Floor, Vinyl Sheet Flooring, Shower & Tub Room (Location #: 12)

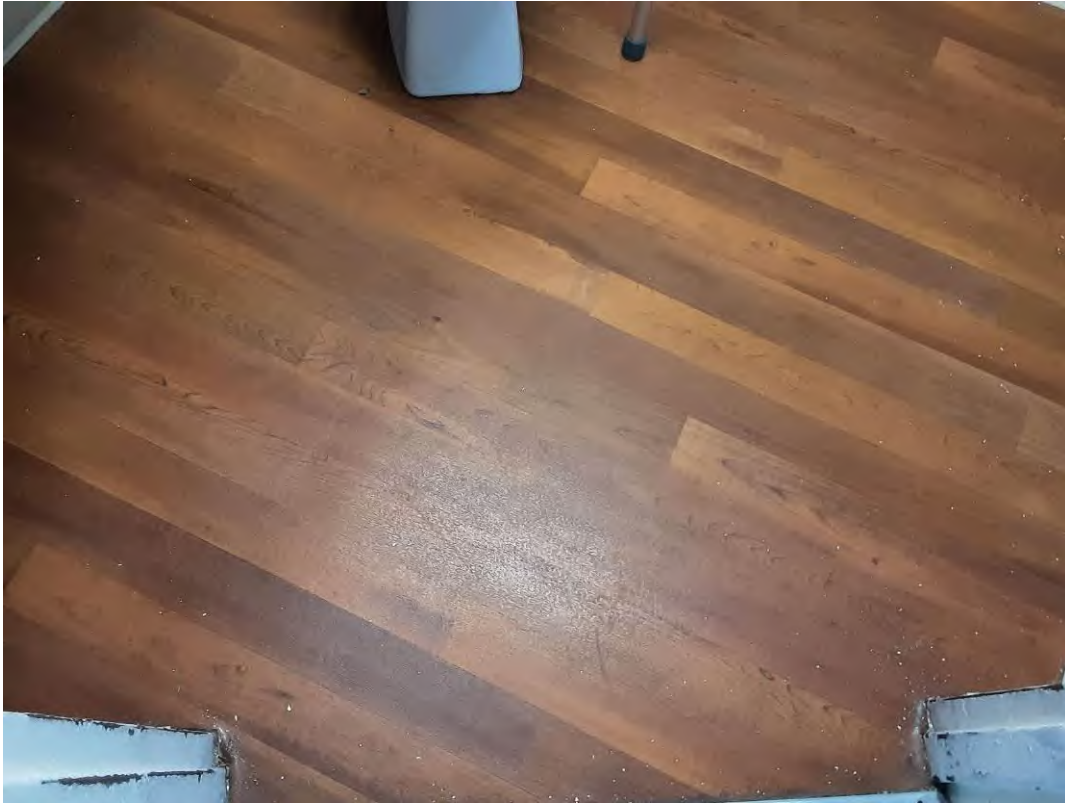
S0018A (None), Floor, Vinyl Sheet Flooring, Tenant Room (Location #: 14)

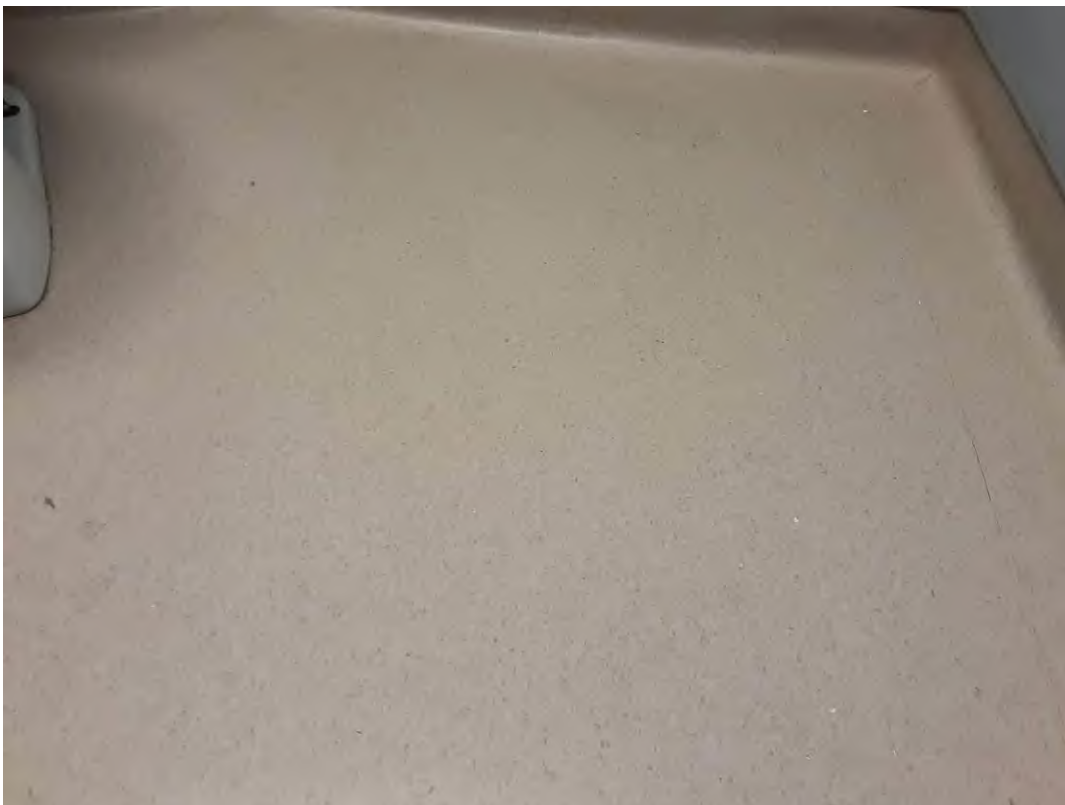
S0019A (None), Floor, Vinyl Sheet Flooring, Tenant Room (Location #: 16)

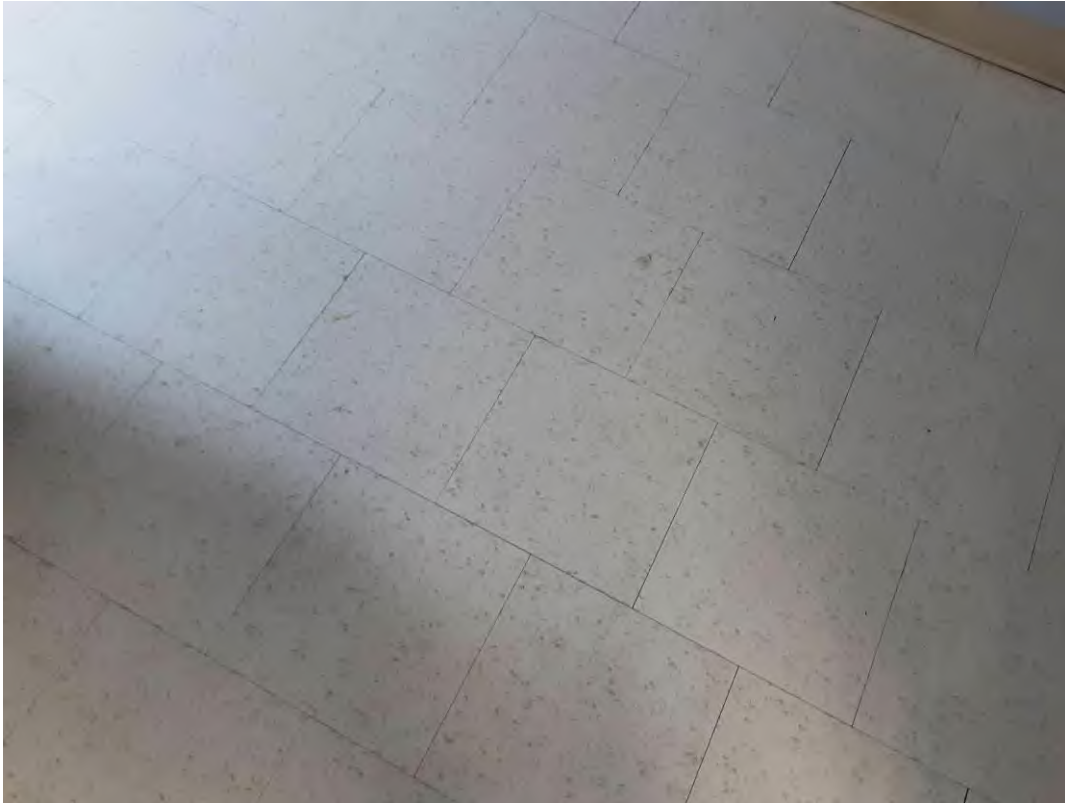
S0020A (None), Floor, All, Vinyl Floor Tile and Mastic, Tenant Room (Location #: 19)

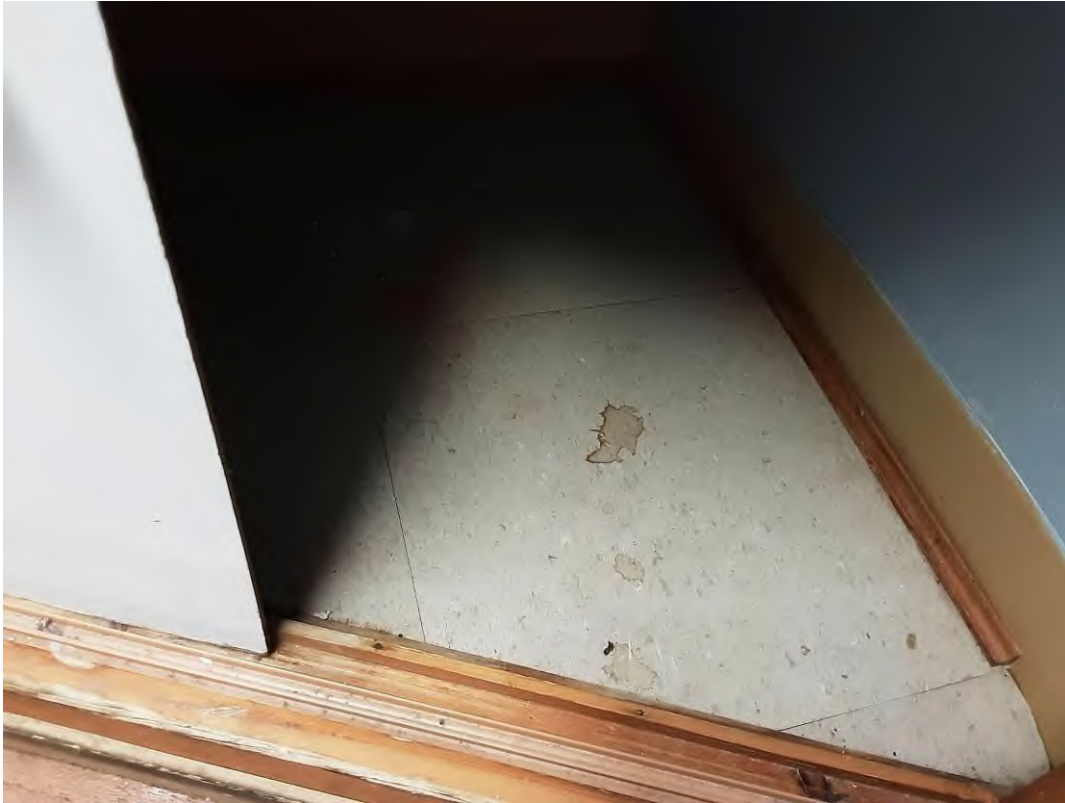
S0021A (None), Floor, Vinyl Floor Tile and Mastic, Tenant Room (Location #: 19)
Under washroom millwork

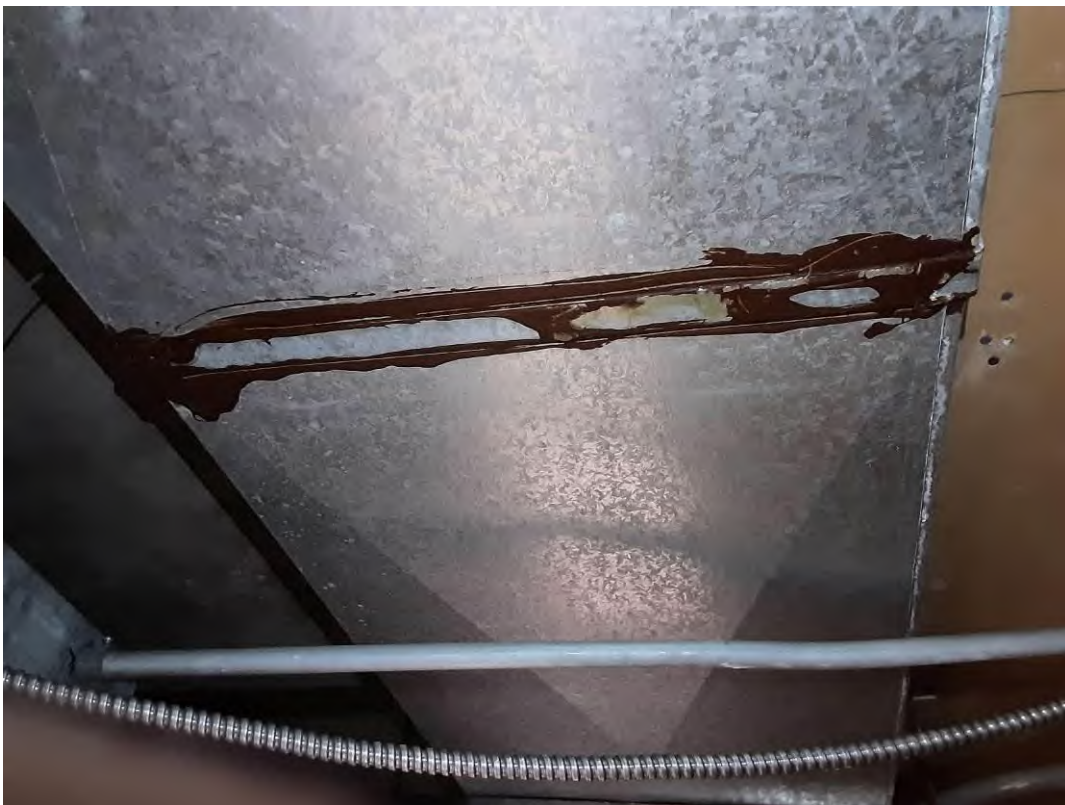
S0029A (None), Duct, Caulking, North Corridor (Location #: 57)

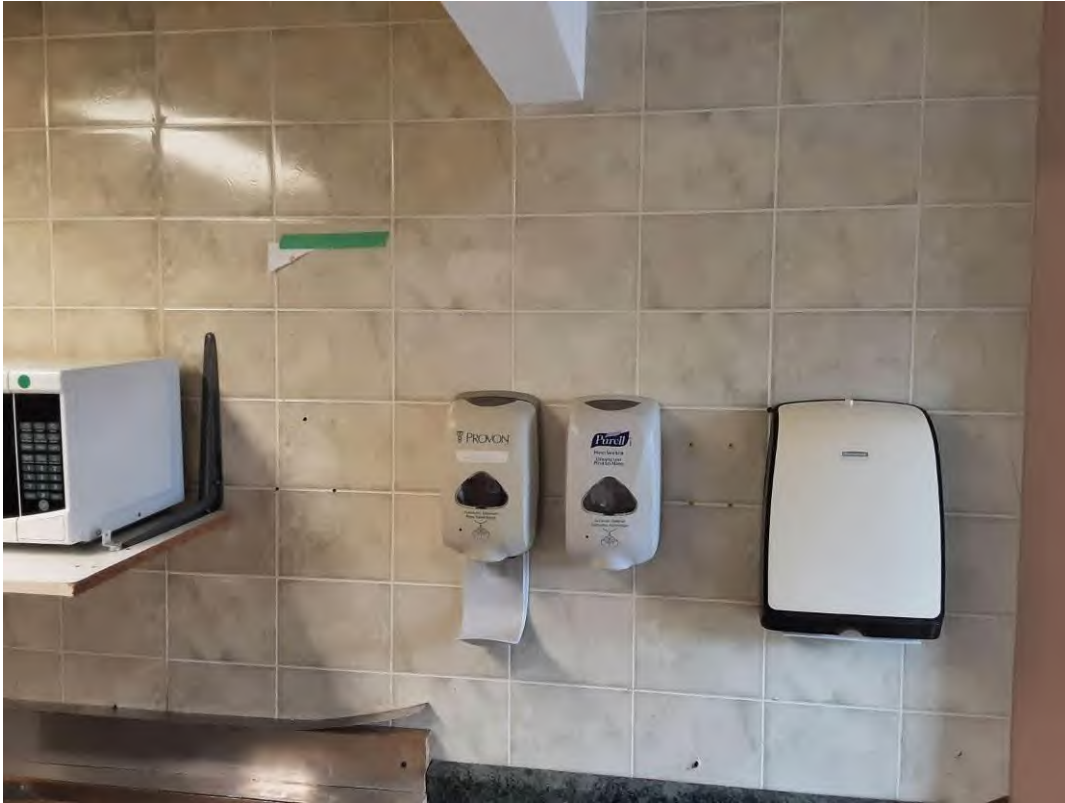
S0030A (None), Wall, Wall covering, Dining Room (Location #: 58)

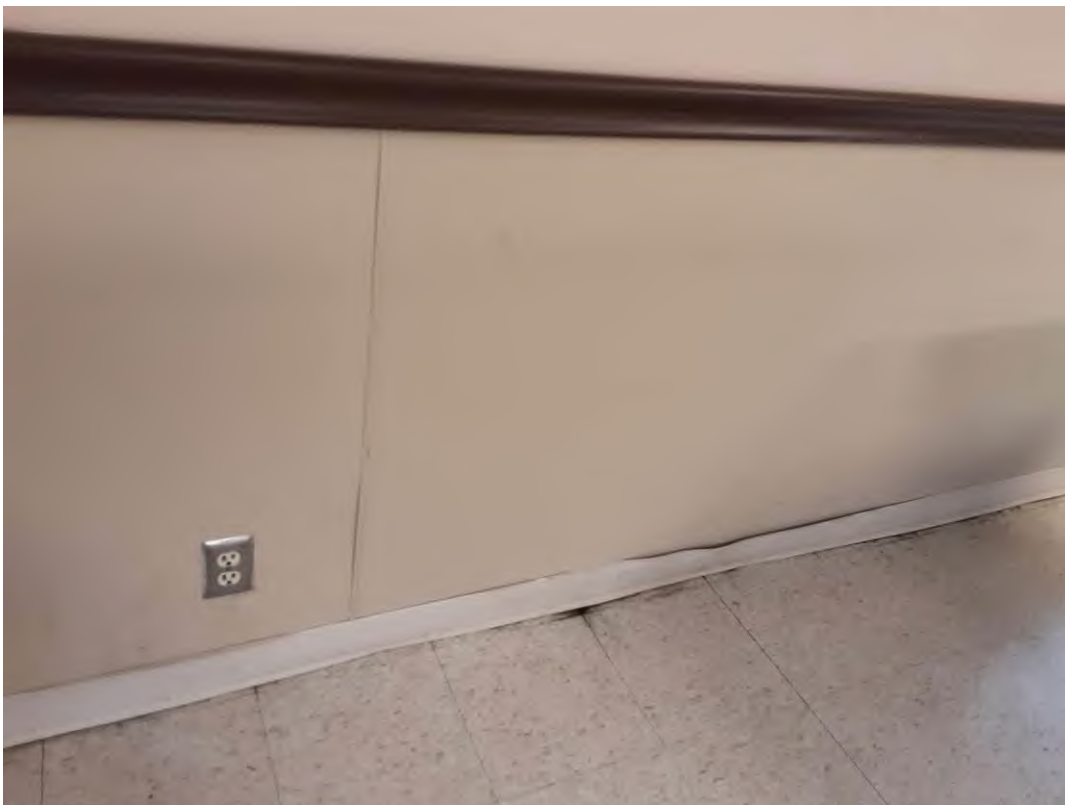
S0031A (None), Wall, Base, Wall covering, Dining Room (Location #: 58)

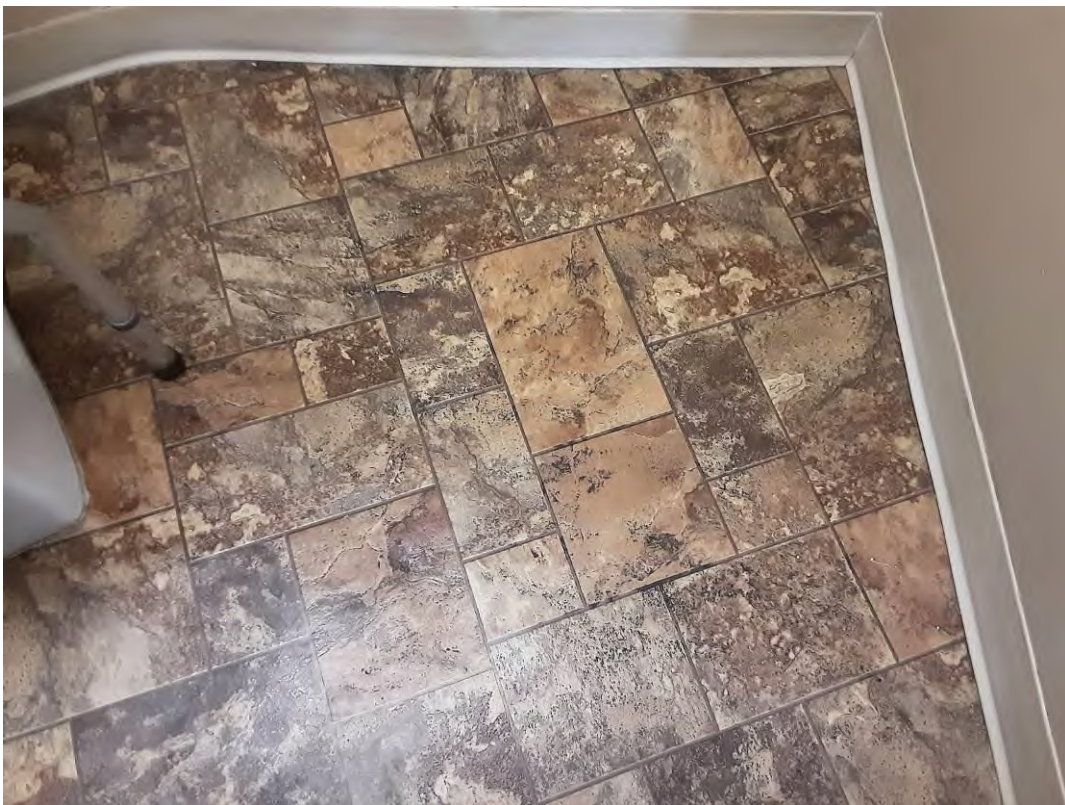
S0034A (Confirmed Asbestos), Floor, Vinyl Sheet Flooring, Tenant Room (Location #: 71)

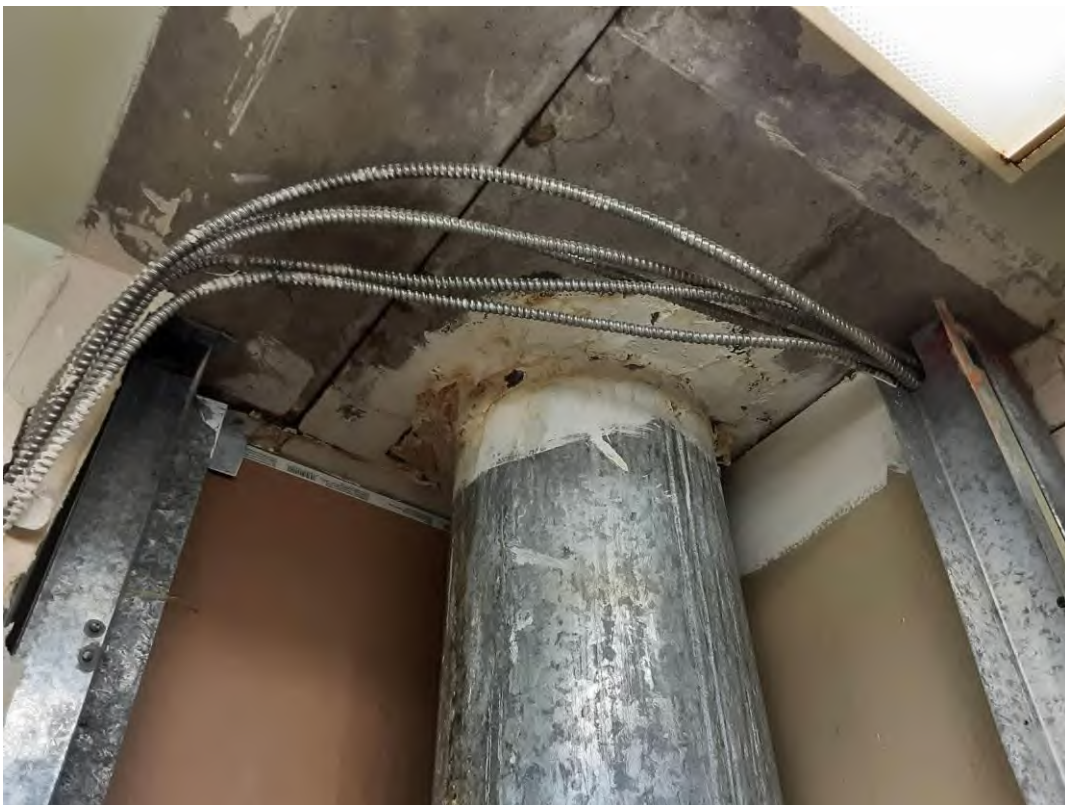
S0035A (None), Duct, Parging Cement, Utility Room (Location #: 79)

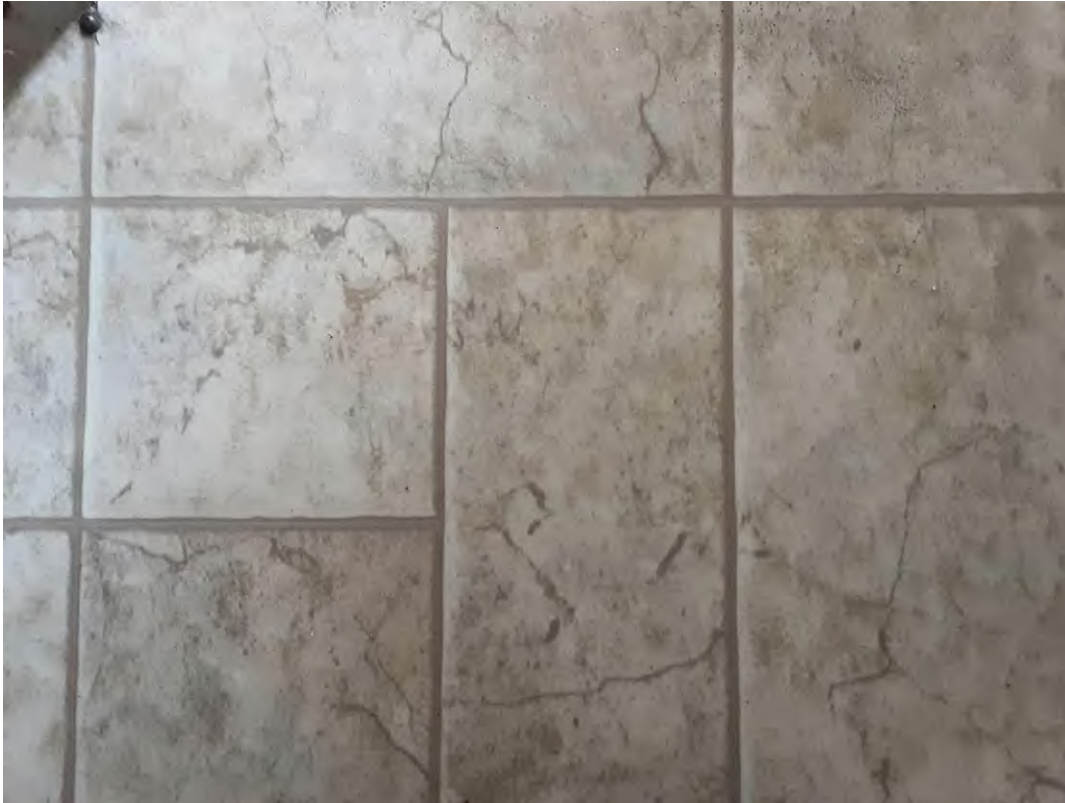
S0037A (None), Floor, Vinyl Sheet Flooring, Tenant Room (Location #: 98)
VFT present in sample is S0001

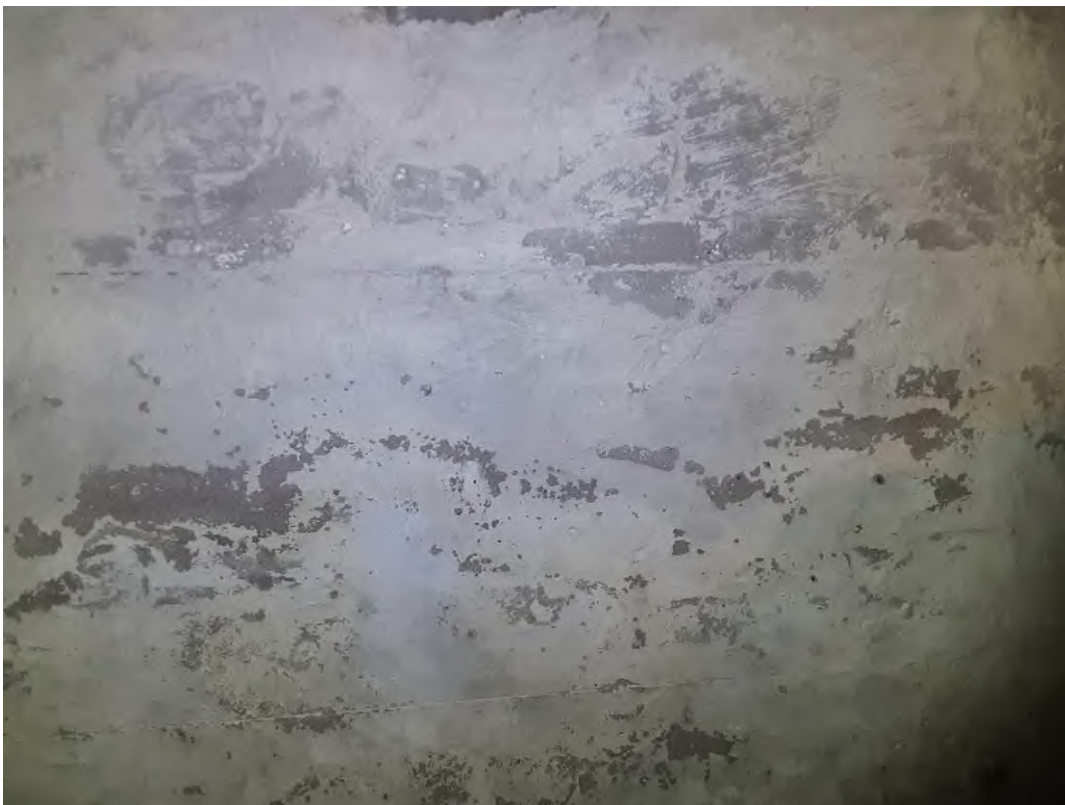
S0041A (None), Wall, All, Plaster, Old House - Basement (Location #: 135)
