- 1. Hazardous Building Materials Assessment (Preconstruction) 1635 Dundas Street East, Whitby, Ontario**

Re: Revised Hazardous Building Materials Assessment (Preconstruction)

Region of Durham (Client) retained Pinchin Ltd. (Pinchin) to conduct a hazardous building materials assessment of Sunnycrest Nursing Home located at 1635 Dundas Street East, Whitby, Ontario.

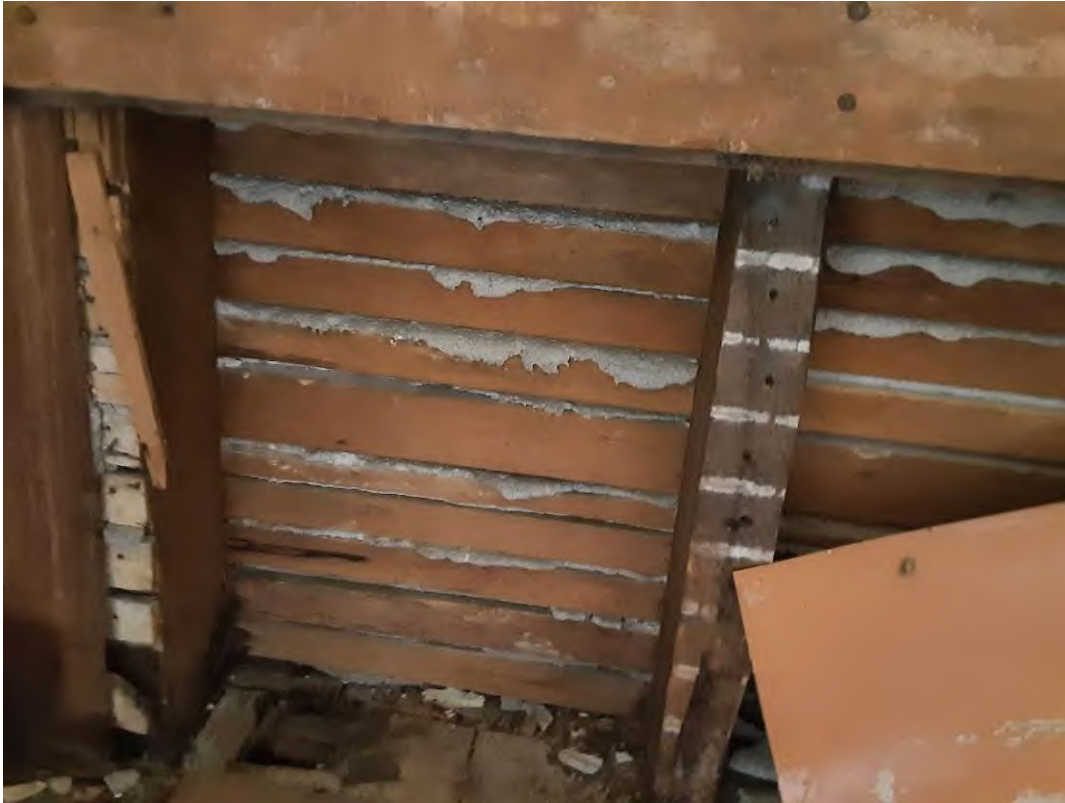
S0041C (None), Wall, All, Plaster, Old House - Ground Floor (Location #: 177)

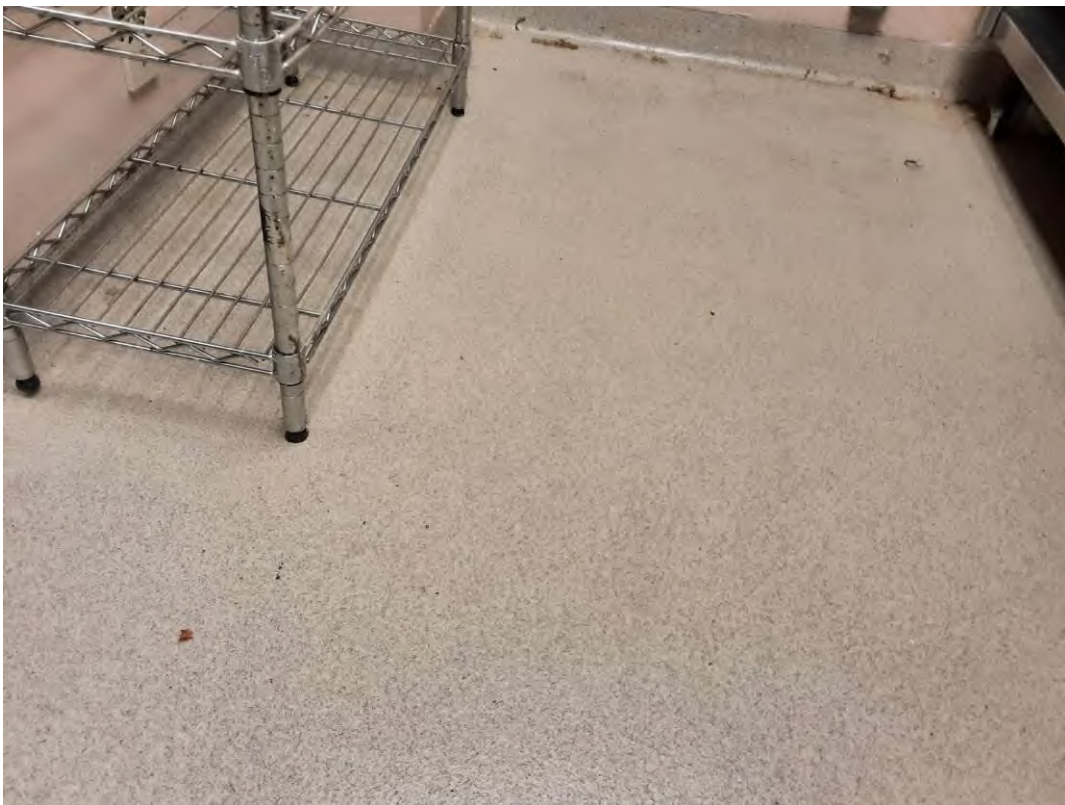
S0045A (None), Floor, All, Vinyl Sheet Flooring, Kitchen Refrigeration (Location #: 139)
Resilient flooring

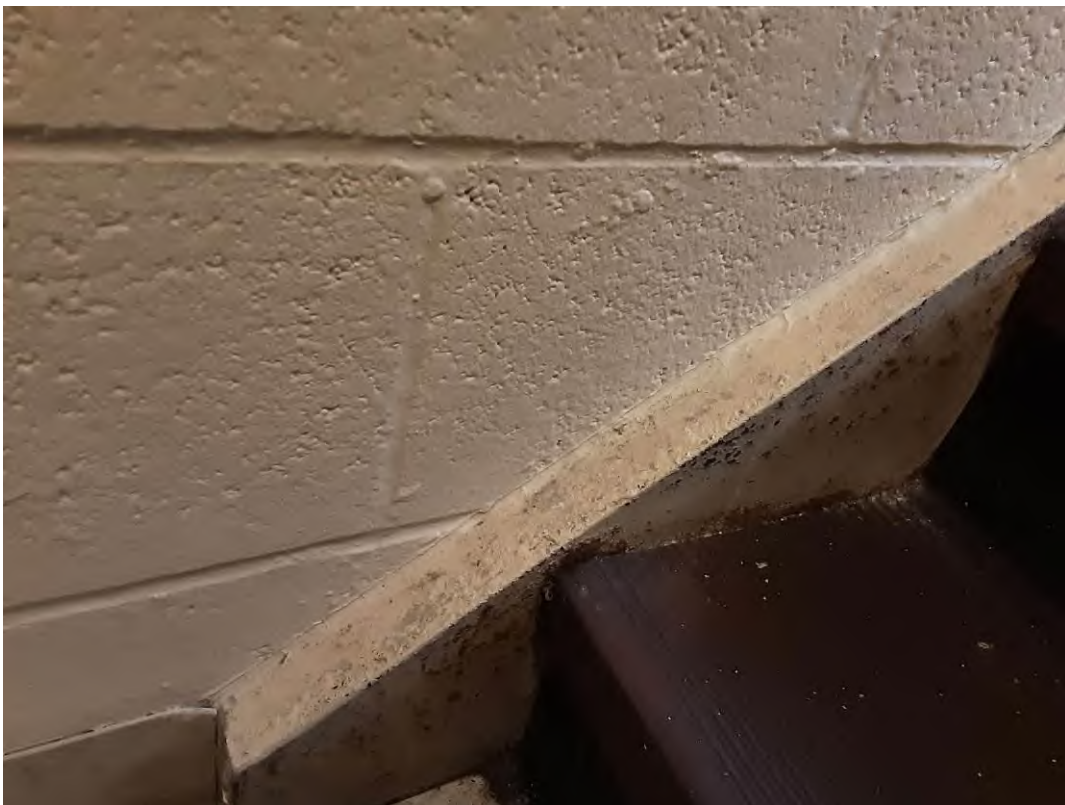
S0047A (None), Structure, Caulking, South Stairwell (Location #: 143)

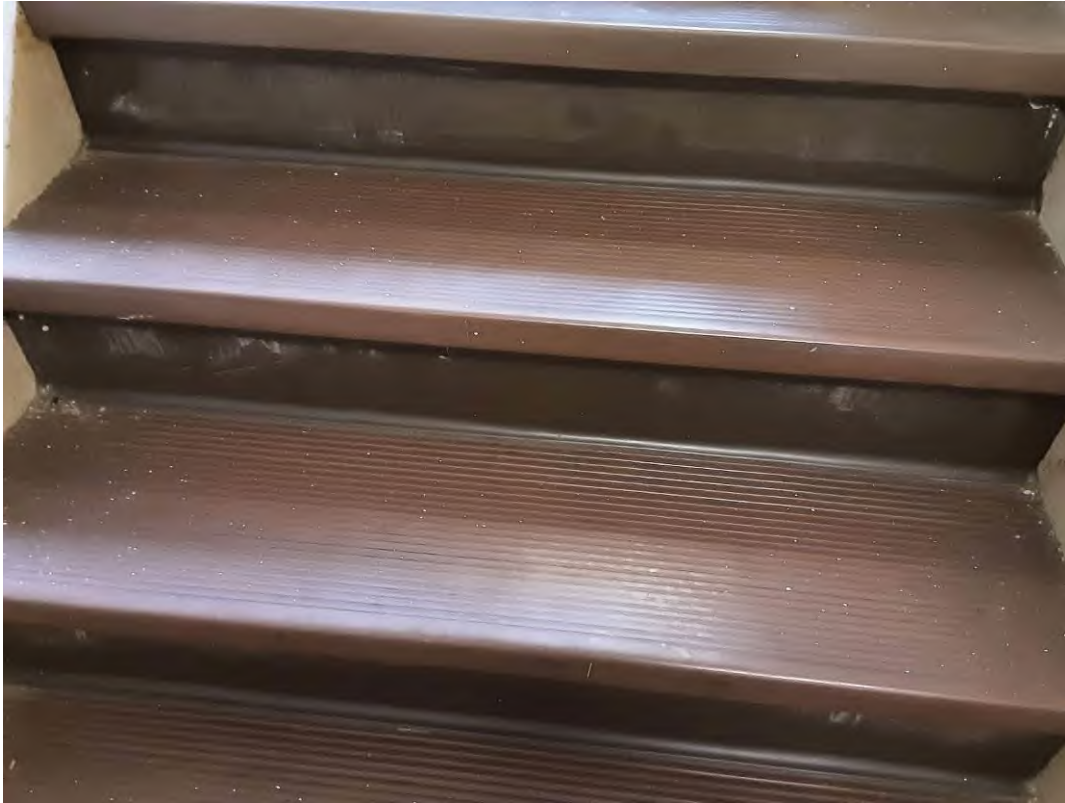
S0048A (None), Floor, Non-slip Flooring, South Stairwell (Location #: 143)

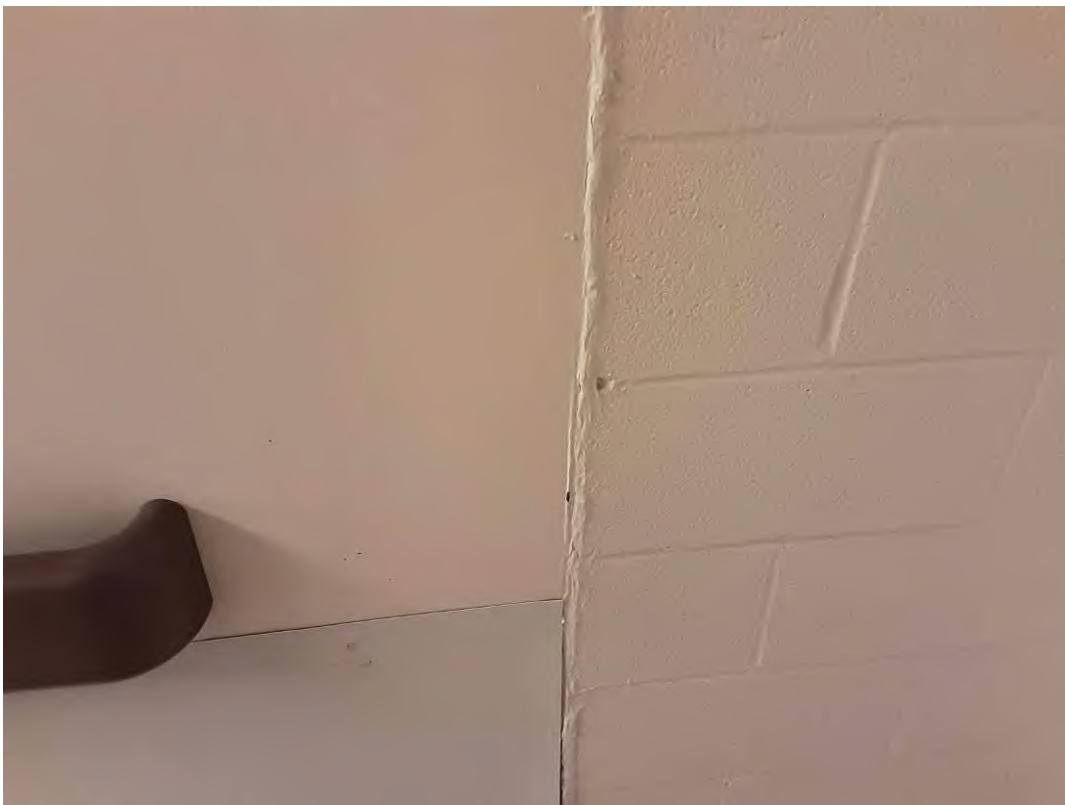
S0049C (None), Wall, Expansion Joint, Caulking, North Corridor (Location #: 106)

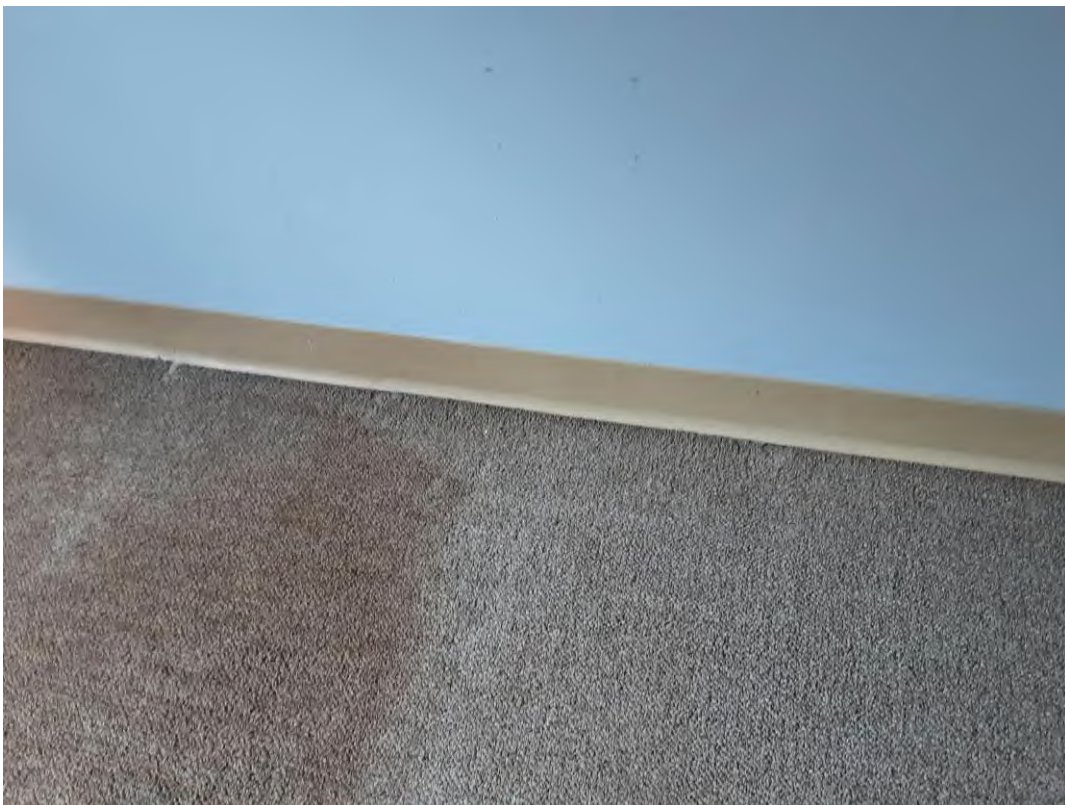
S0052A (None), Wall, Base, Mastic, Medical Supply (Location #: 174)

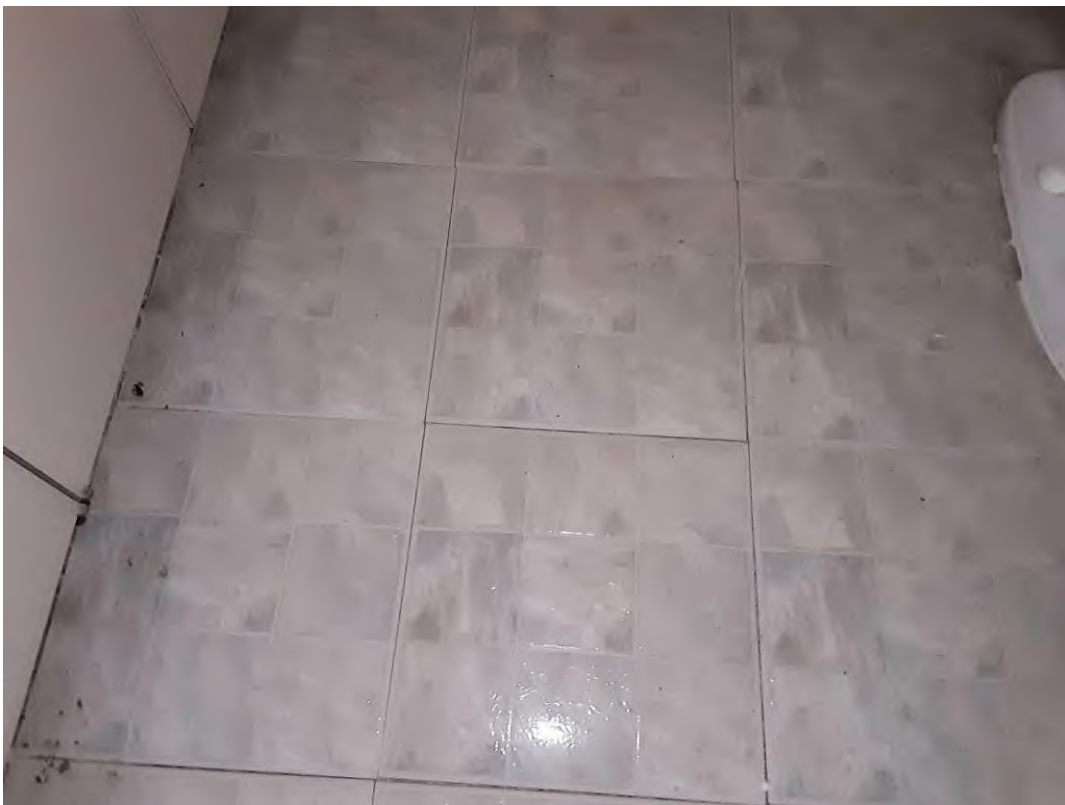
S0054A (Confirmed Asbestos), Floor, Vinyl Floor Tile and Mastic, Records (Location #: 171)

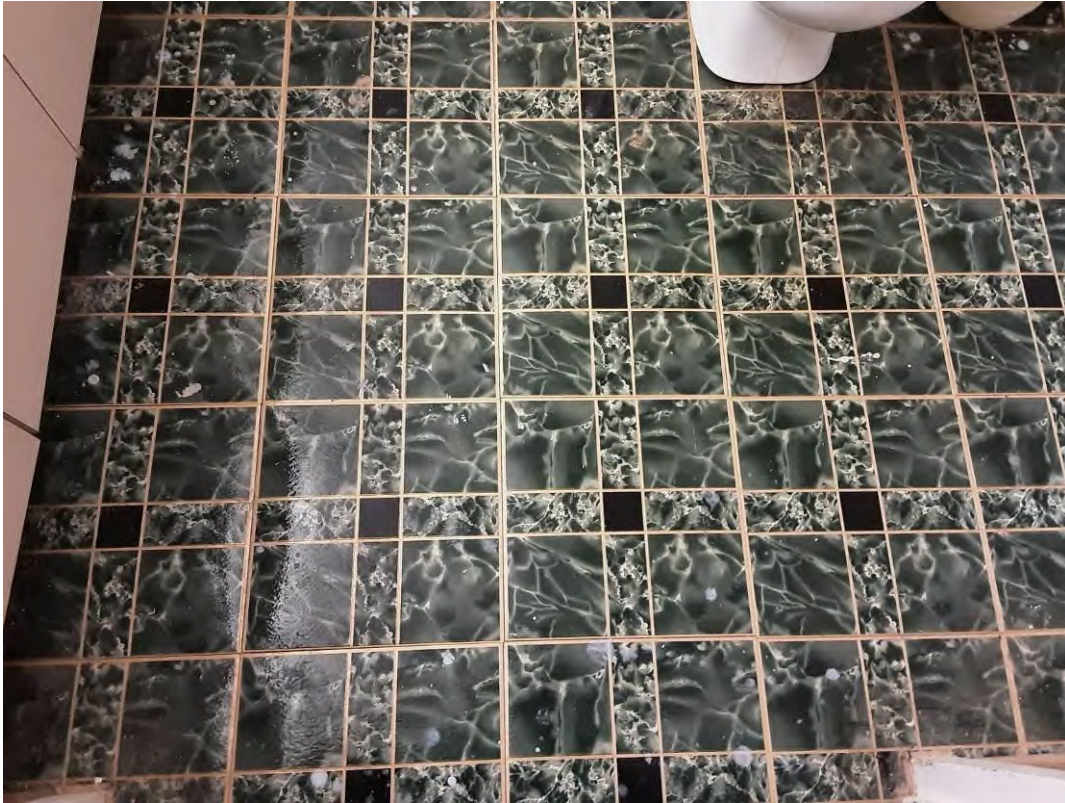
S0055C (Confirmed Asbestos), Floor, Vinyl Floor Tile and Mastic, Maintenance Supplies (Location #: 176)

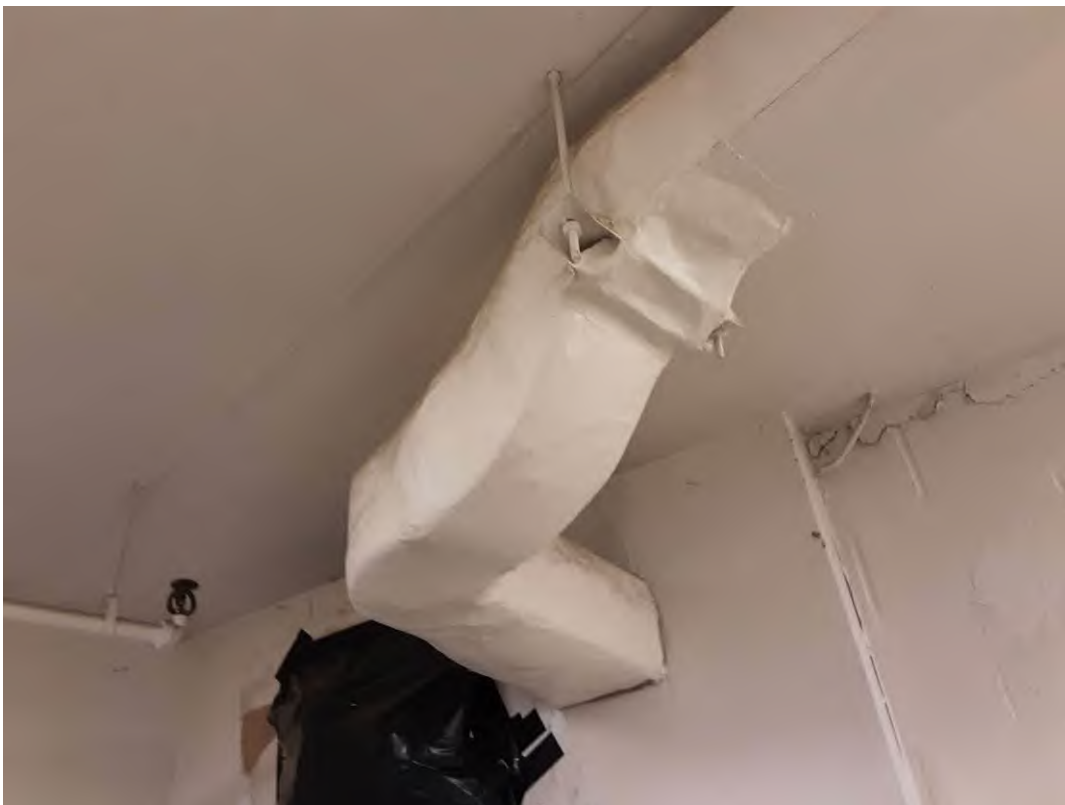
S0056C (None), Duct, Thermal Insulation, Maintenance Shop (Location #: 166)

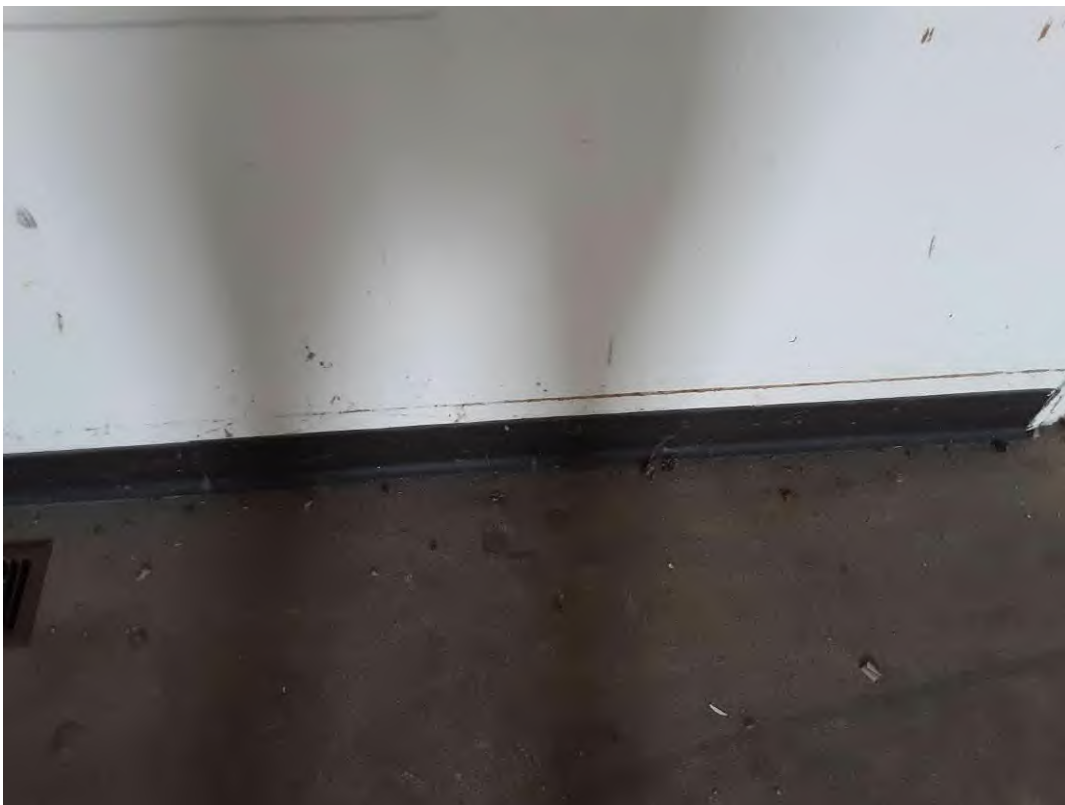
S0061C (None), Wall, Base, Adhesive/mastic, Old House - Ground Floor (Location #: 177)

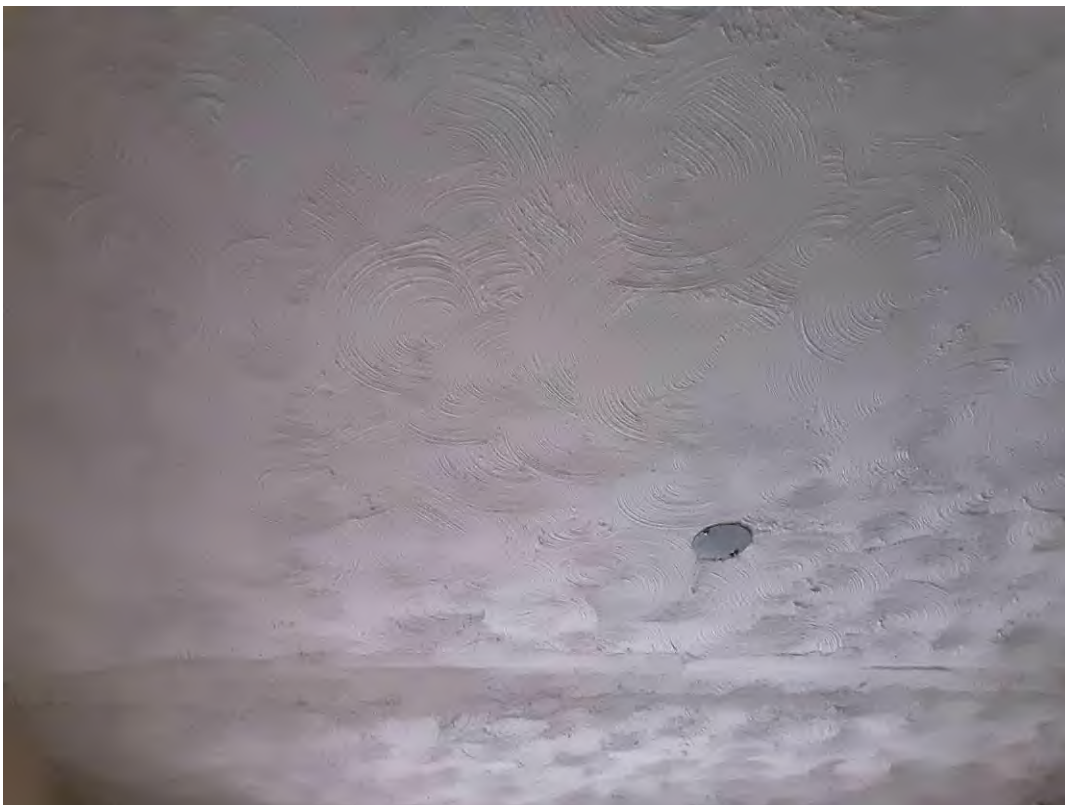
S0064C (None), Ceiling, Texture Coat, Old House - Ground Floor (Location #: 177)

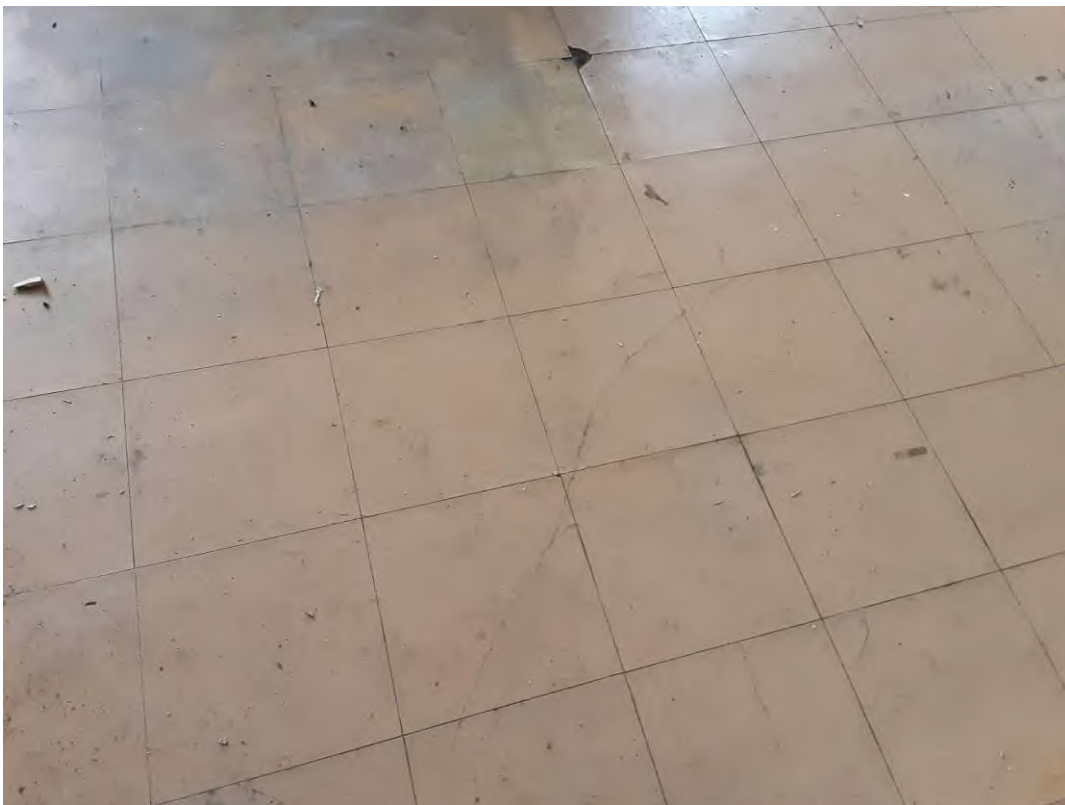
S0066C (Confirmed Asbestos), Floor, Vinyl Floor Tile and Mastic, Old House - 2nd Floor (Location #: 178)

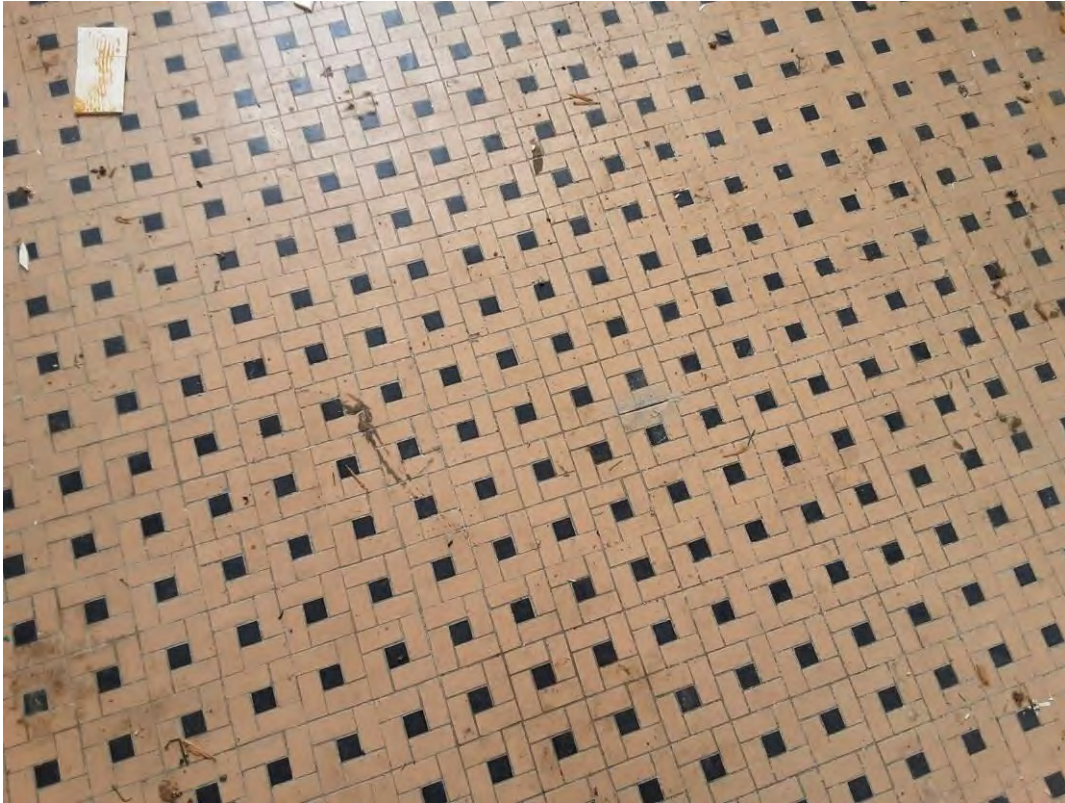
S0067C (None), Floor, Mortar, Old House - 2nd Floor (Location #: 178)

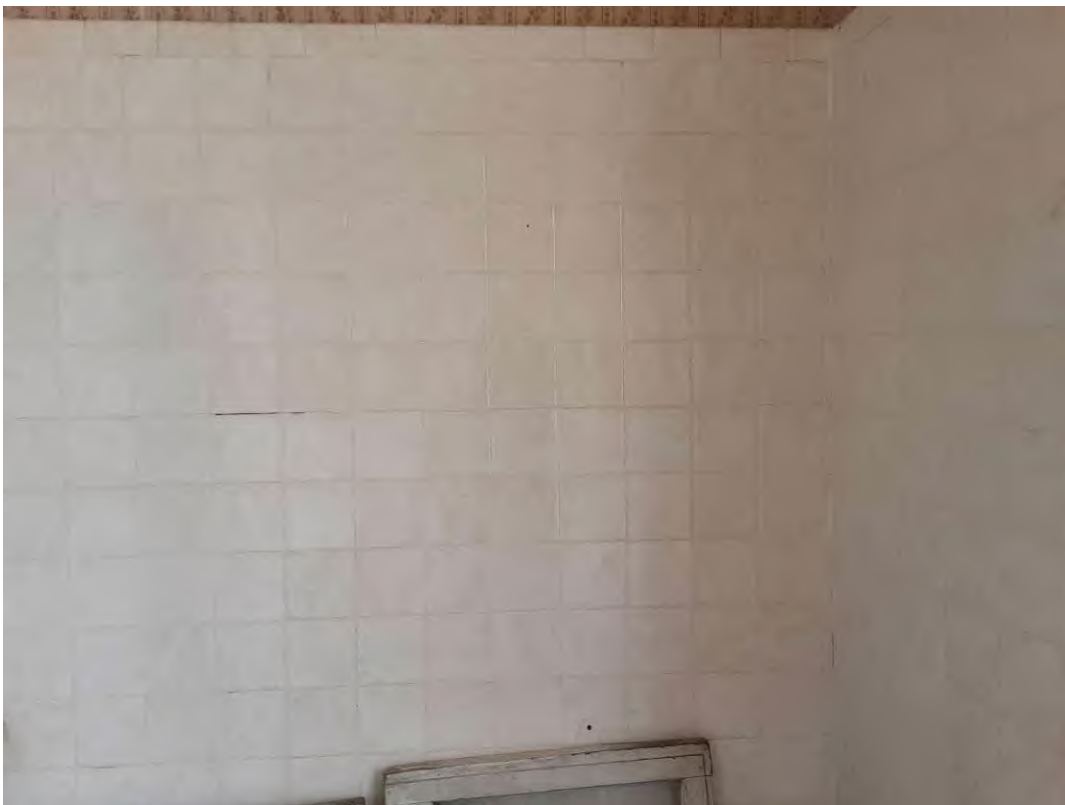
S0068C (None), Wall, Mortar, Old House - 2nd Floor (Location #: 178)

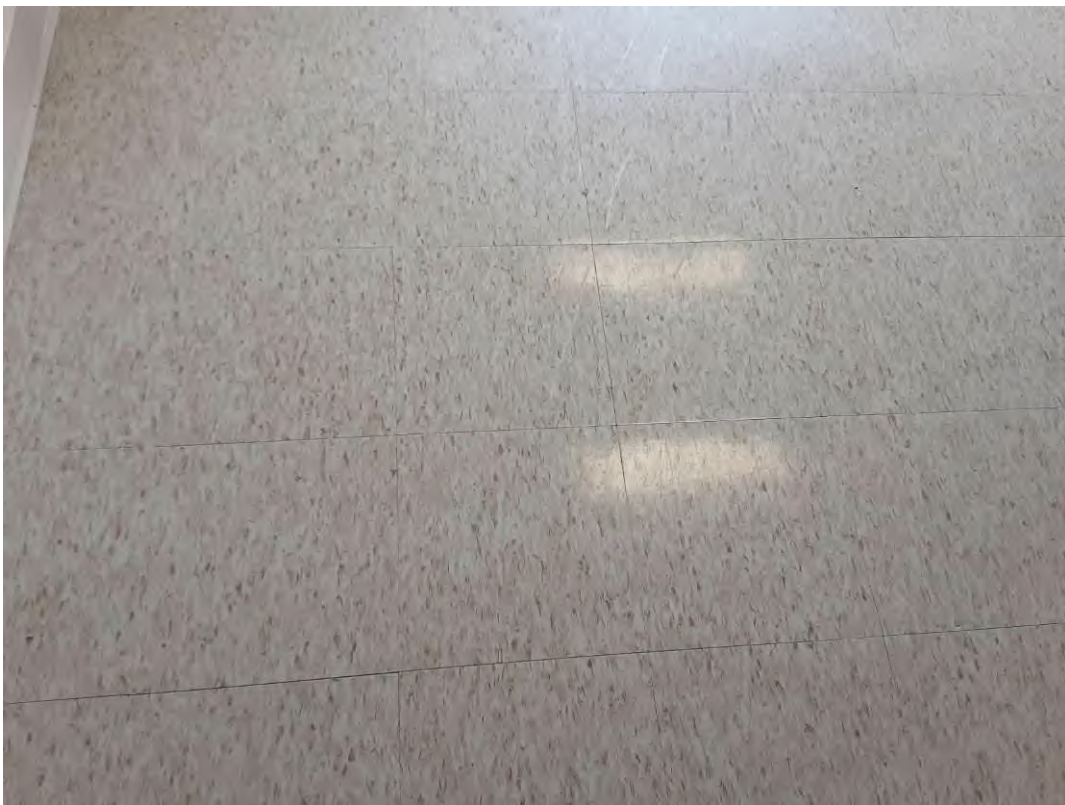
S0070A (None), Floor, Vinyl Floor Tile and Mastic, Office (Location #: 161)

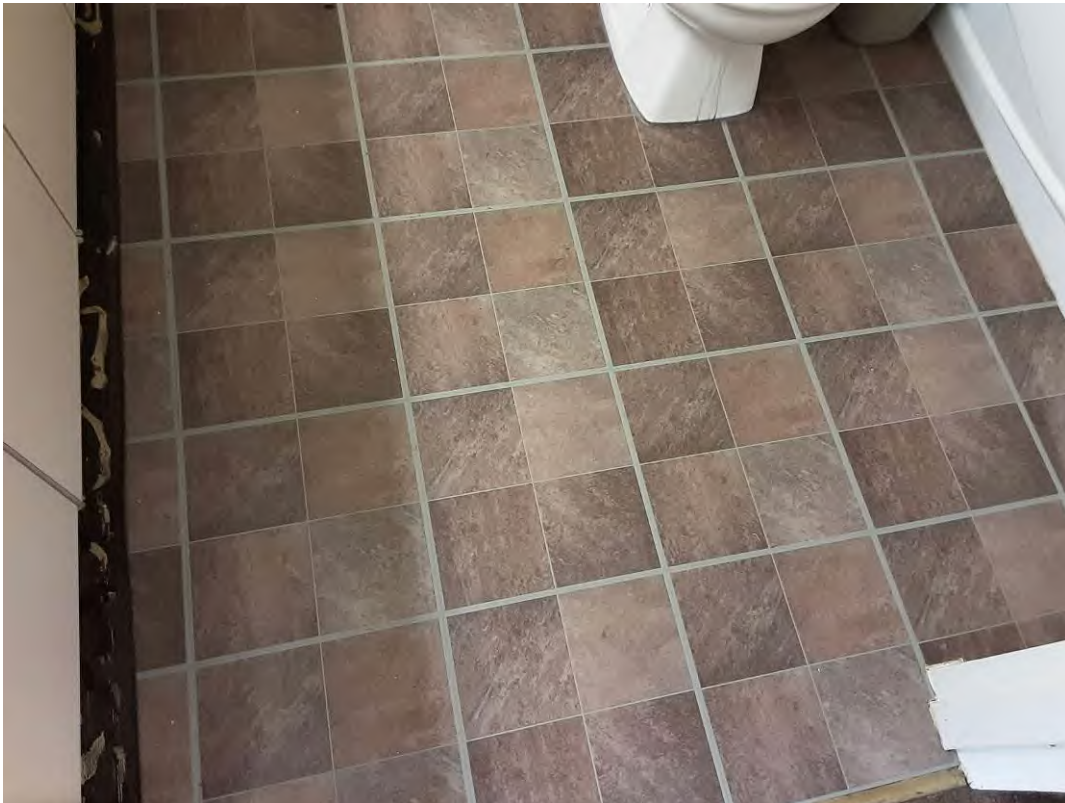
S0071C (Confirmed Asbestos), Floor, Vinyl Floor Tile and Mastic, Accounting Storage (Location #: 157)

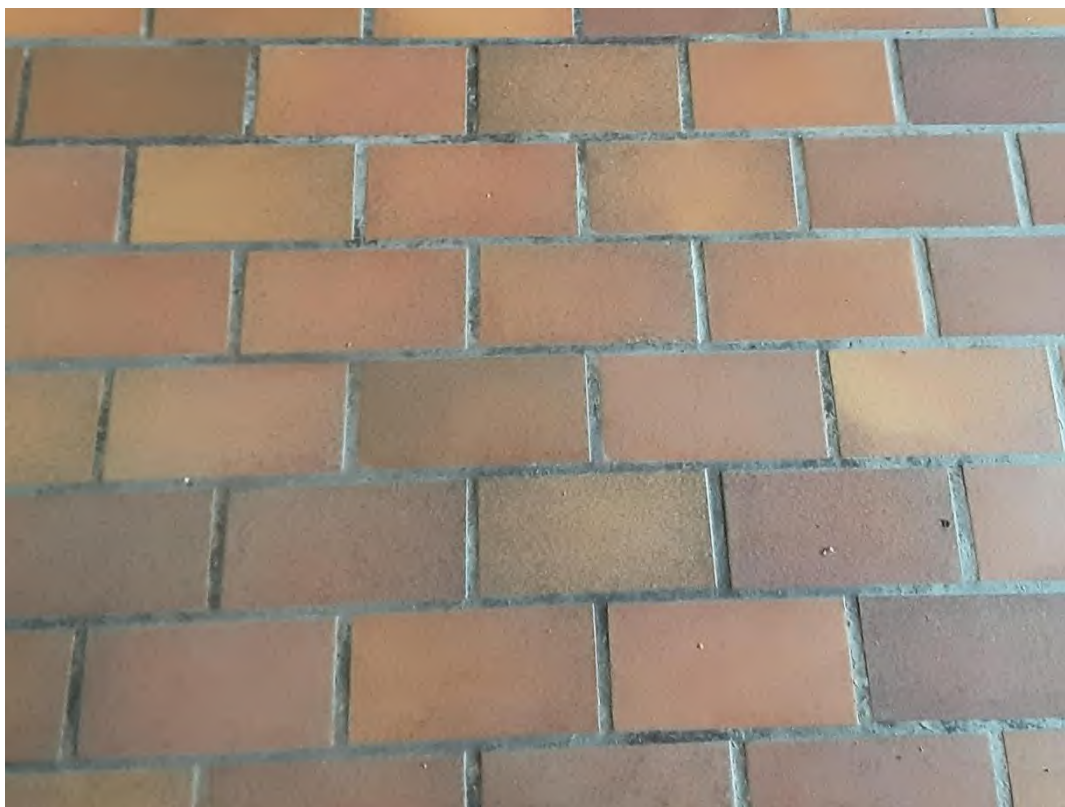
S0079A (Confirmed Asbestos), Floor, Mortar, under 2" x 6" red faux brick ceramic tile, Vestibule (Location #: 116)

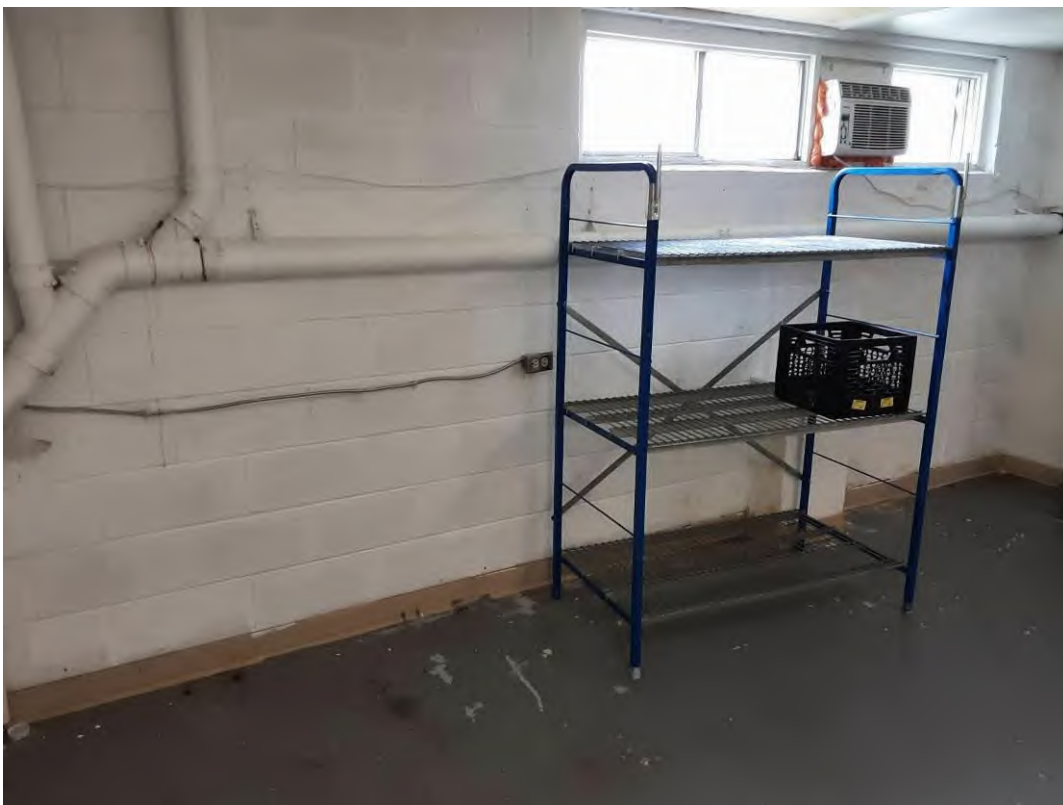
V9000 (Confirmed Asbestos), Piping, Rain Water Leader, Cement Product, Dietary Storage (Location #: 130)

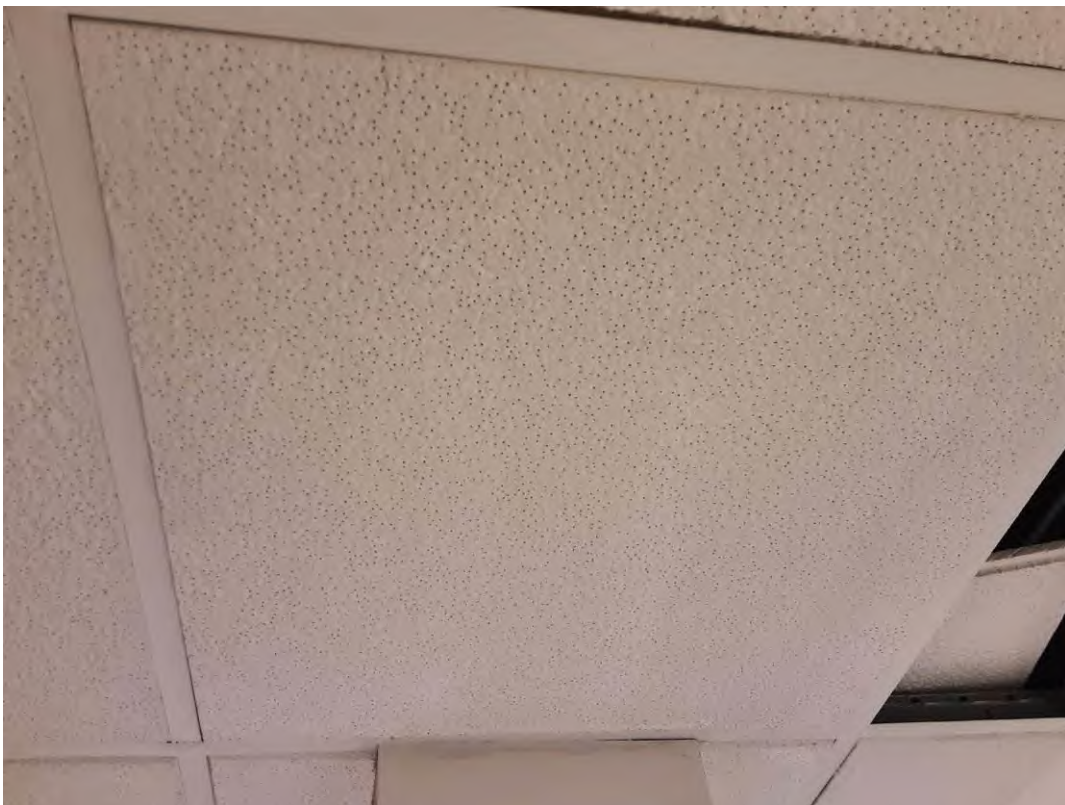
V0000 (None), Ceiling, Ceiling Tiles (lay-in), Dining Room (Location #: 113)
Date code 2004

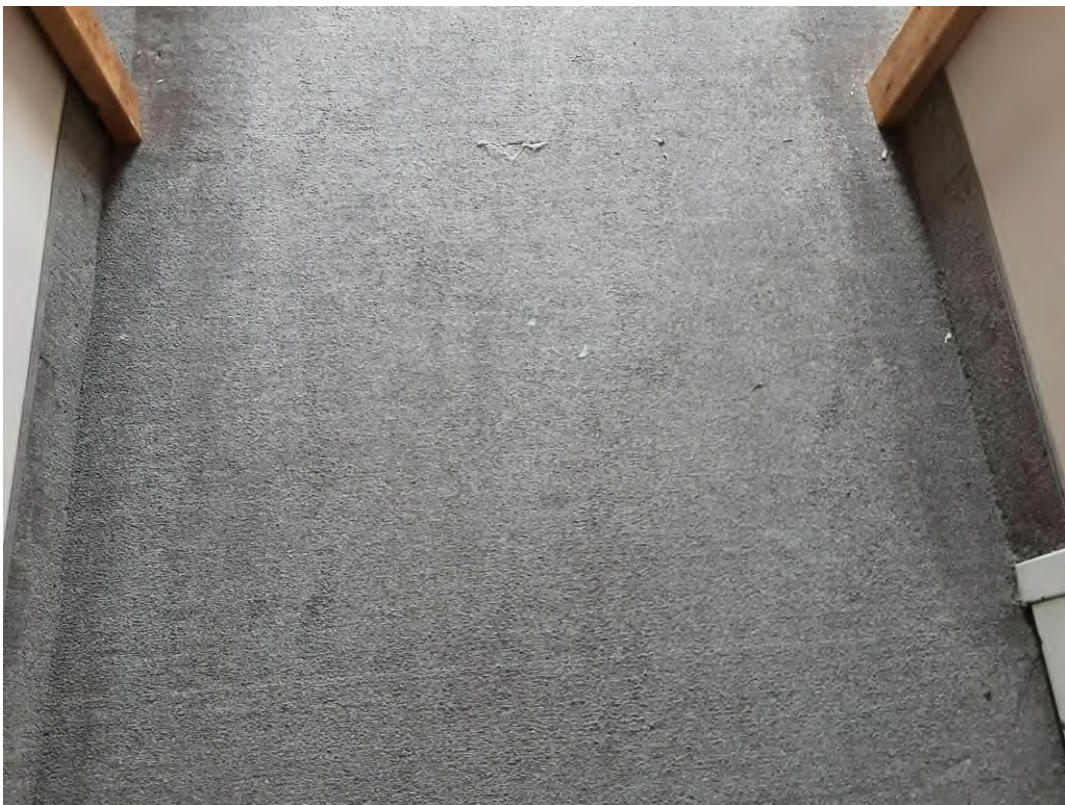
V0000 (None), Floor, Carpet, Records (Location #: 170)

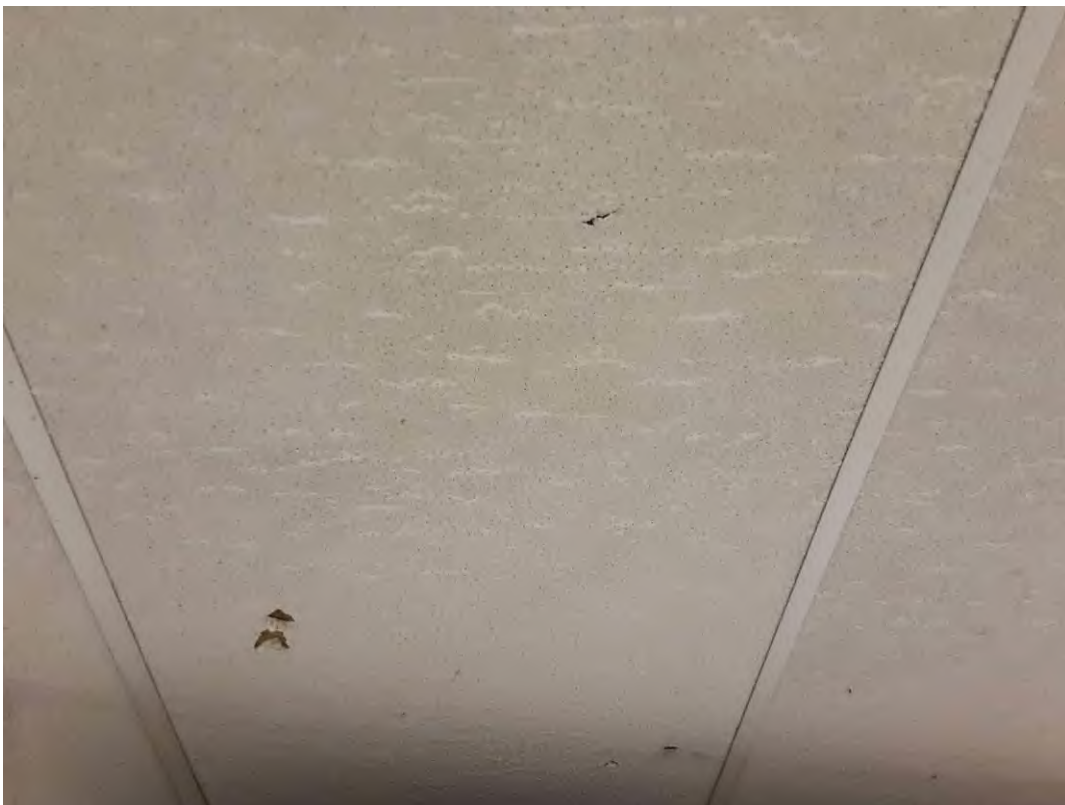
V0000 (None), Ceiling, All, Ceiling Tiles (lay-in), Med Room (Location #: 32)
Fiberglass lay-in ceiling tile

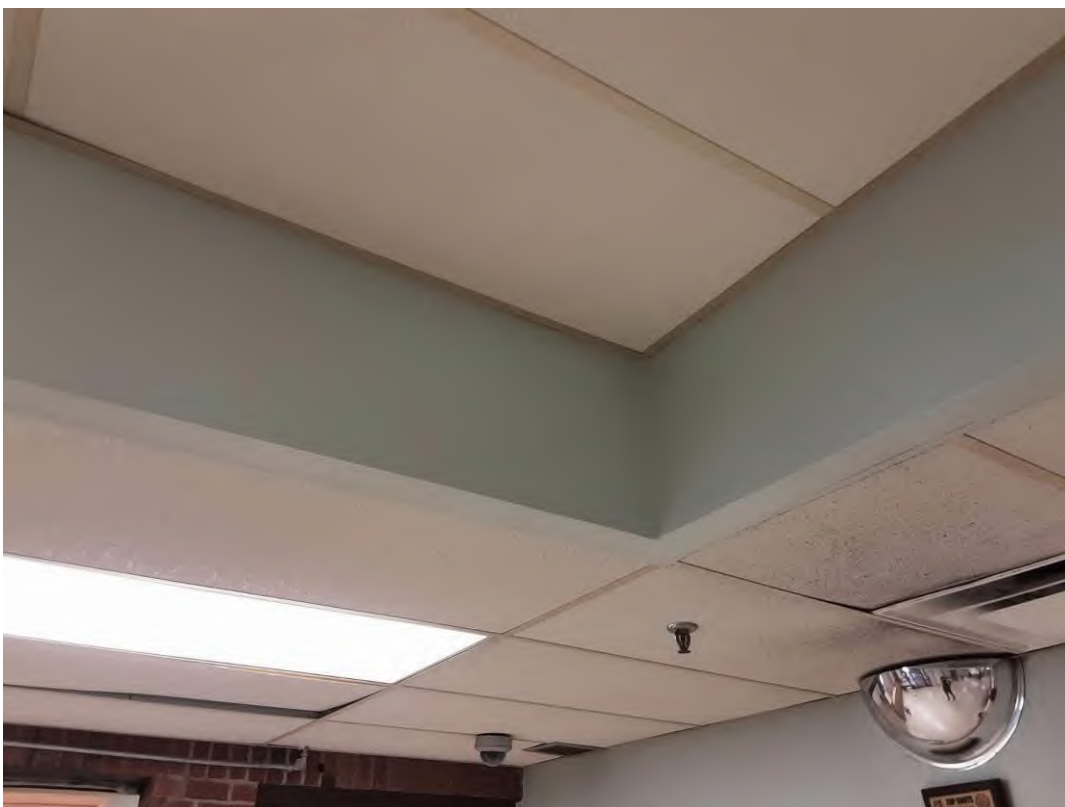
V0000 (None), Ceiling, Drywall (no compound), Lobby (Location #: 4)
Mechanically fastened

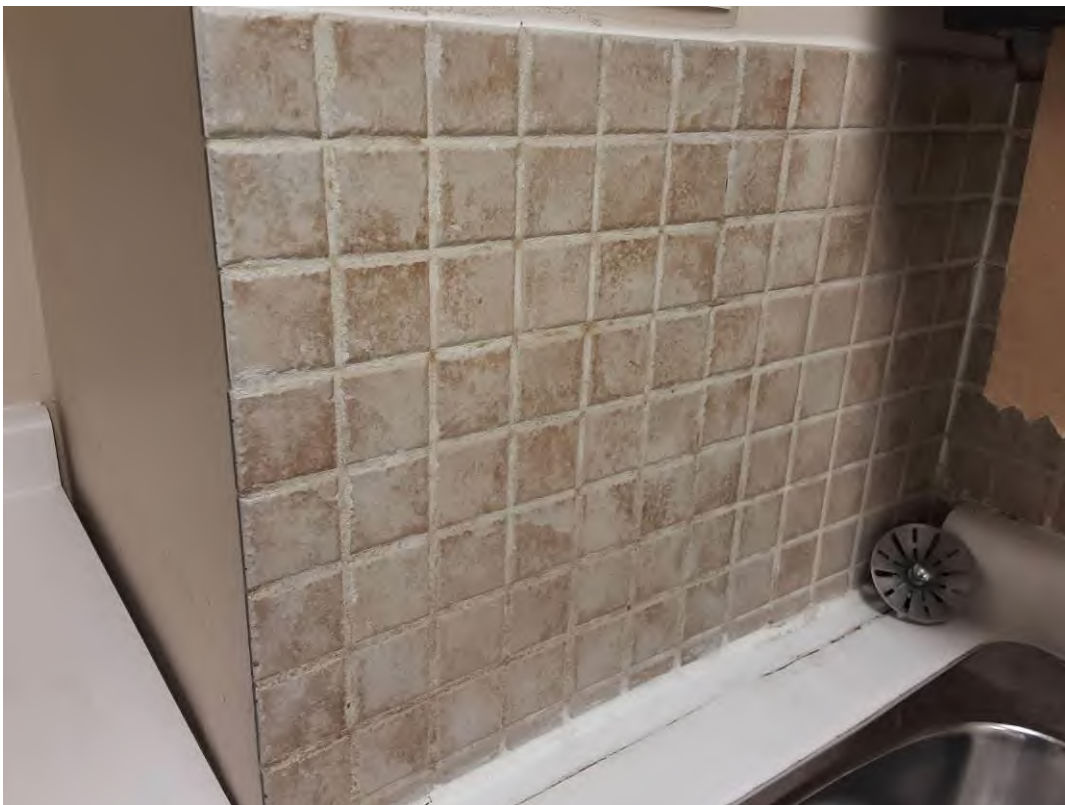
V0000 (None), Wall, Ceramic Tiles, Kitchenette (Location #: 81)

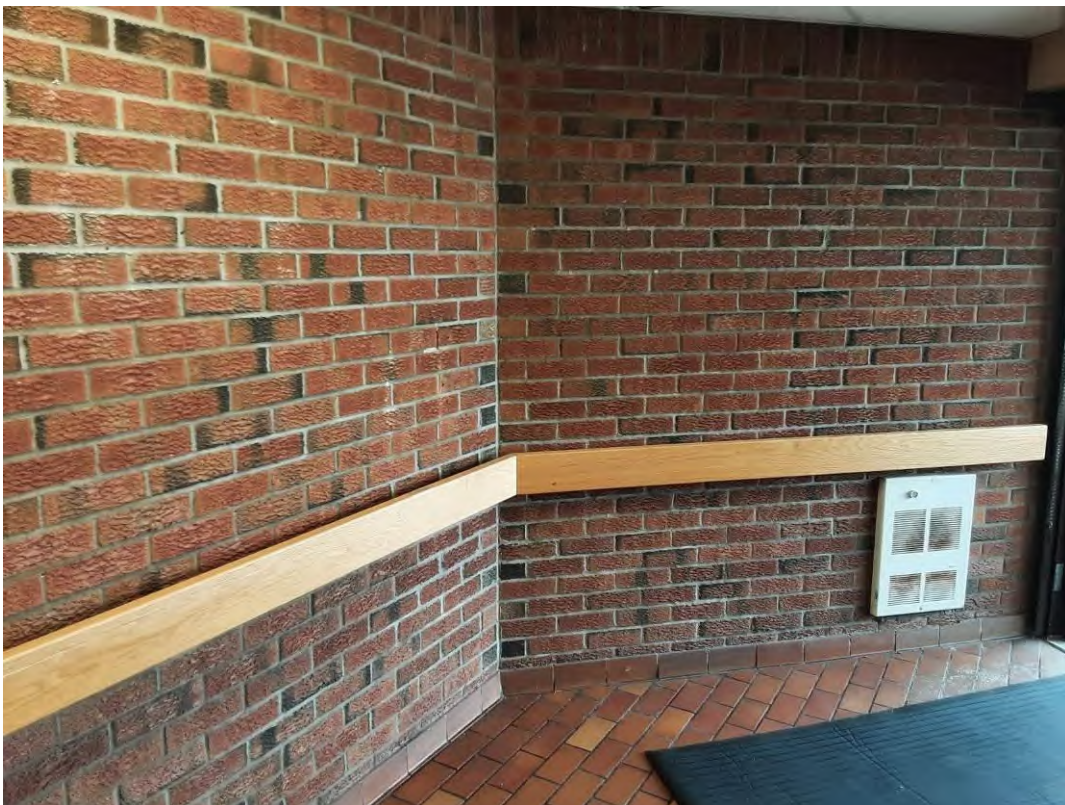
Wall, All, Masonry, Vestibule (Location #: 3)

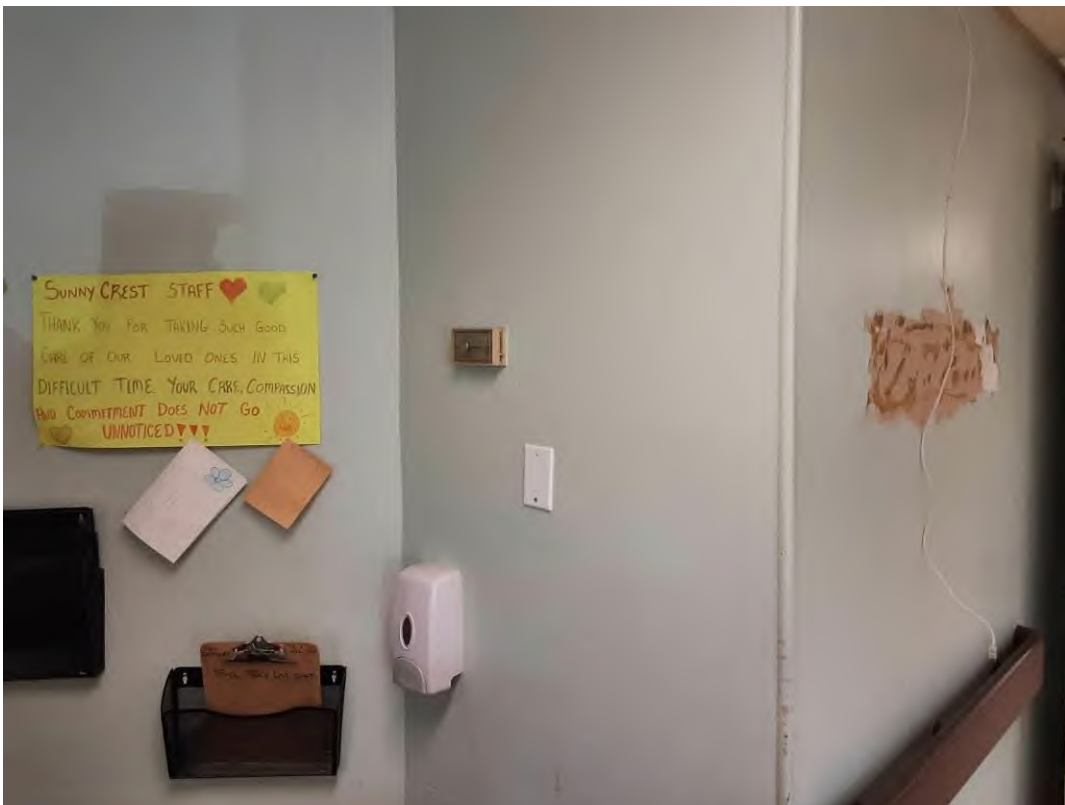
Drywall and joint compound, Light blue/teal paint, L0001, Lobby (Location #: 4)
