Re: Revised Hazardous Building Materials Assessment (Preconstruction)

Sunnycrest Nursing Home, 1635 Dundas Street East, Whitby, Ontario

Pinchin File: 329911.000

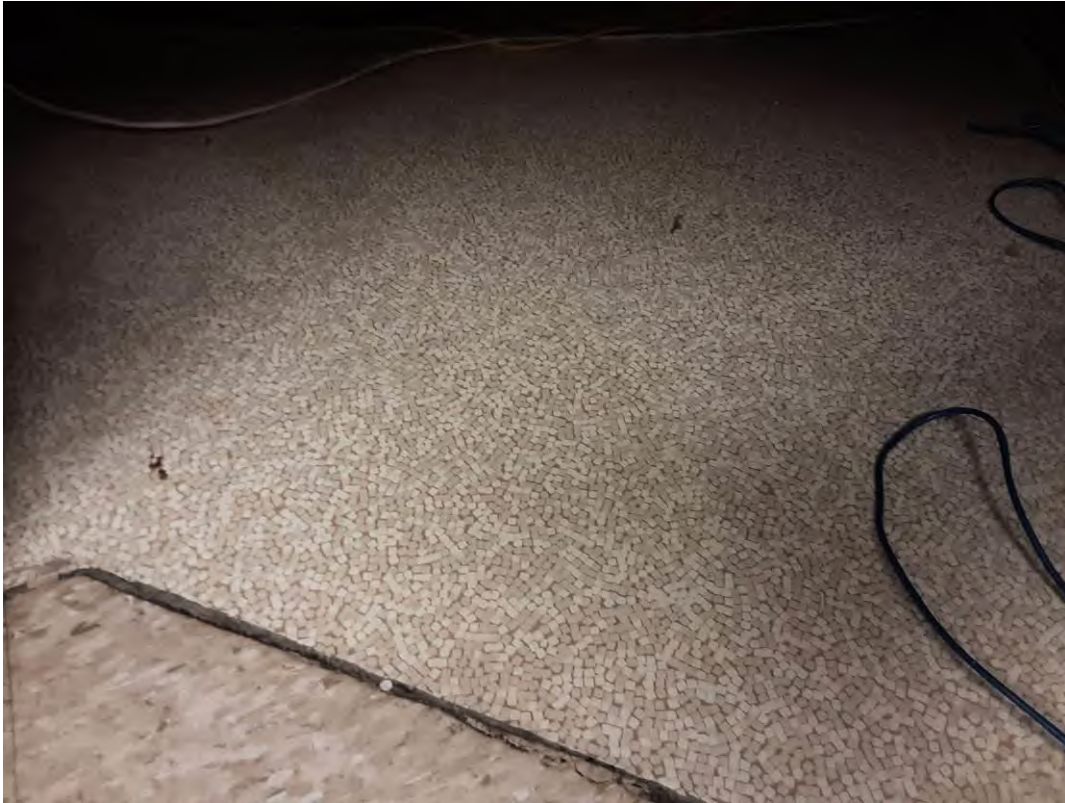
S0004A (Confirmed Asbestos), Floor, Vinyl Sheet Flooring, Lobby (Location #: 4)

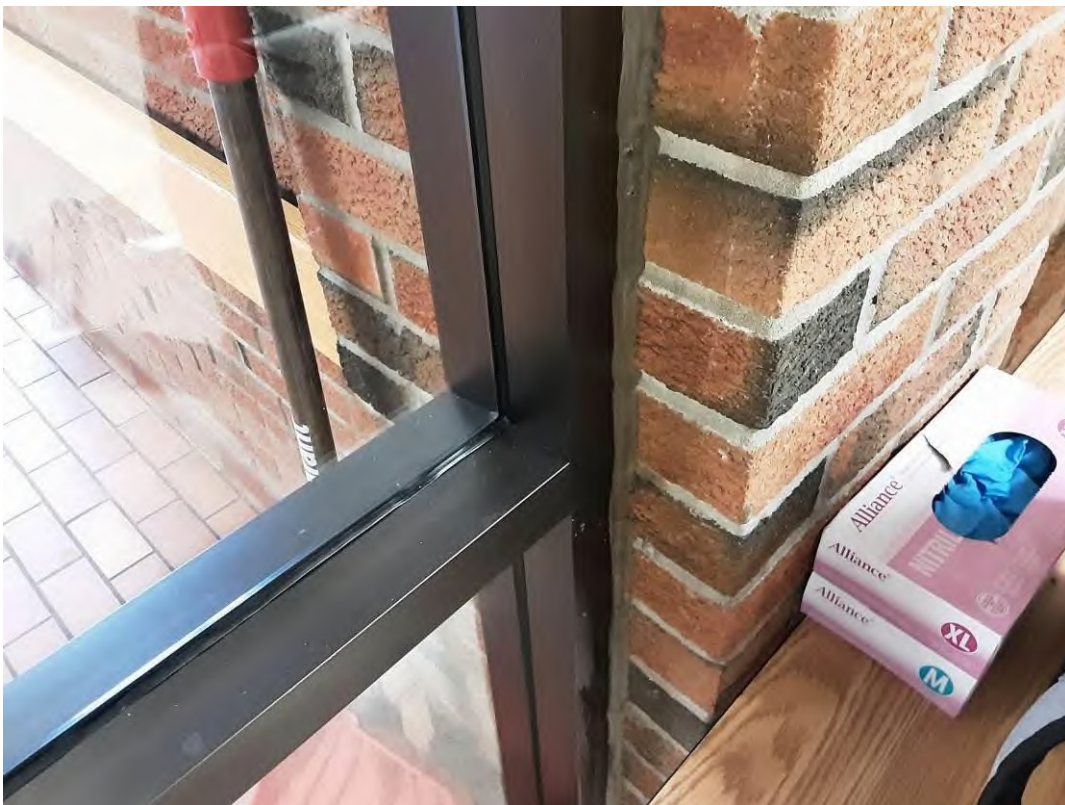
S0005A (None), Other, Door, Caulking, Lobby (Location #: 4)

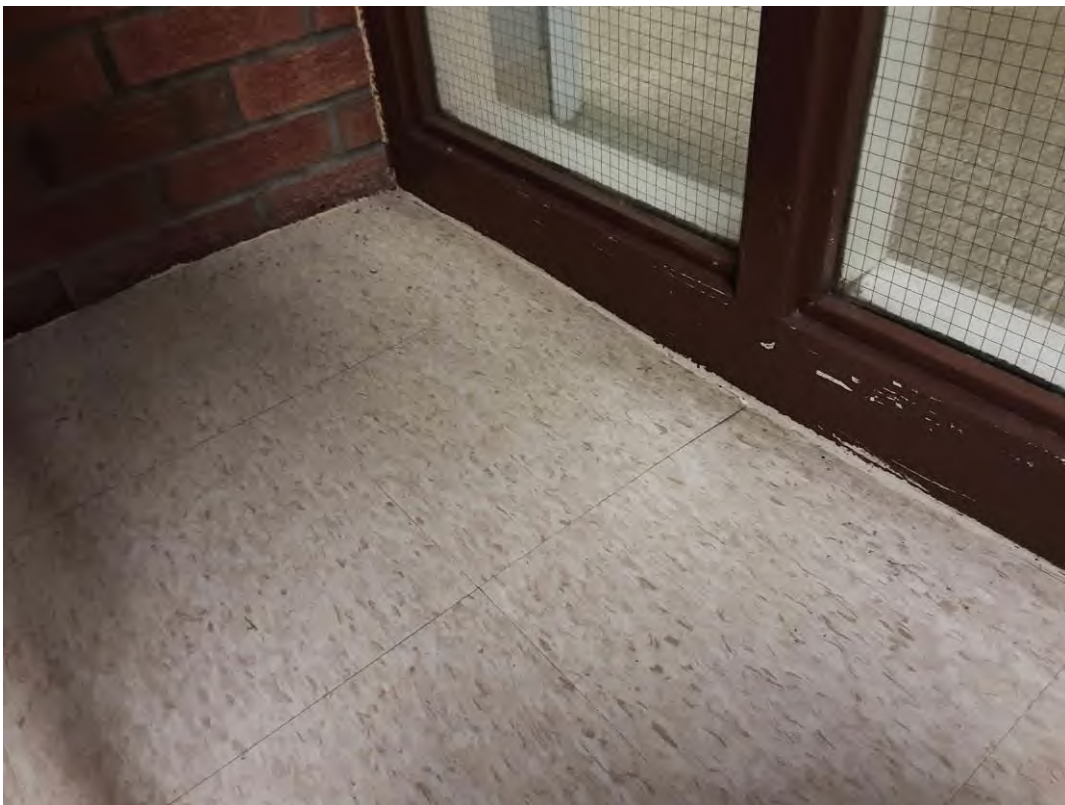
S0006A (None), Wall, Base, Caulking, Lobby (Location #: 4)

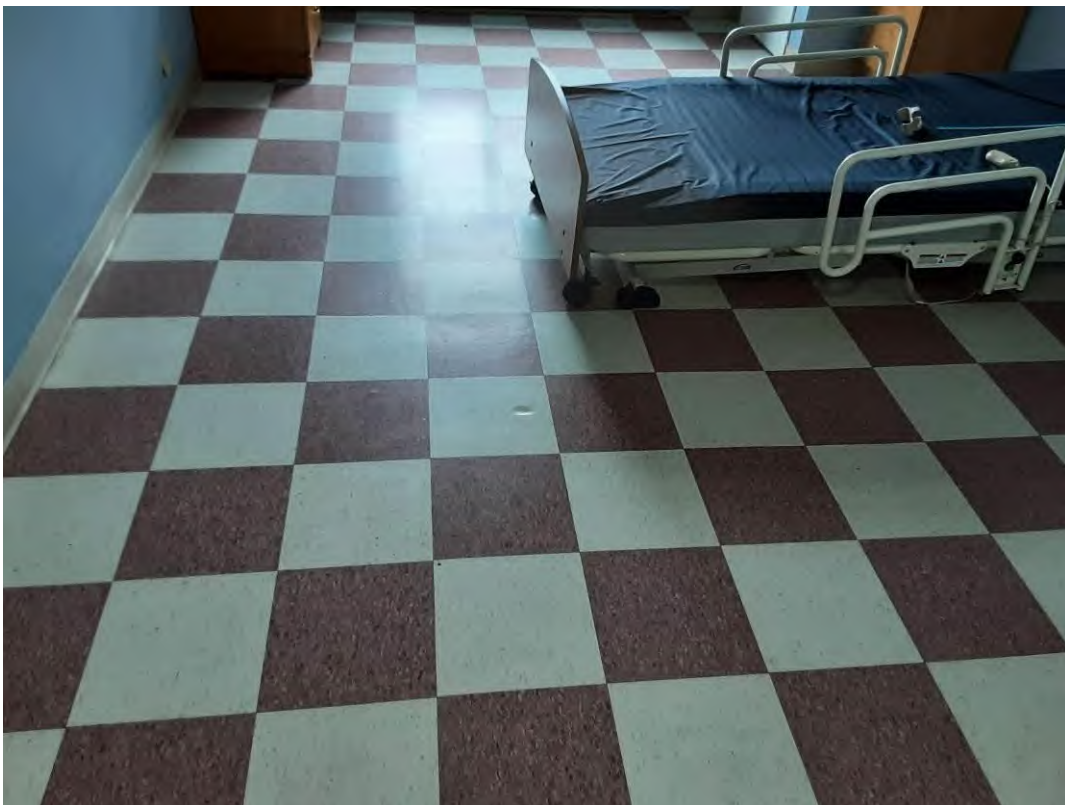
V0020 (None), Floor, All, Vinyl Floor Tile and Mastic, Tenant Room (Location #: 21)

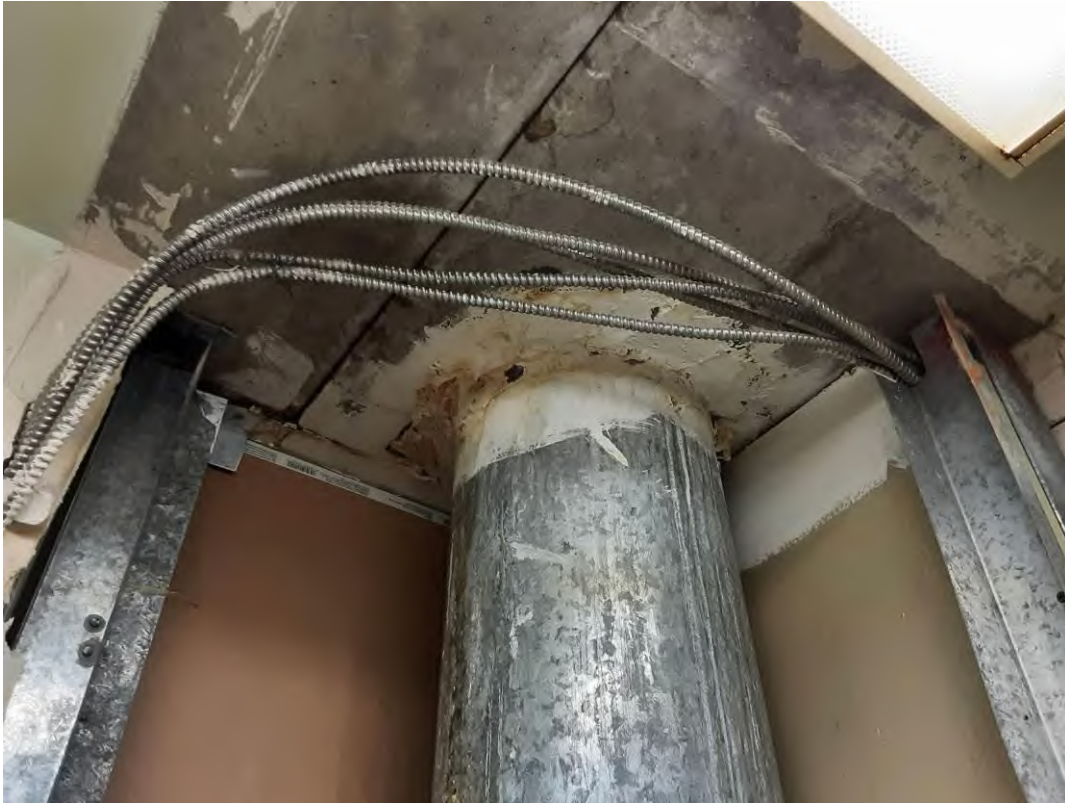
S0035A (None), Duct, Parging Cement, Utility Room (Location #: 79)

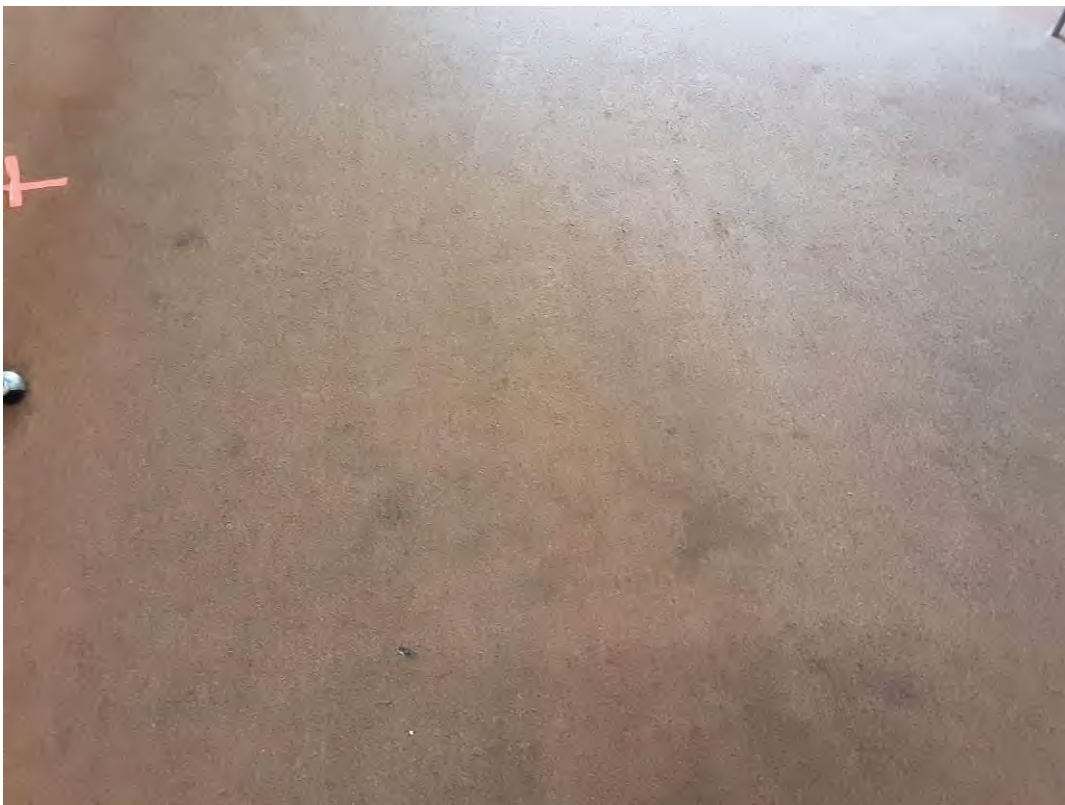
S0039A (None), Floor, Adhesive/mastic, Storage (Location #: 118)

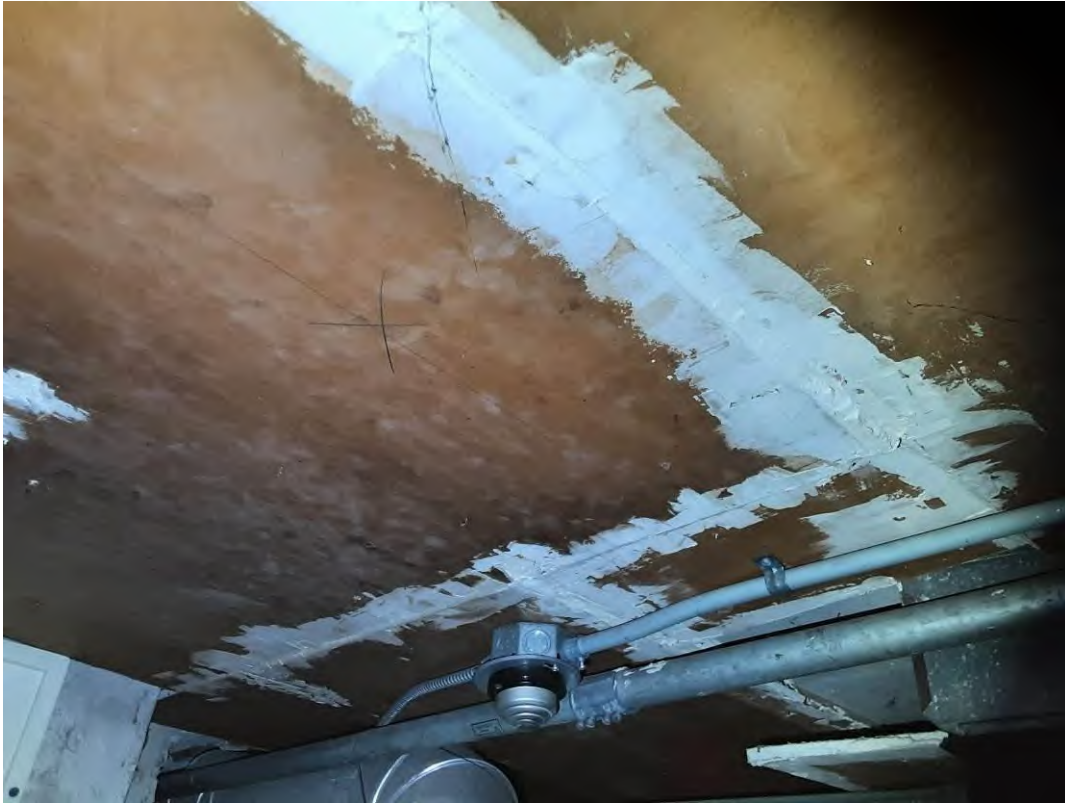
S0040A (Confirmed Asbestos), Ceiling, All, Drywall and joint compound, Old House - Basement (Location #: 135)

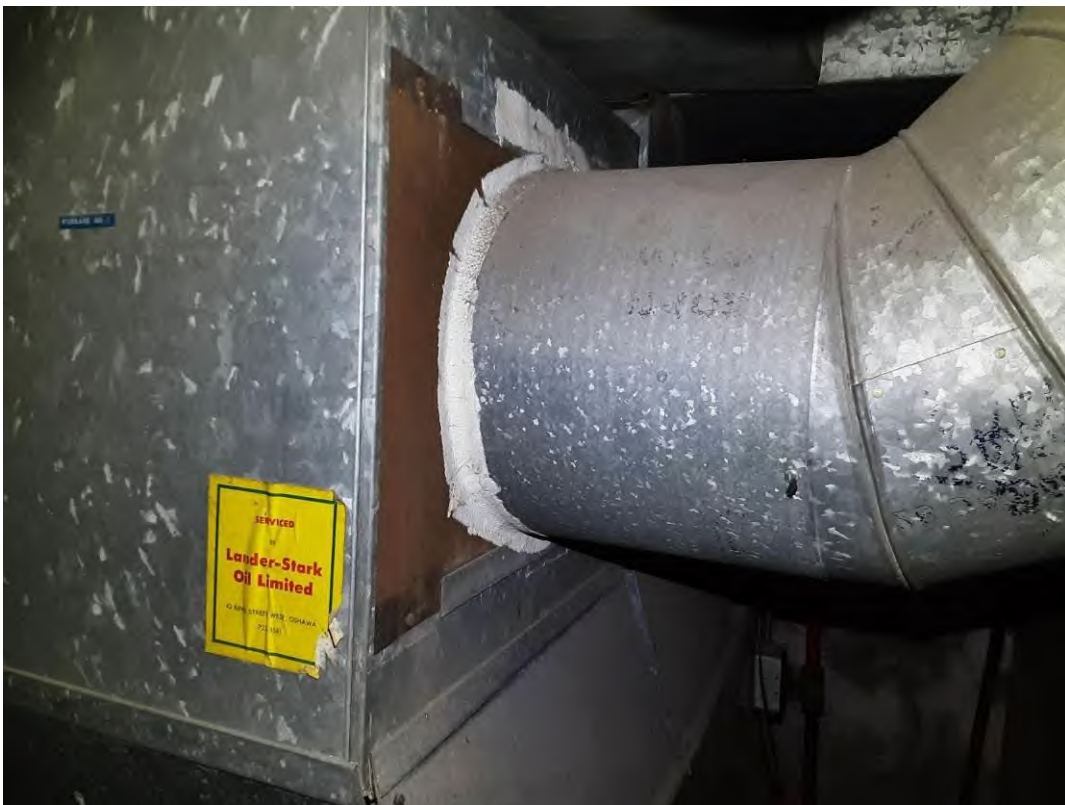
S0042A (Confirmed Asbestos), Duct, Textile, Old House - Basement (Location #: 135)

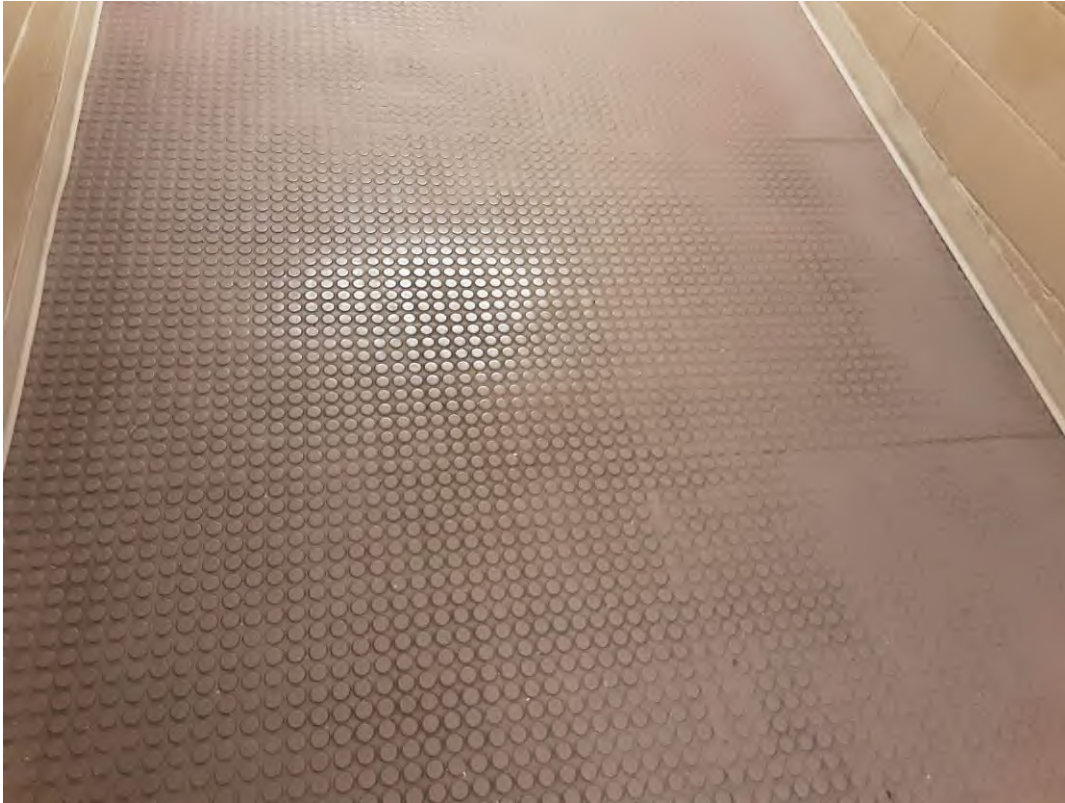
S0046A (Confirmed Asbestos), Floor, Non-slip Flooring, North Corridor (Location #: 142)

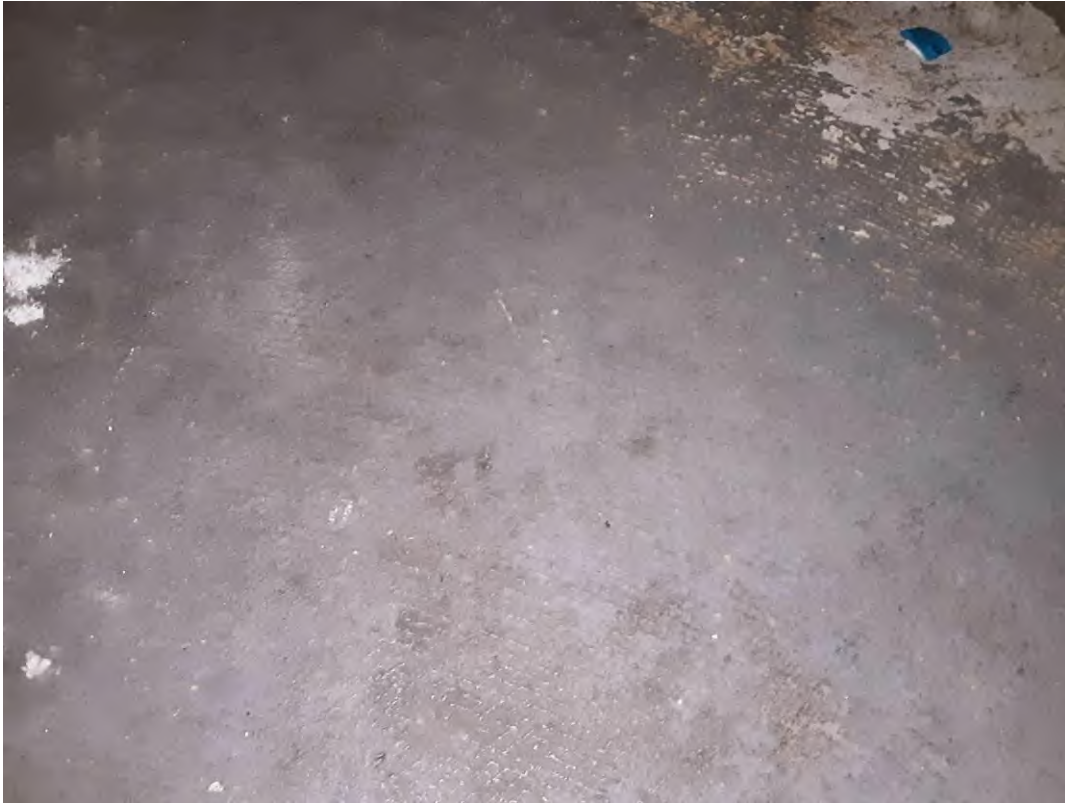
S0058C (None), Floor, All, Mastic, Storage (Location #: 163)

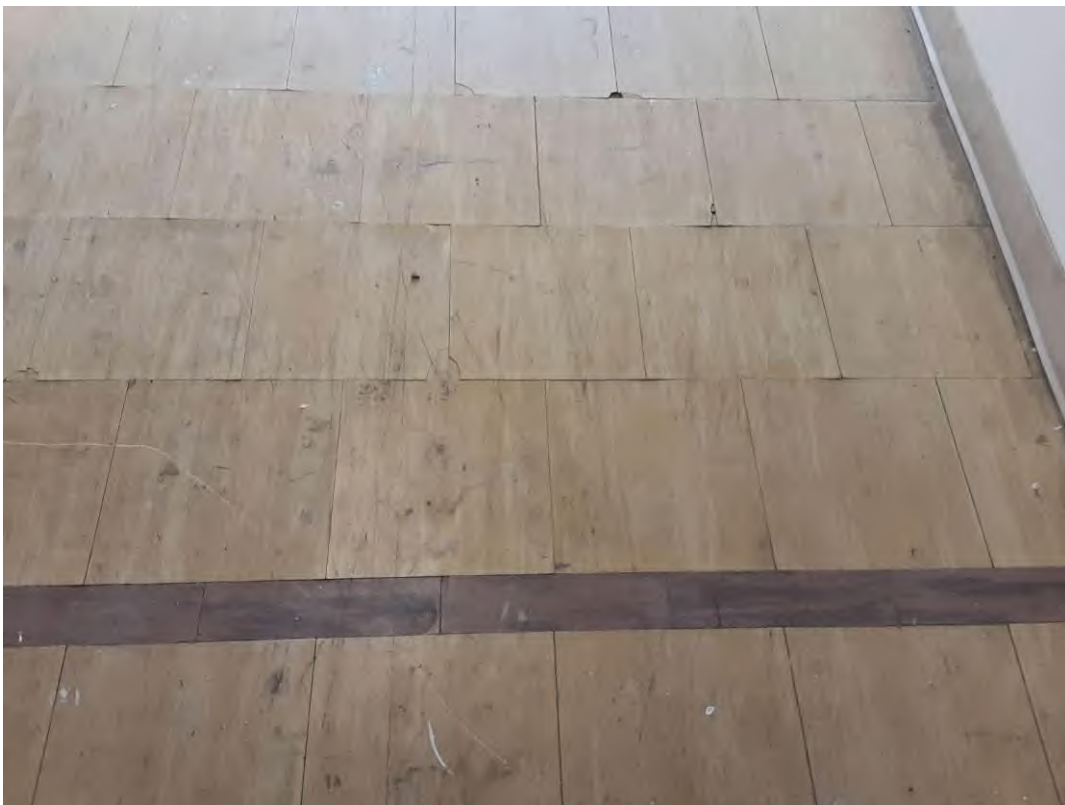
S0059C (Confirmed Asbestos), Floor, All, Vinyl Floor Tile and Mastic, Foyer (Location #: 149)

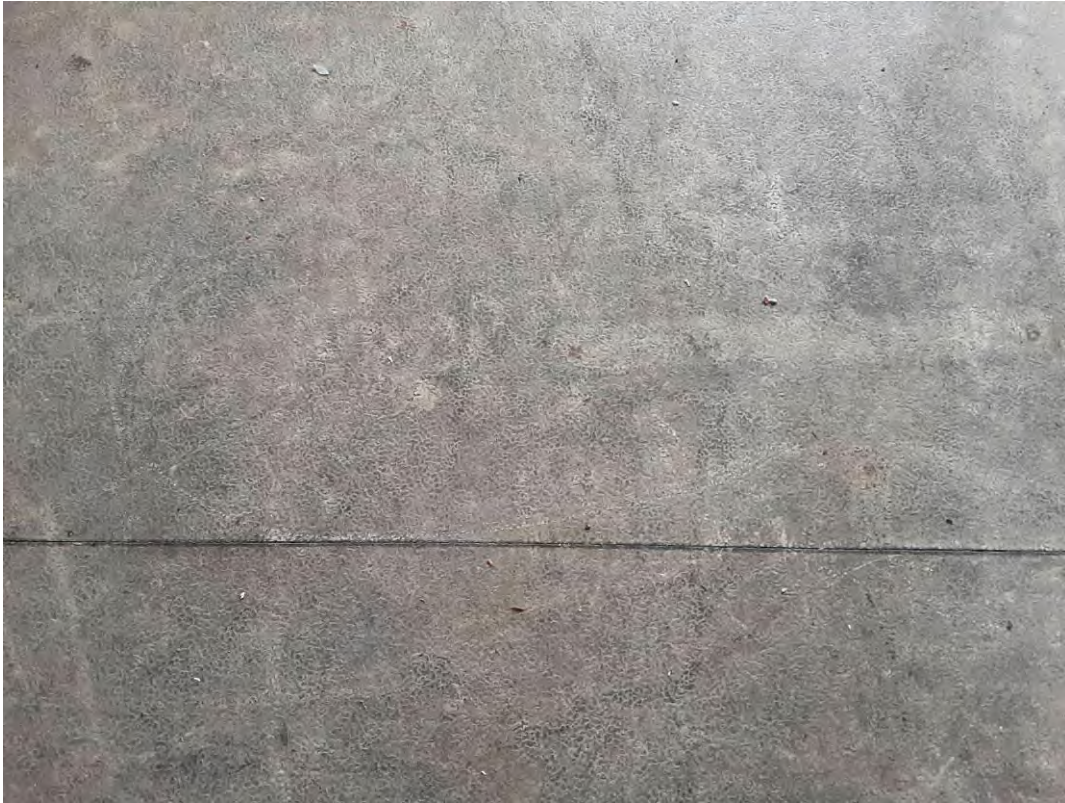
S0060A (None), Floor, Vinyl Sheet Flooring, Old House - Ground Floor (Location #: 177)

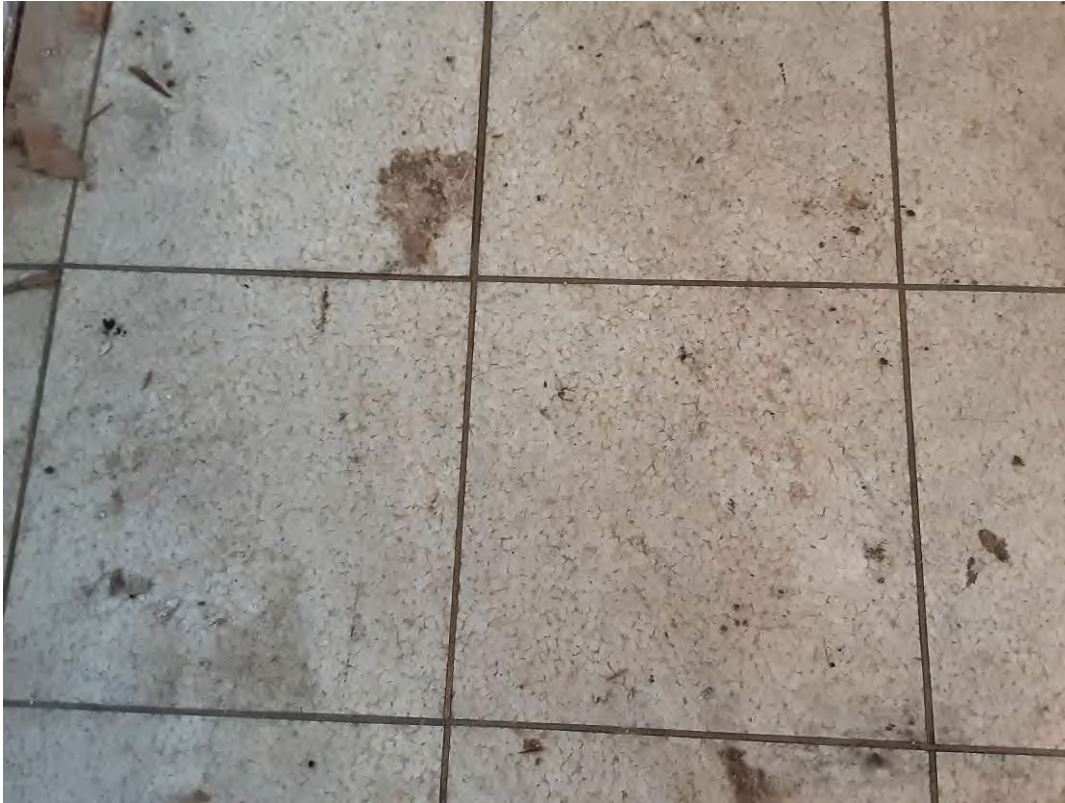
S0065C (None), Floor, Vinyl Floor Tile and Mastic, Old House - 2nd Floor (Location #: 178)

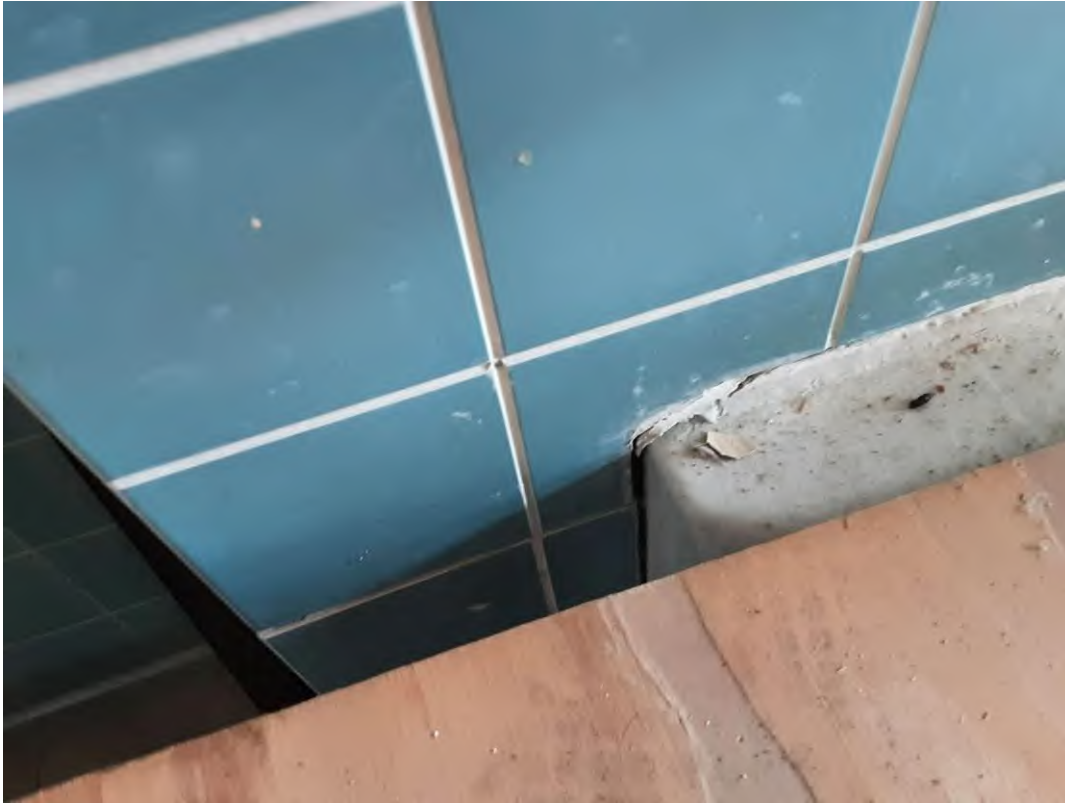
S0069C (None), Other, Caulking, Old House - 2nd Floor (Location #: 178)

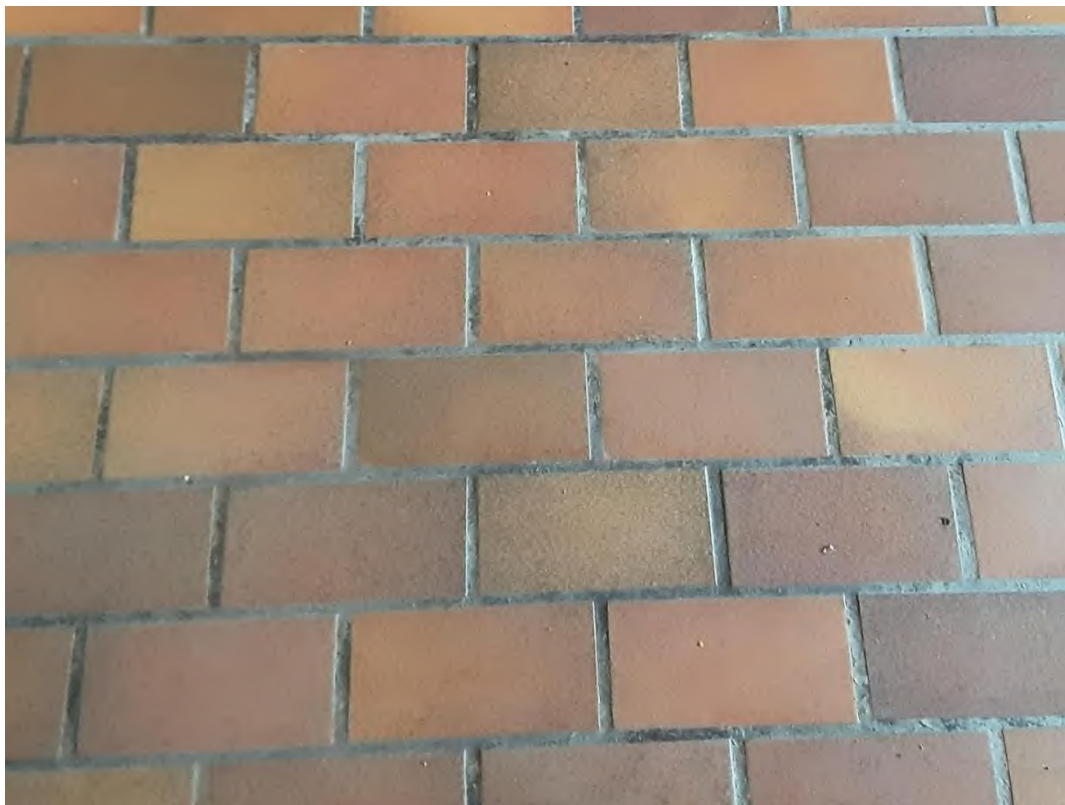
S0079A (Confirmed Asbestos), Floor, Mortar, under 2" x 6" red faux brick ceramic tile, Vestibule (Location #: 116)

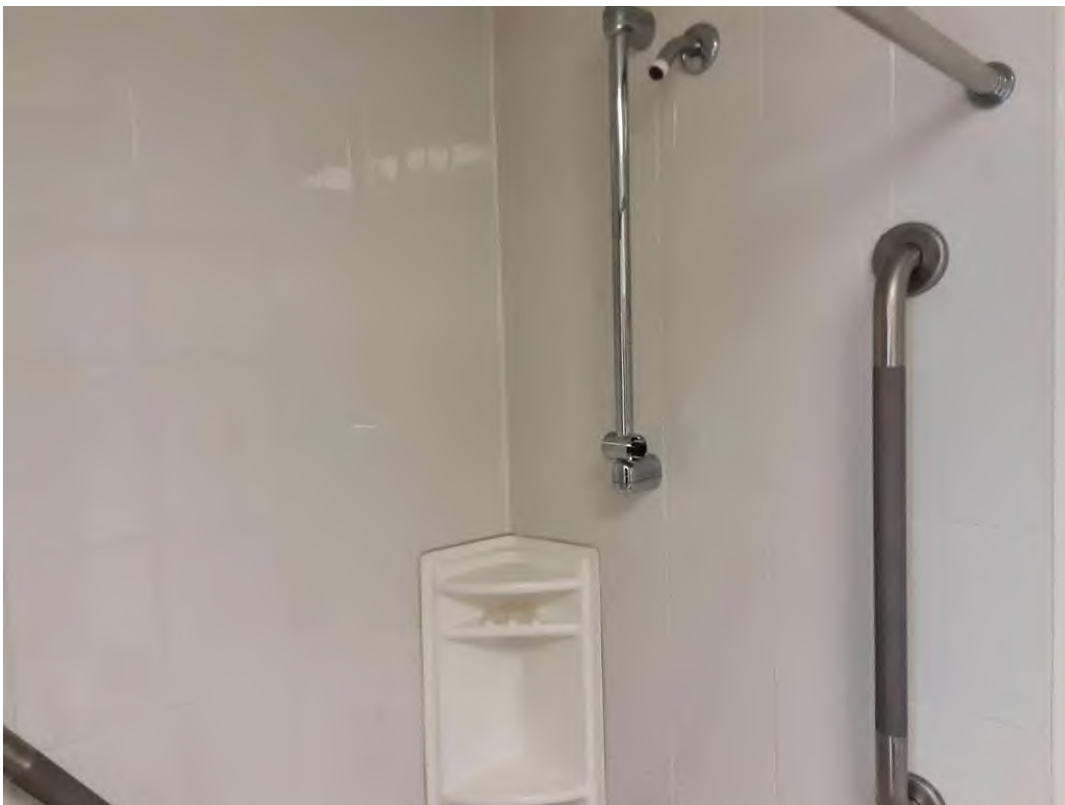
V9500 (Presumed Asbestos), Wall, Mortar, Meeting And Training Room (Location #: 150)

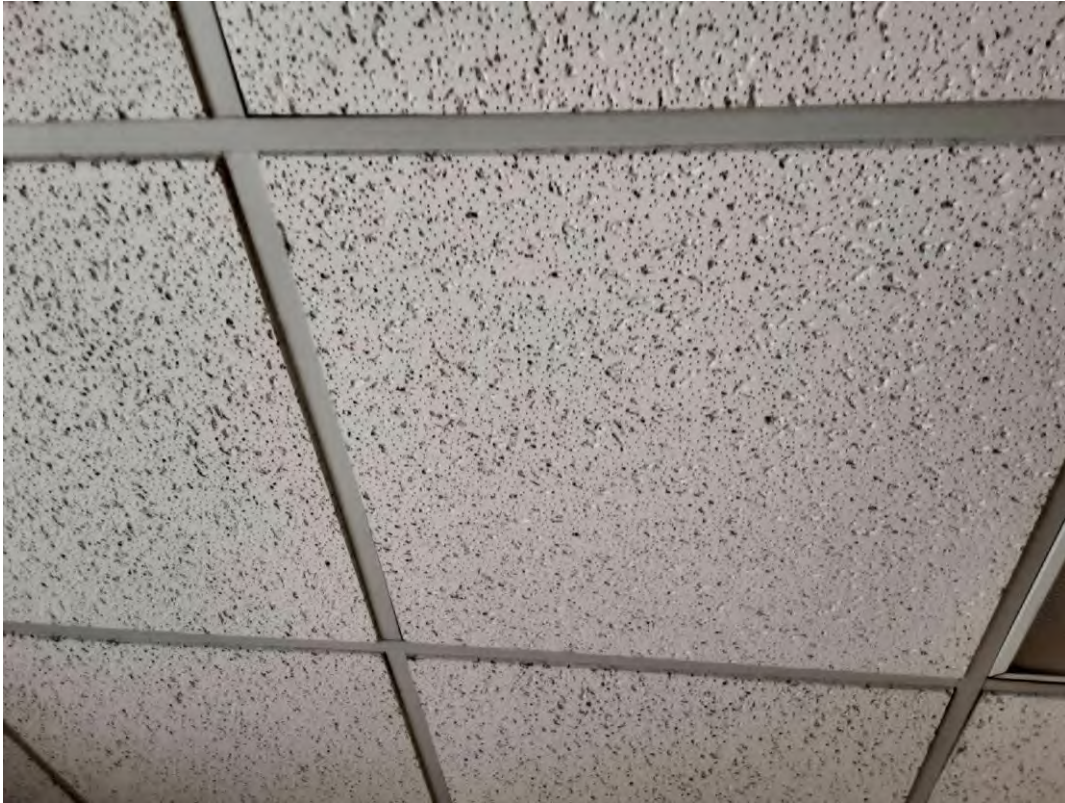
V0000 (None), Ceiling, All, Ceiling Tiles (lay-in), Meeting And Training Room (Location #: 150)
Date code 1996

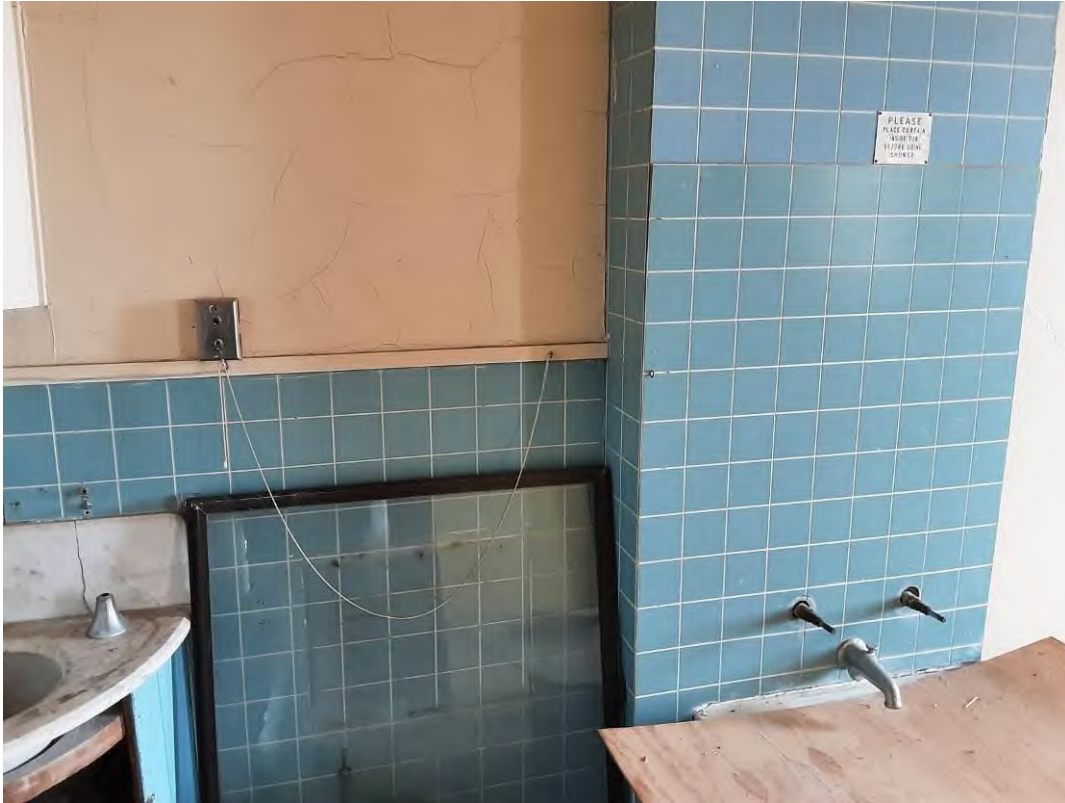
V0000 (None), Wall, Fibrous Board, Old House - 2nd Floor (Location #: 178)

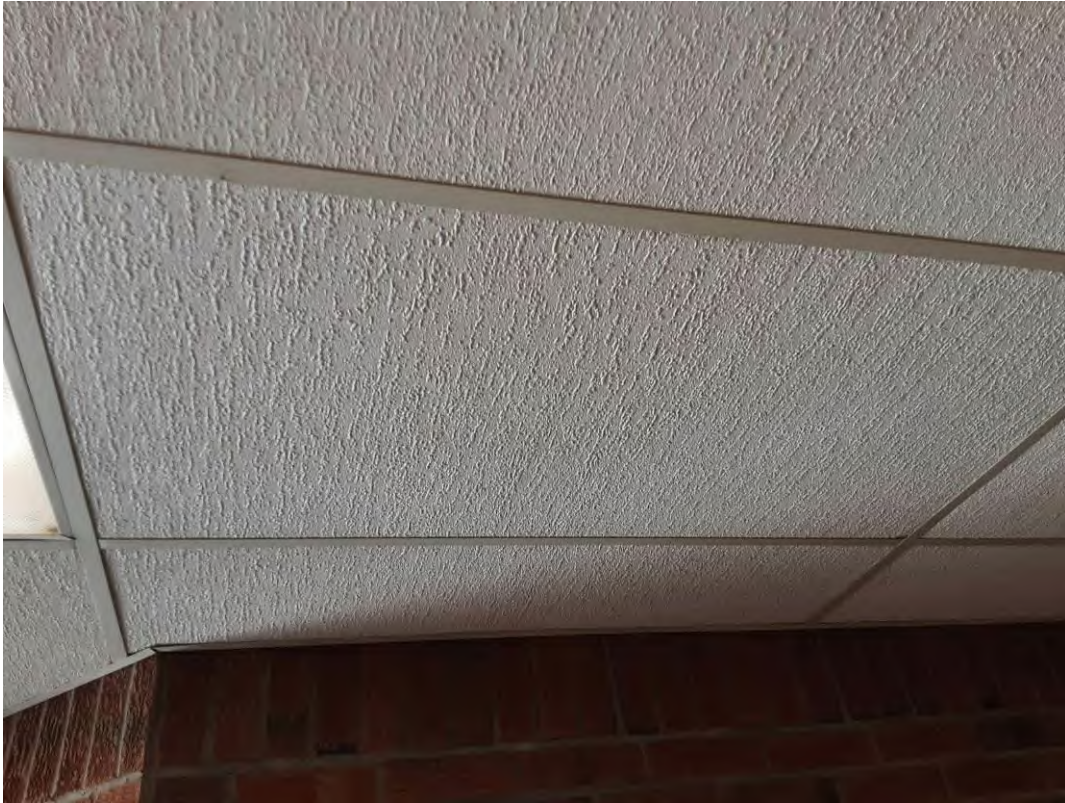
V0000 (None), Ceiling, All, Ceiling Tiles (lay-in), Vestibule (Location #: 3)
Fiberglass

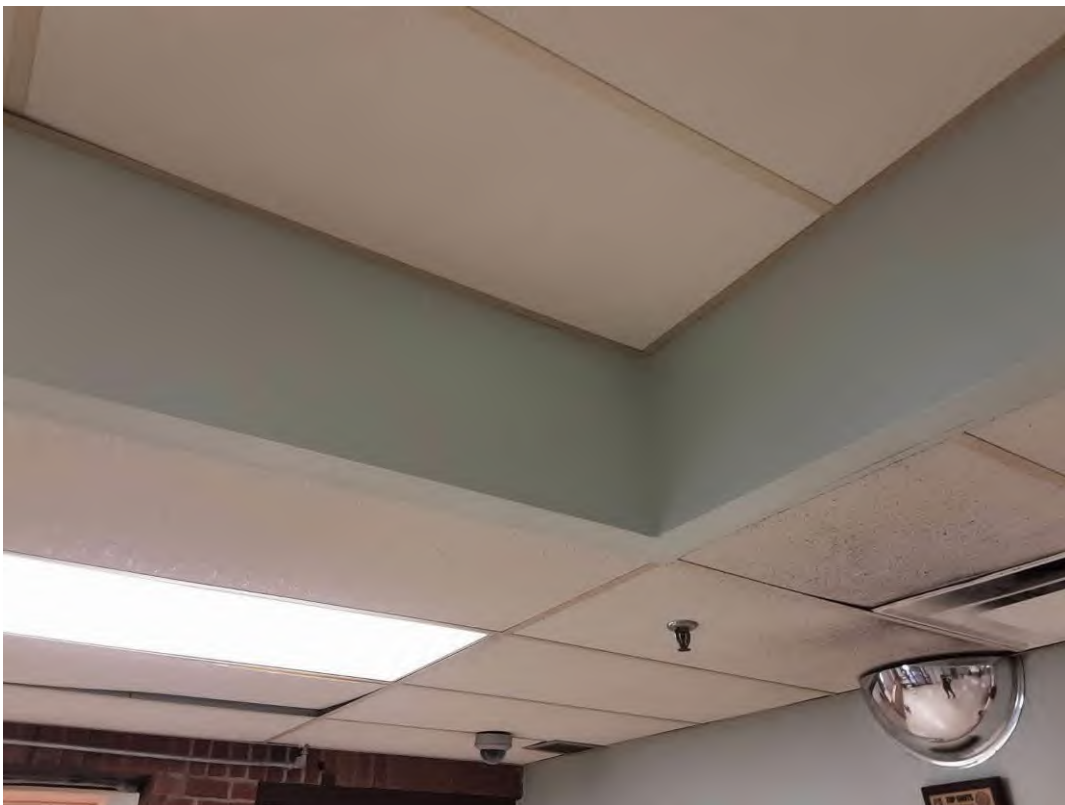
V0000 (None), Ceiling, Drywall (no compound), Lobby (Location #: 4)
Mechanically fastened

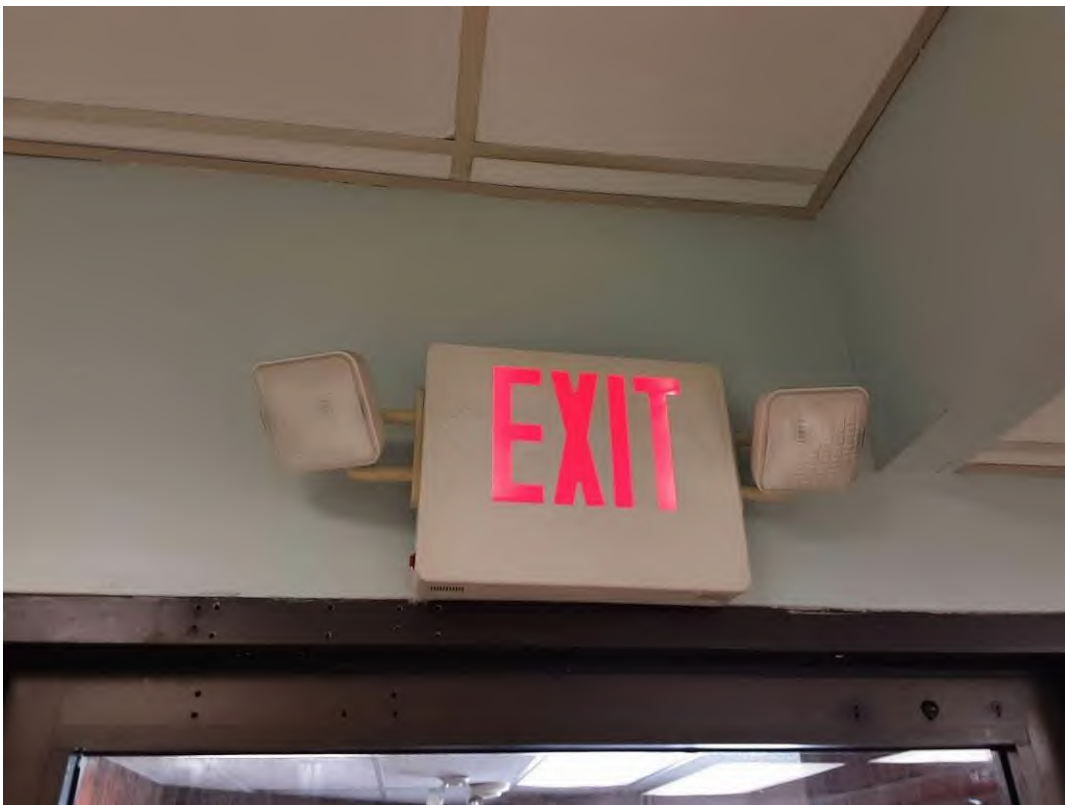
Pb Products, Lobby (Location #: 4)
