- 1. Hazardous Building Materials Assessment (Preconstruction) 1635 Dundas Street East, Whitby, Ontario**

Re: Revised Hazardous Building Materials Assessment (Preconstruction)

Region of Durham (Client) retained Pinchin Ltd. (Pinchin) to conduct a hazardous building materials assessment of Sunnycrest Nursing Home located at 1635 Dundas Street East, Whitby, Ontario.

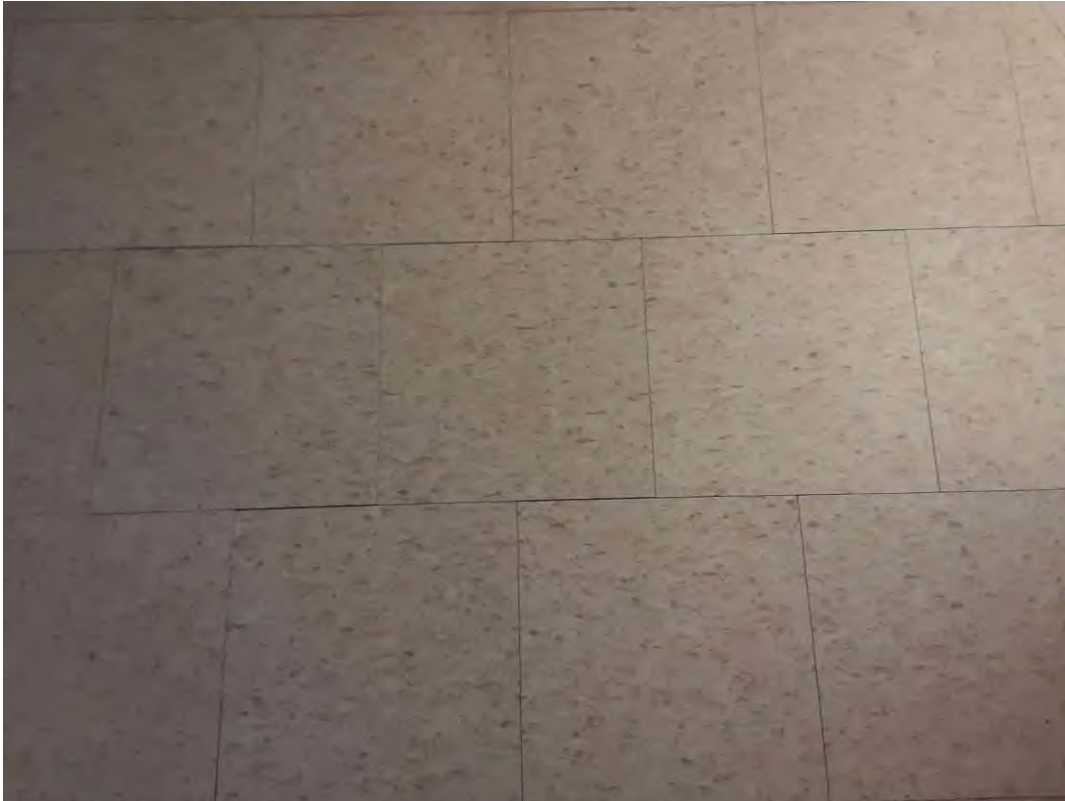
S0022A (None), Floor, Vinyl Sheet Flooring, Tenant Room (Location #: 25)

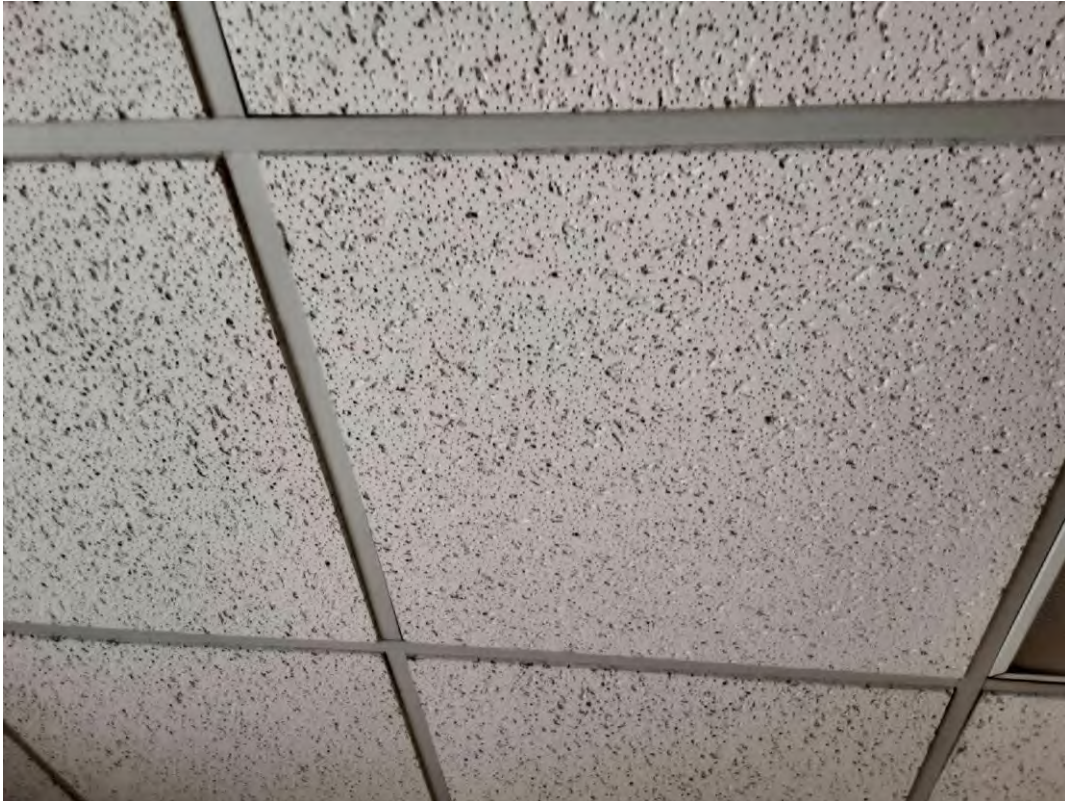
V0000 (None), Ceiling, Ceiling Tiles (lay-in), Dining Room (Location #: 113)
Date code 2004

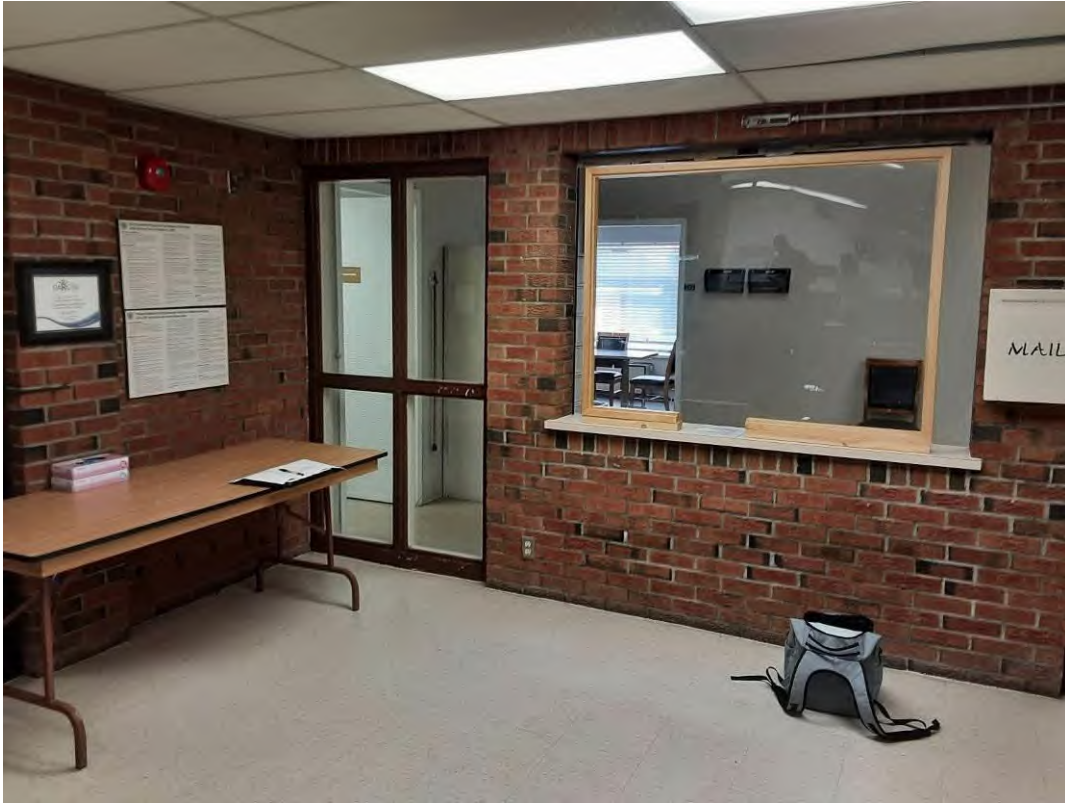
Wall, All, Masonry, Vestibule (Location #: 3)

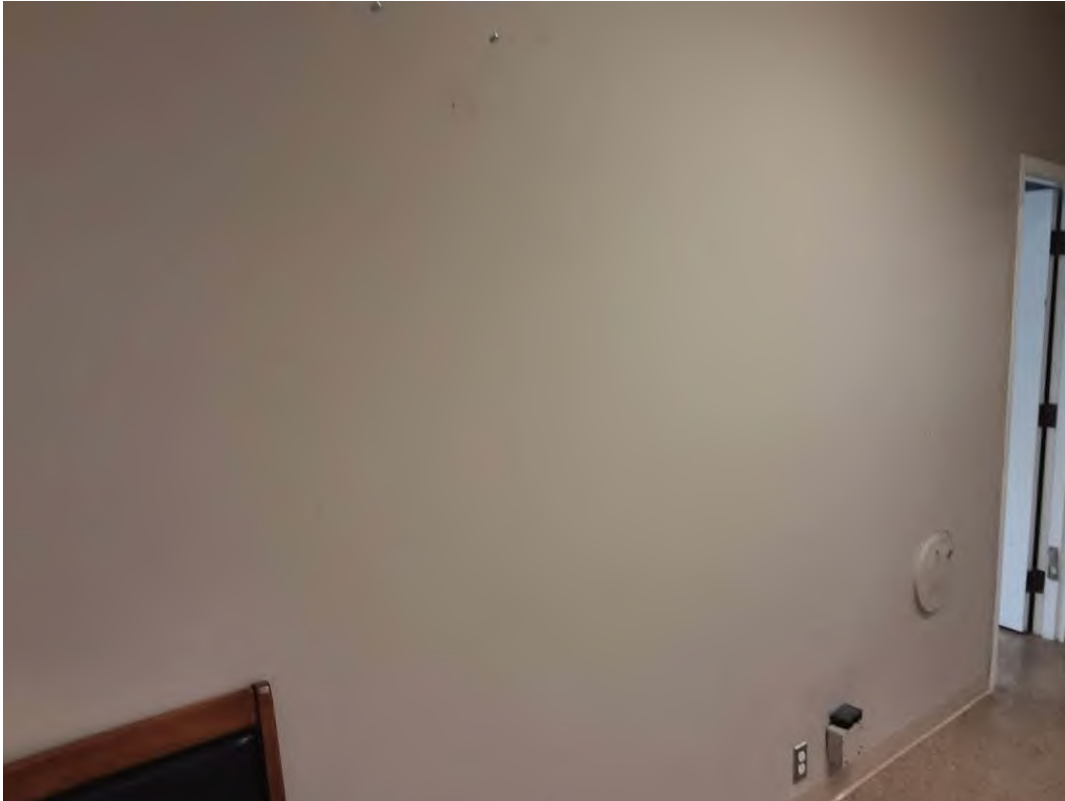
Drywall and joint compound, Light blue/teal paint, L0001, Lobby (Location #: 4)

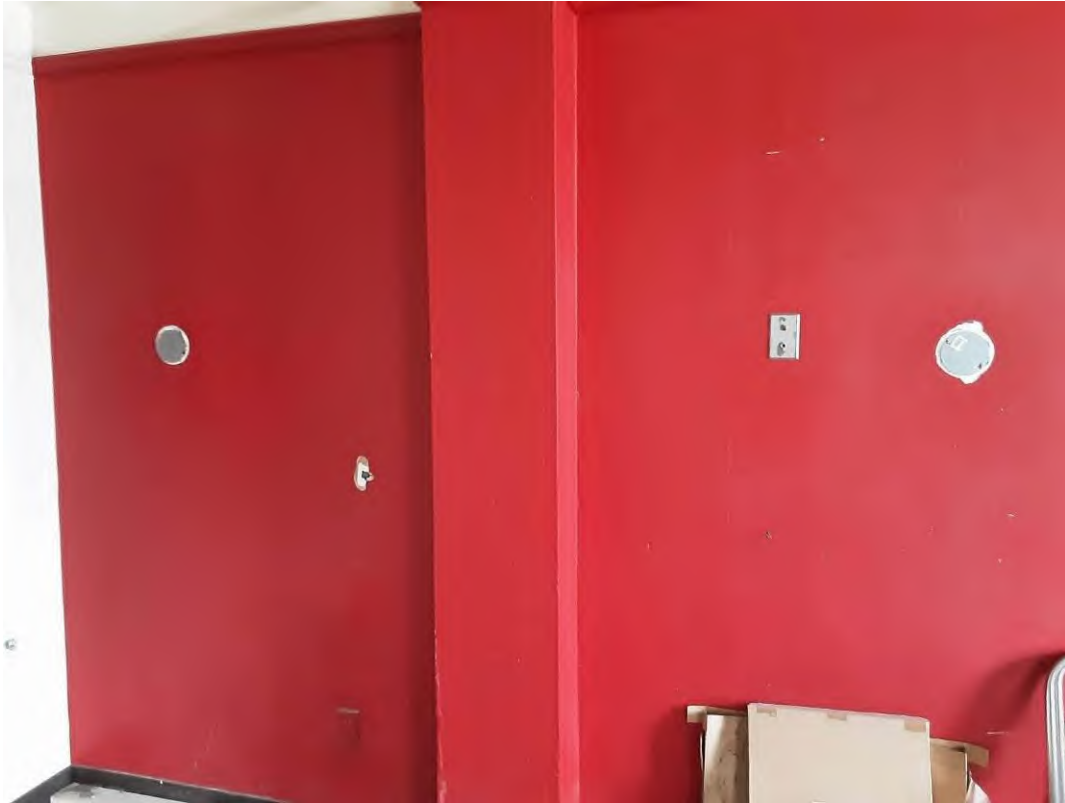
Plaster, White paint on plaster, L0012, Old House - Basement (Location #: 135)

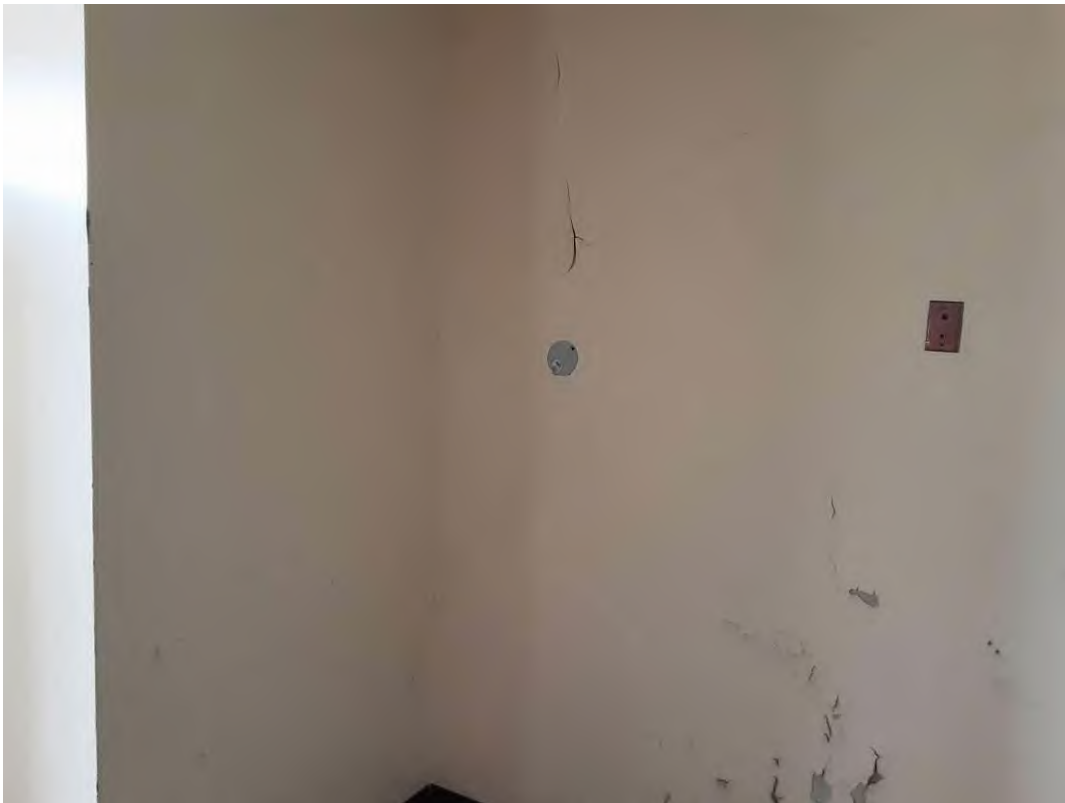
Drywall and joint compound, Red, L0017(Lead (High)), Old House - Ground Floor (Location #: 177)

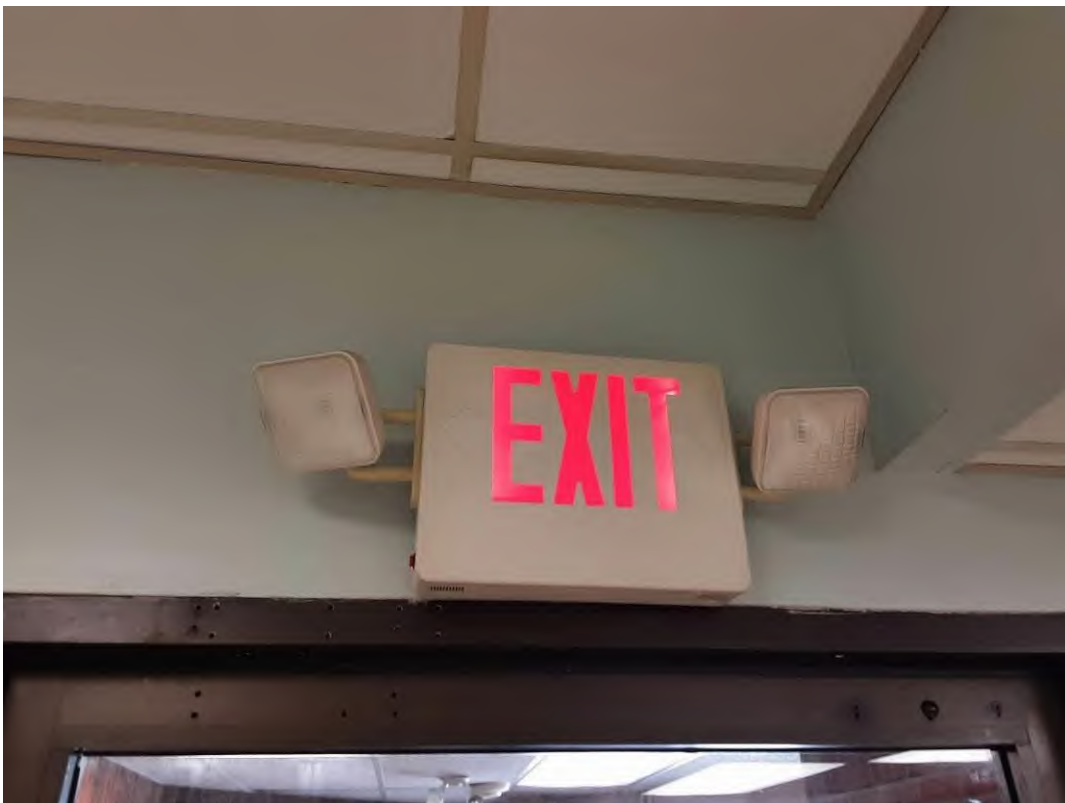
Pb Products, Lobby (Location #: 4)

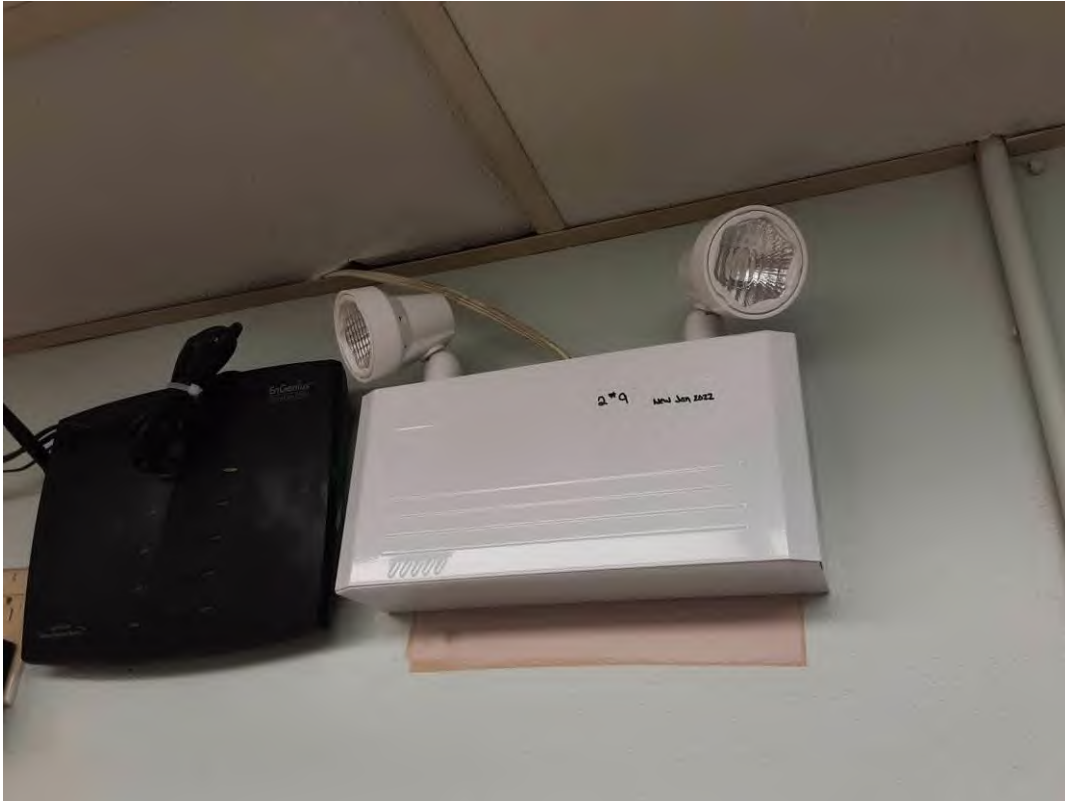
Pb Products, Lobby (Location #: 4)

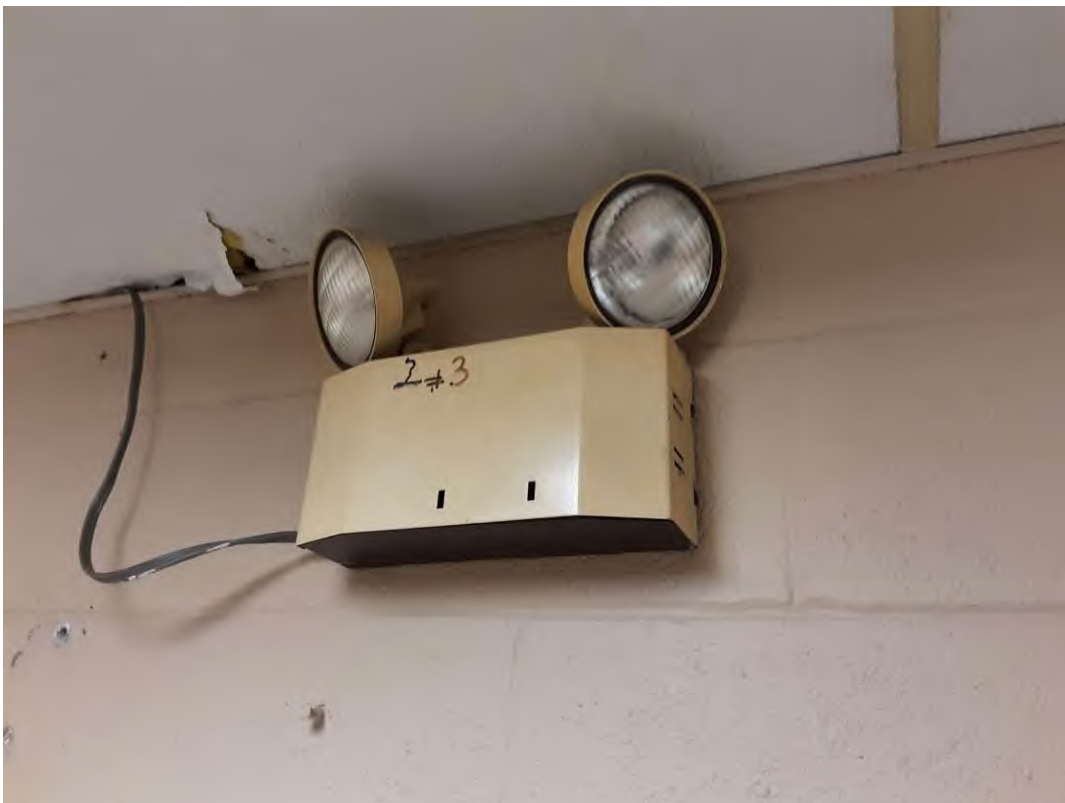
Pb Products, Lobby (Location #: 4)
