Re: Revised Hazardous Building Materials Assessment (Preconstruction)

Sunnycrest Nursing Home, 1635 Dundas Street East, Whitby, Ontario

Pinchin File: 329911.000

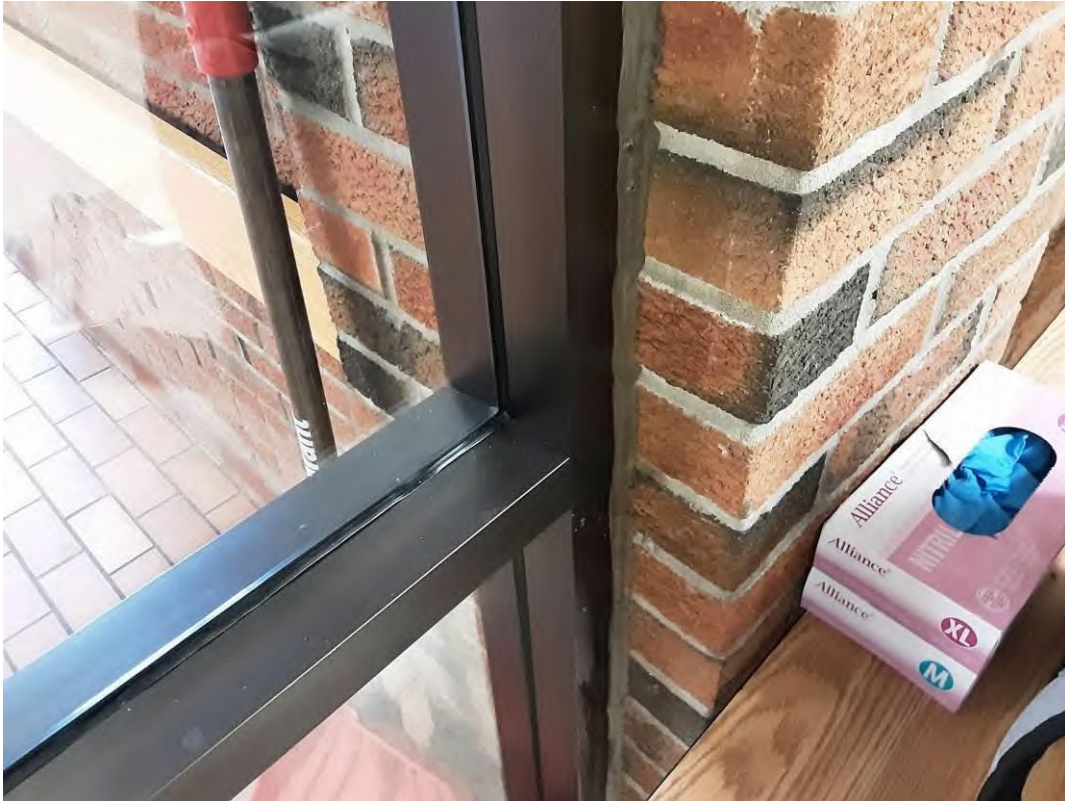
S0005A (None), Other, Door, Caulking, Lobby (Location #: 4)

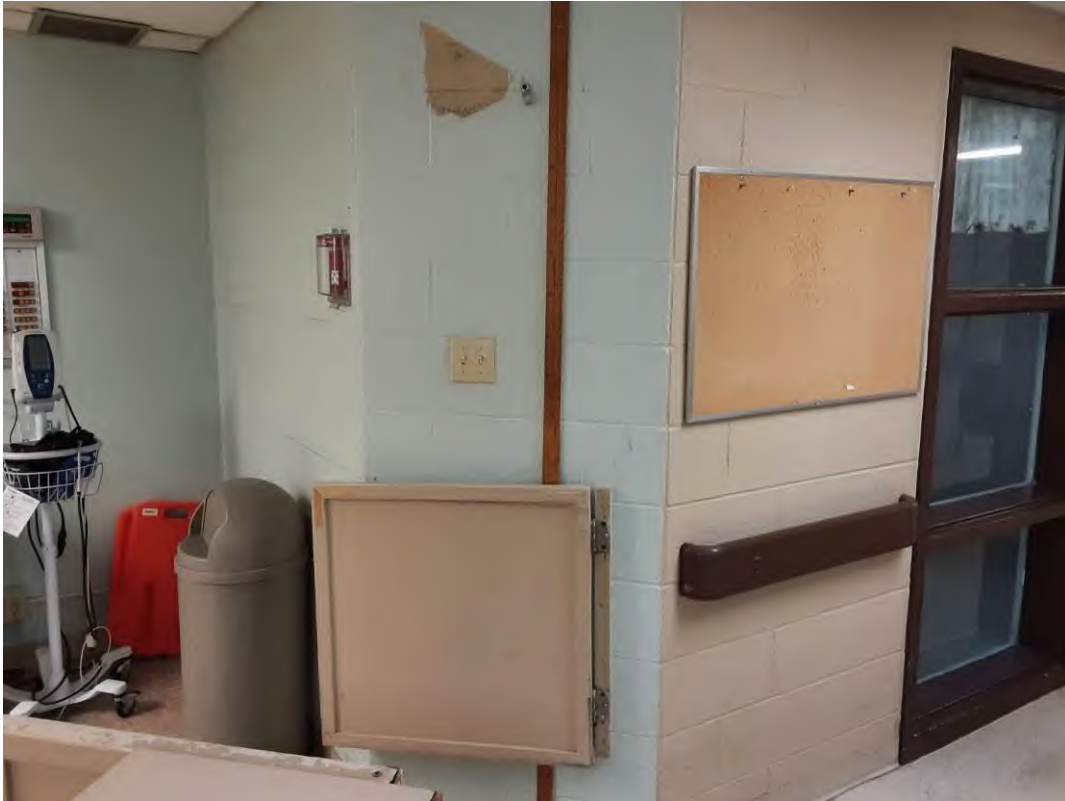
S0007A (None), Wall, Paint, Lobby (Location #: 4)

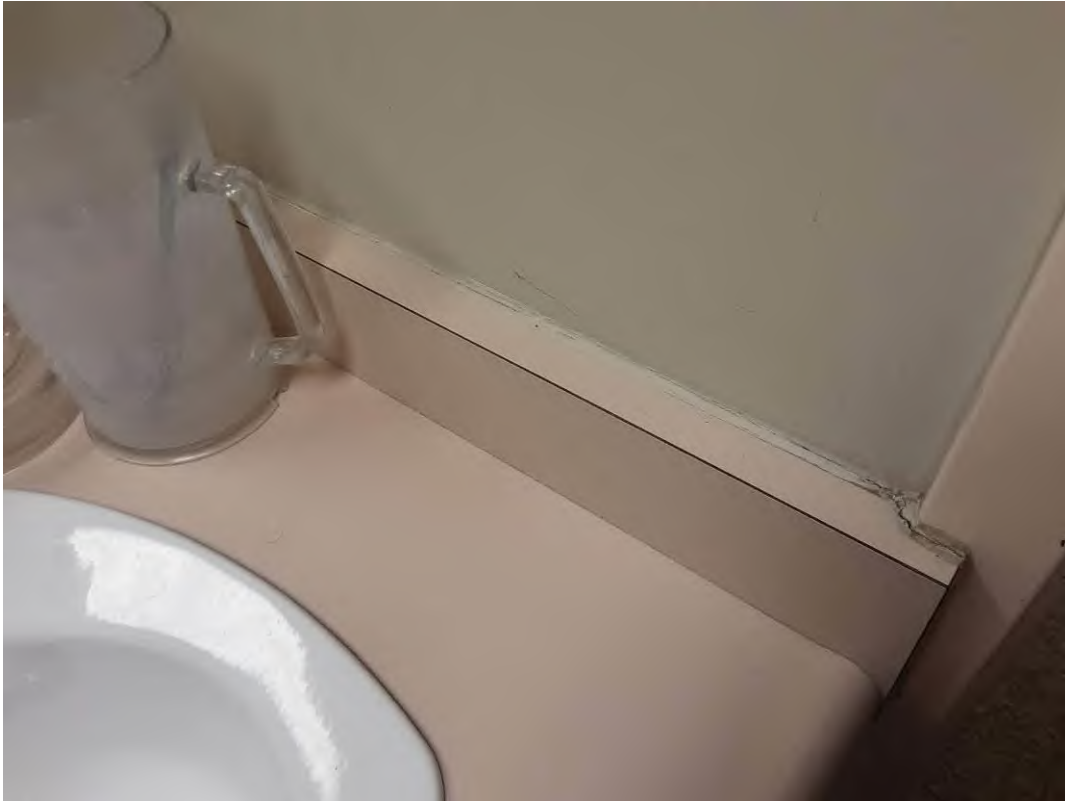
S0012A (None), Other, Caulking, Office (Location #: 9)

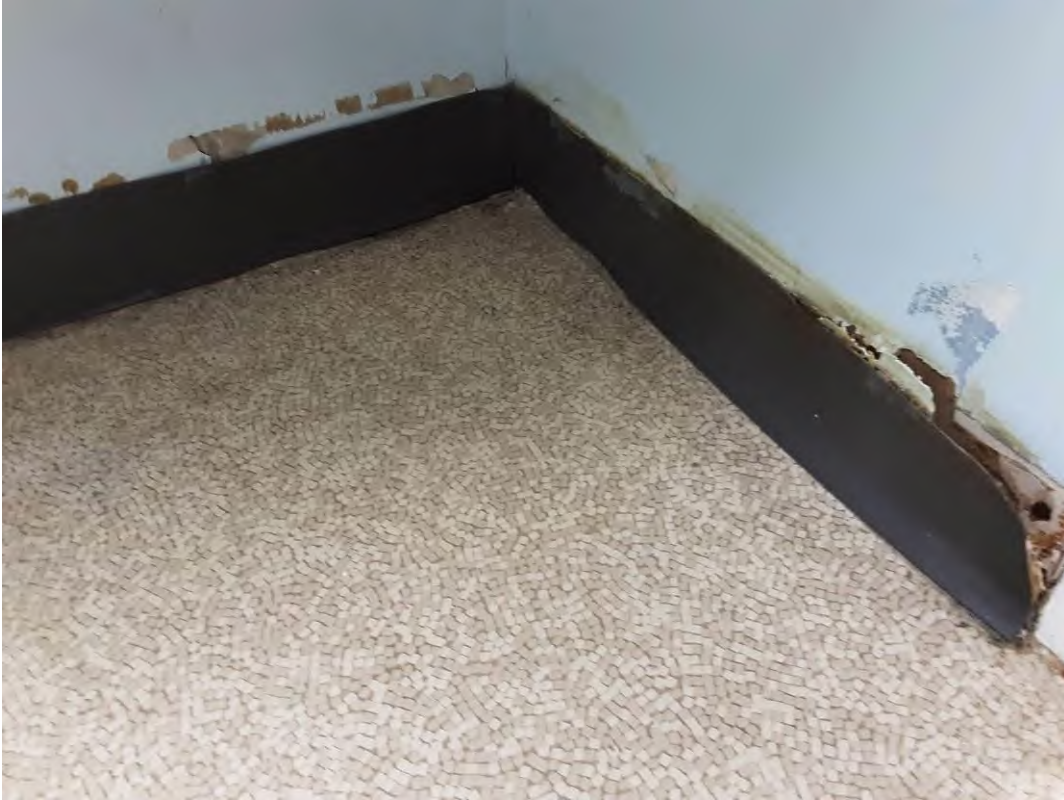
S0014A (None), Wall, Base, Adhesive/mastic, Visitors Washroom (Location #: 13)

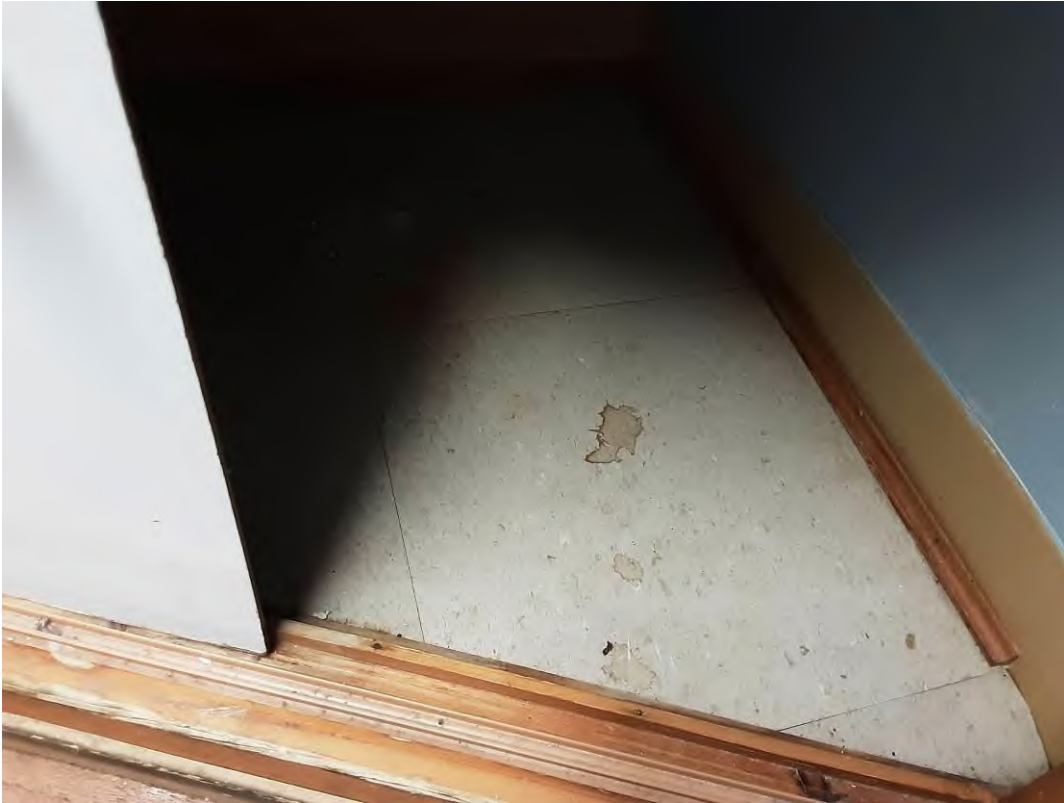
S0021A (None), Floor, Vinyl Floor Tile and Mastic, Tenant Room (Location #: 19)
Under washroom millwork

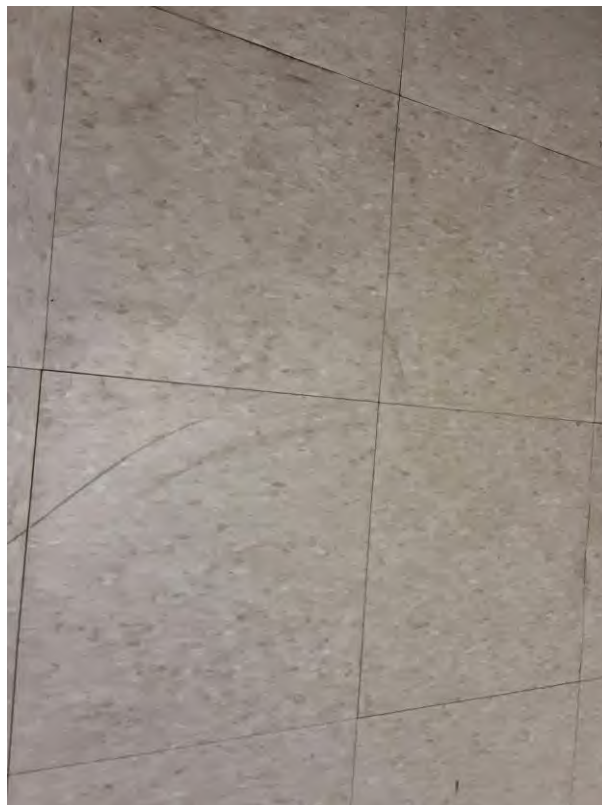
S0022A (None), Floor, Vinyl Sheet Flooring, Tenant Room (Location #: 25)

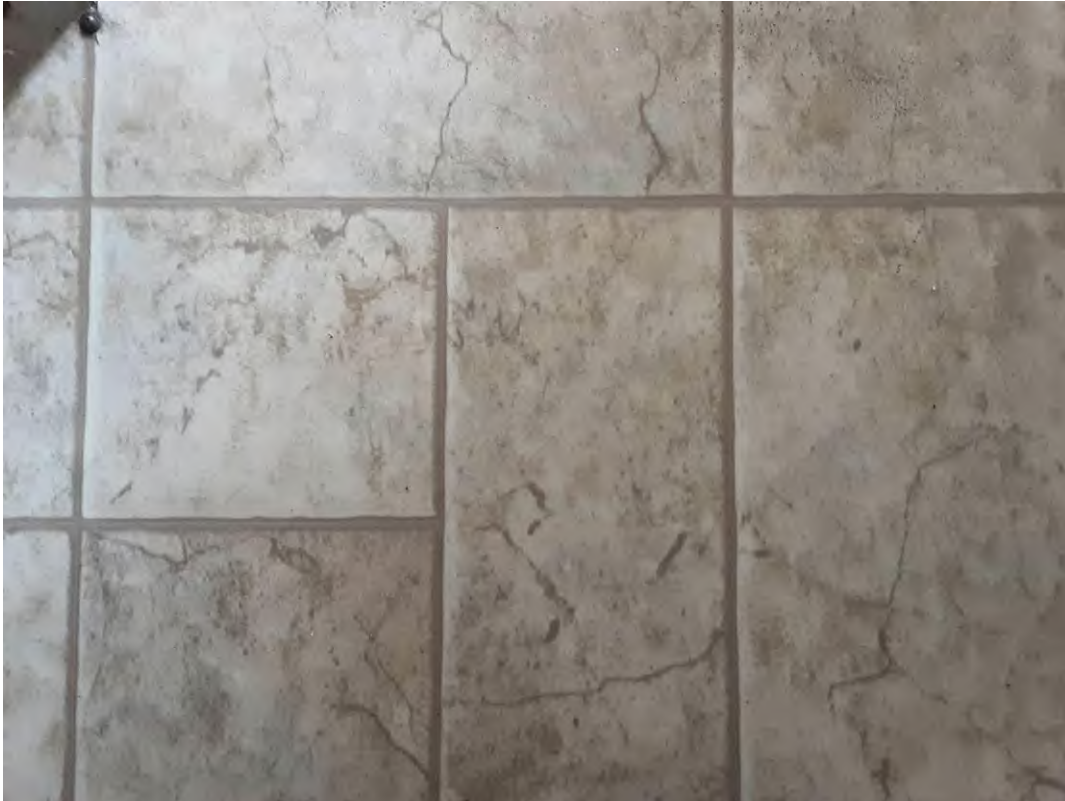
S0037A (None), Floor, Vinyl Sheet Flooring, Tenant Room (Location #: 98)
VFT present in sample is S0001

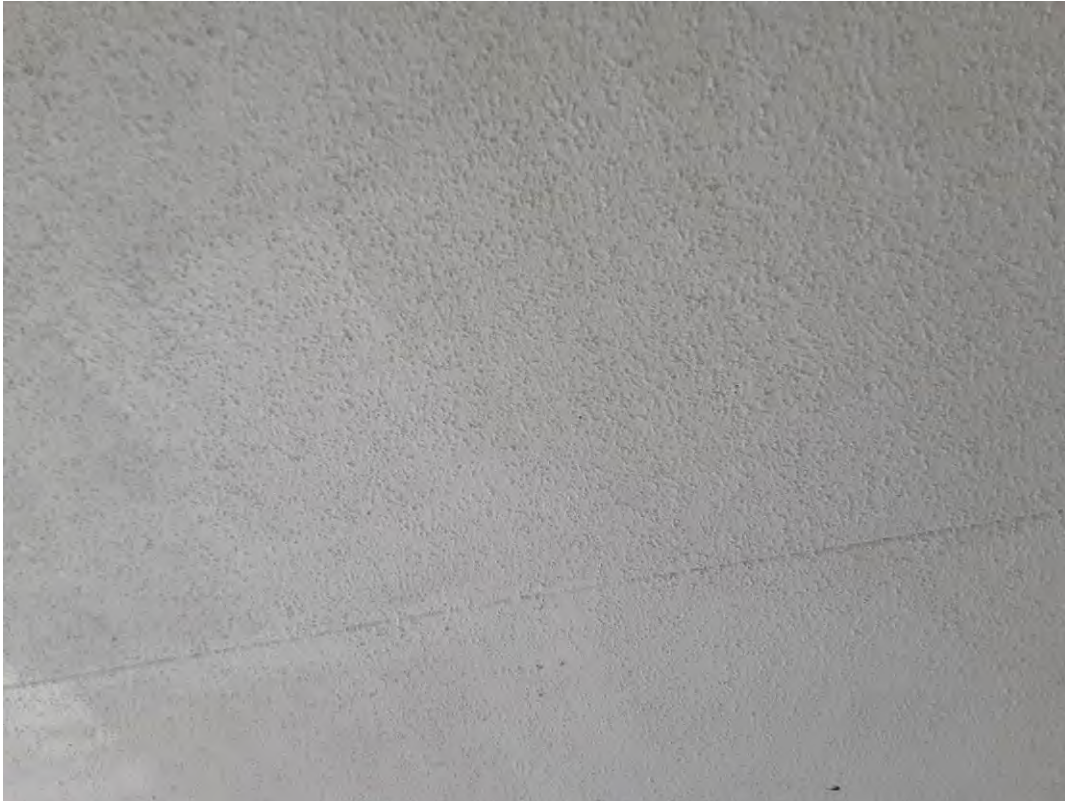
S0051A (None), Ceiling, All, Texture Coat, Medical Supply (Location #: 174)

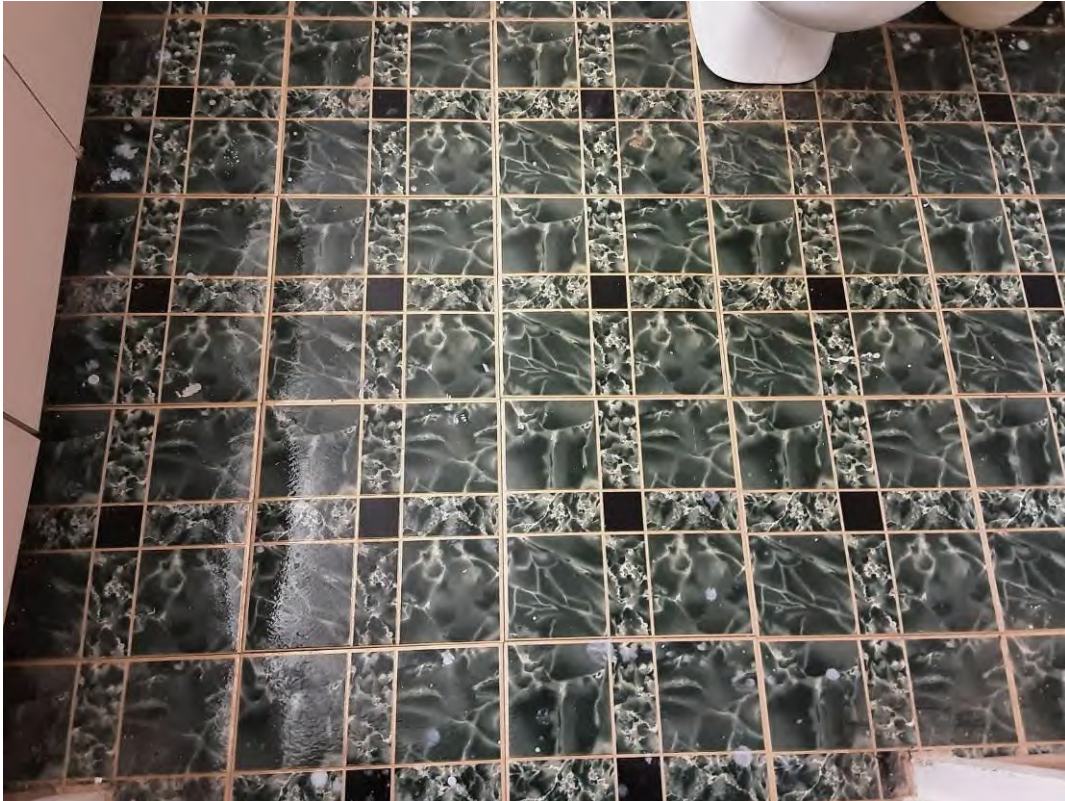
S0055C (Confirmed Asbestos), Floor, Vinyl Floor Tile and Mastic, Maintenance Supplies (Location #: 176)

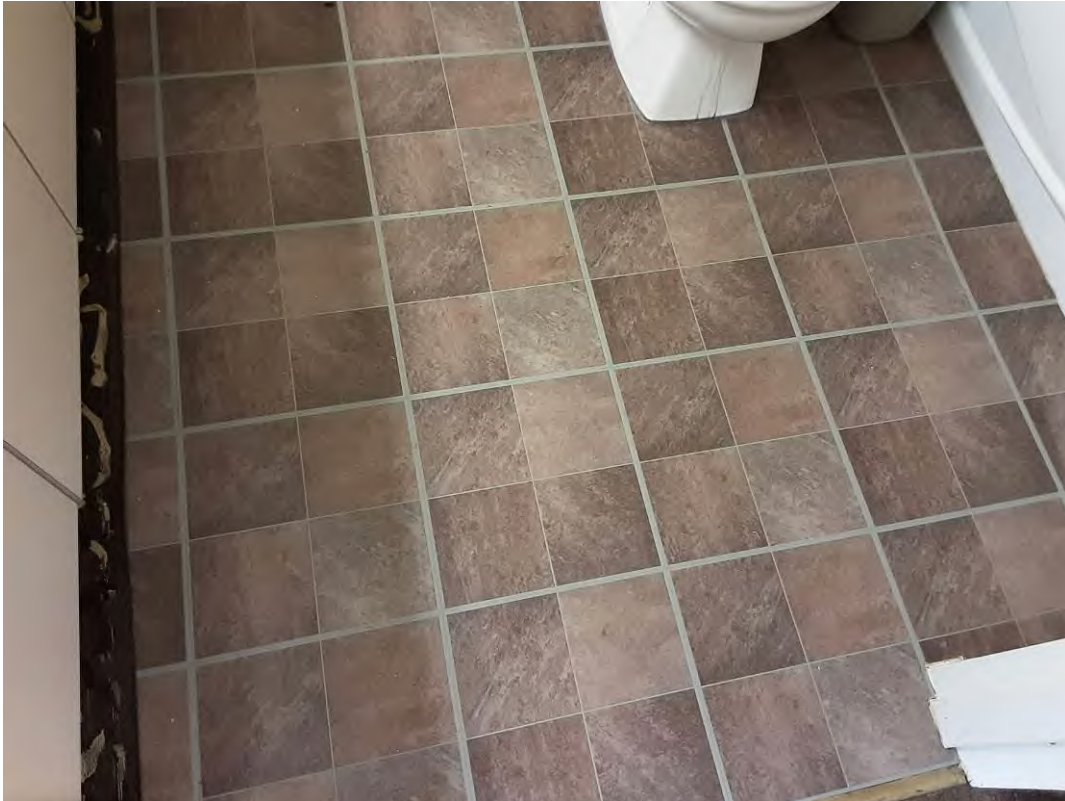
S0071C (Confirmed Asbestos), Floor, Vinyl Floor Tile and Mastic, Accounting Storage (Location #: 157)

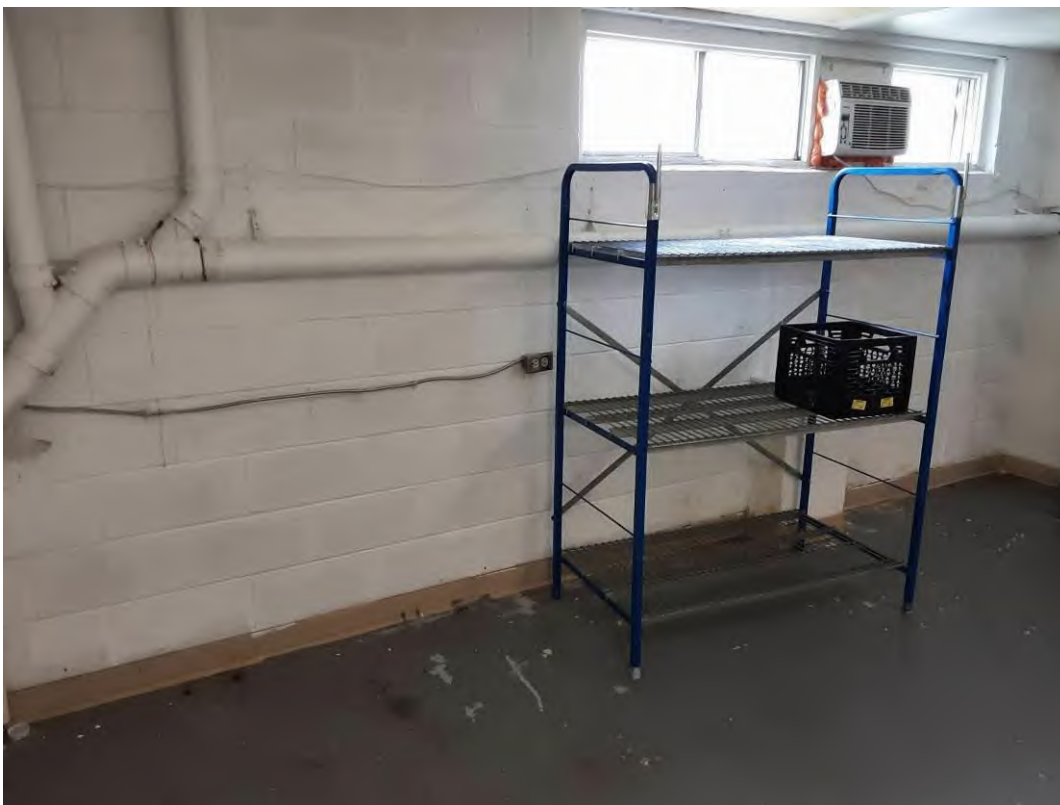
V9000 (Confirmed Asbestos), Piping, Rain Water Leader, Cement Product, Dietary Storage (Location #: 130)

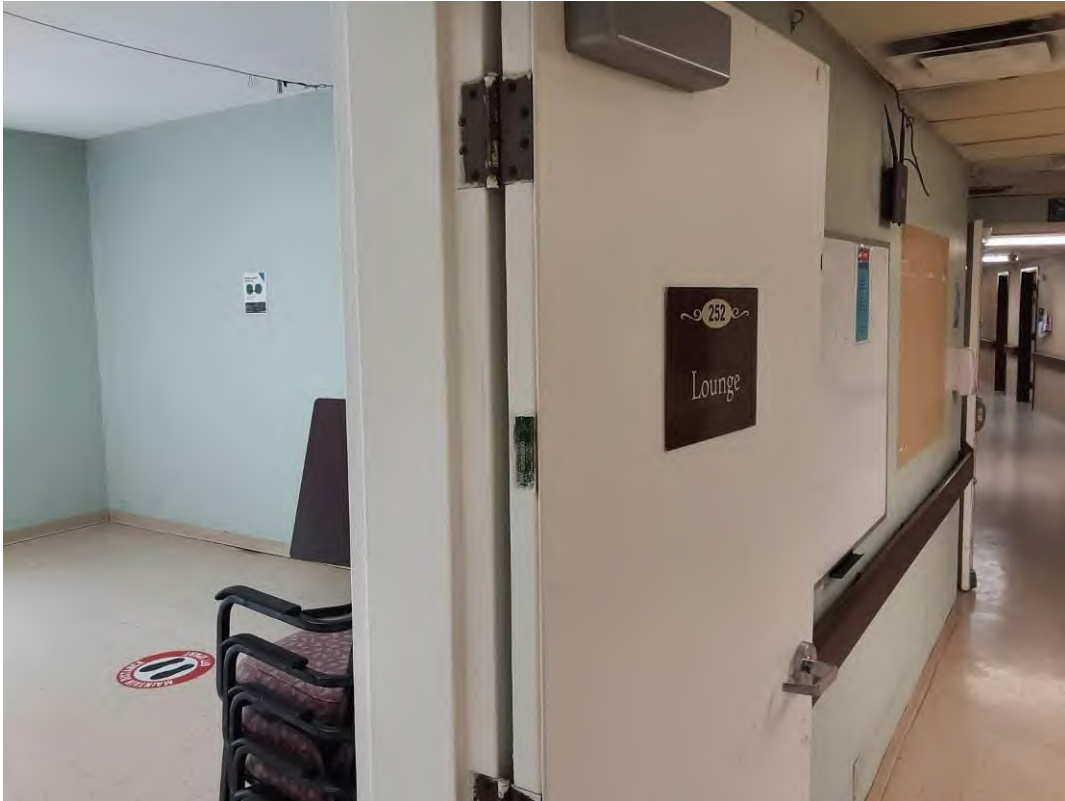
V9500 (Presumed Asbestos), Other, Door, Unidentified Material, Lounge (Location #: 11)

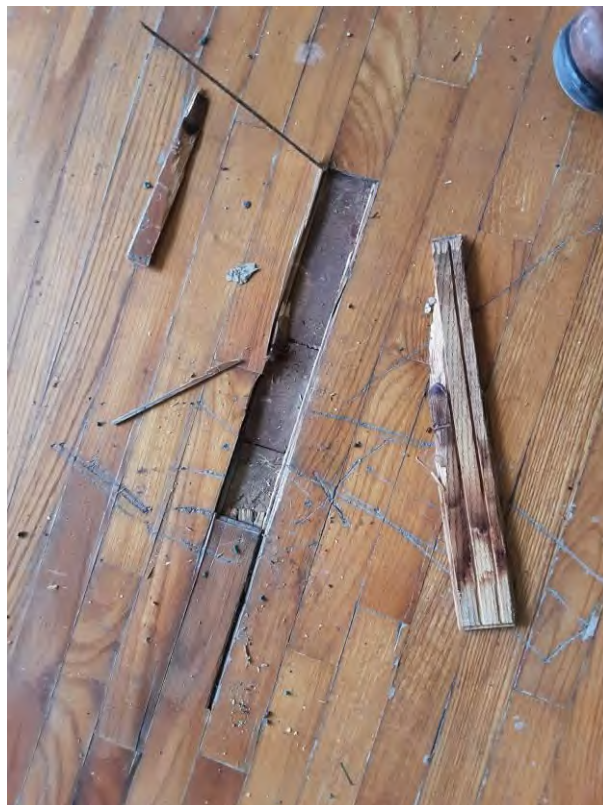
V0000 (None), Floor, Wood, Old House - 2nd Floor (Location #: 178)

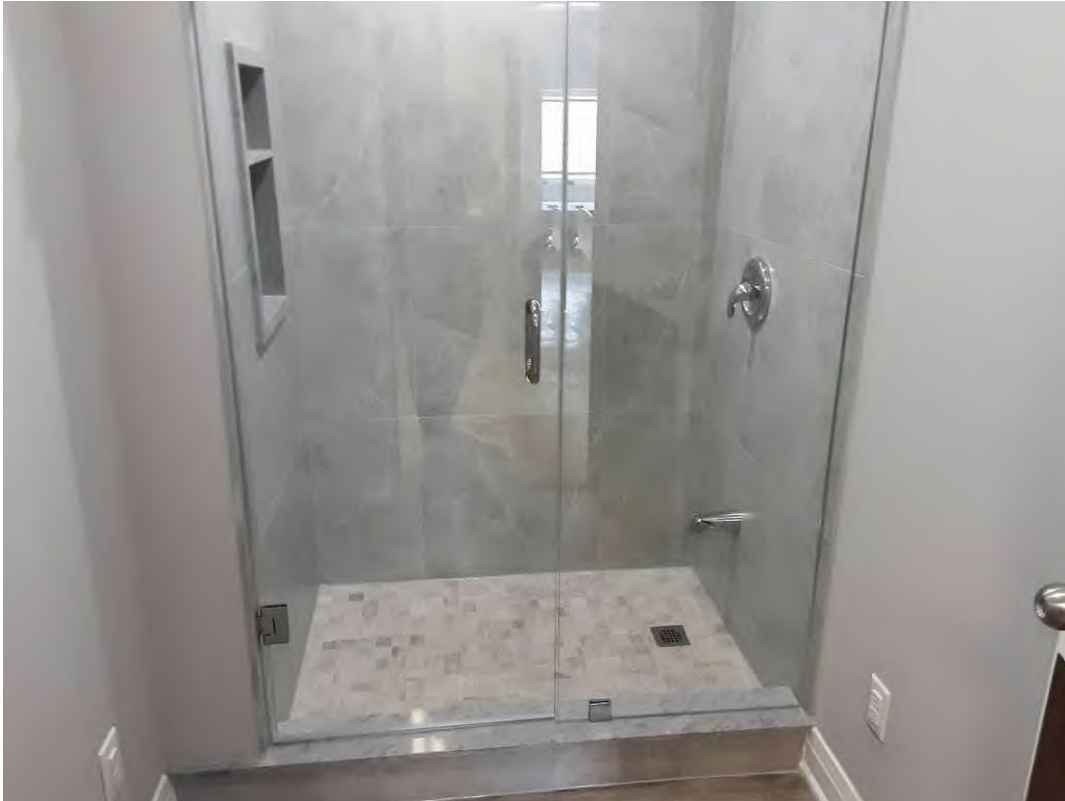
V0000 (None), Wall, Shower Room (Location #: 46)

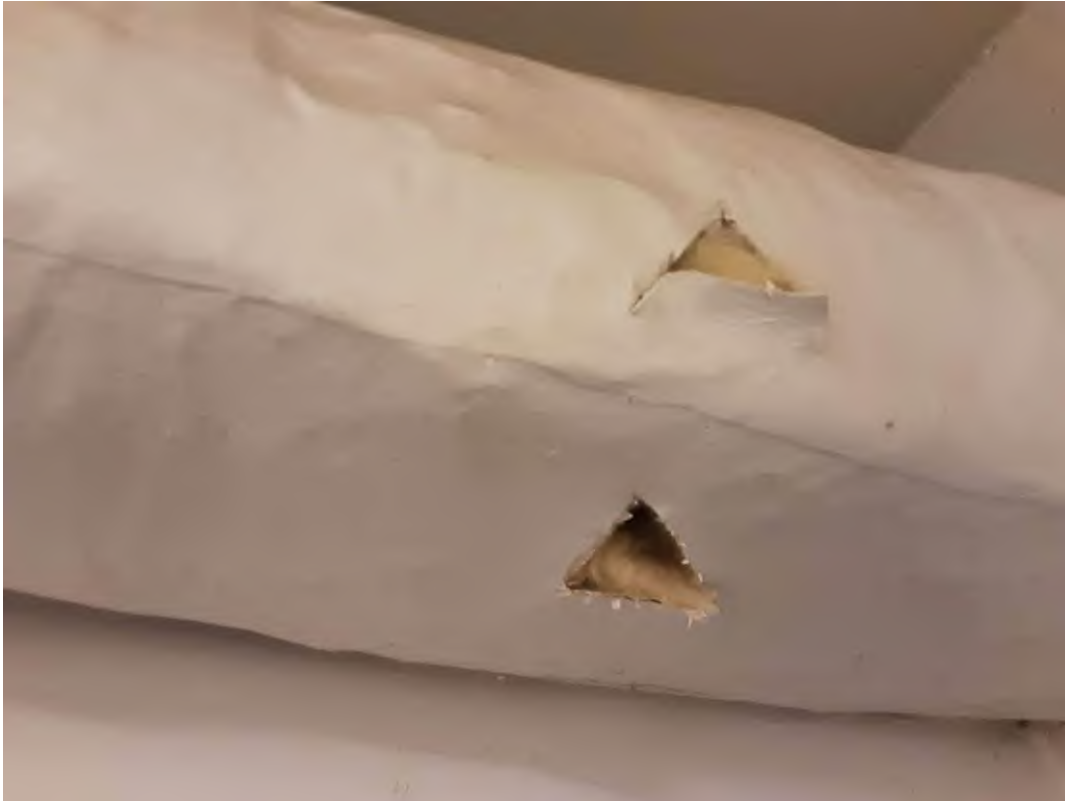
Duct, Fibreglass, Maintenance Shop (Location #: 166)

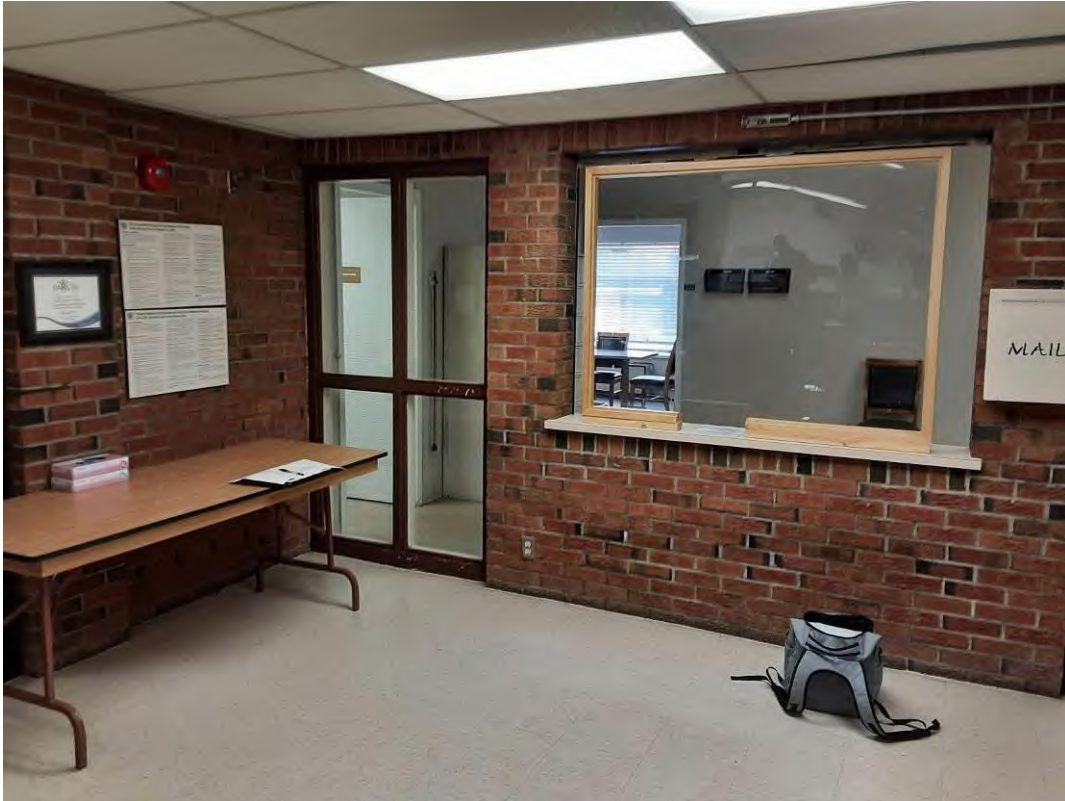
Wall, All, Masonry, Lobby (Location #: 4)

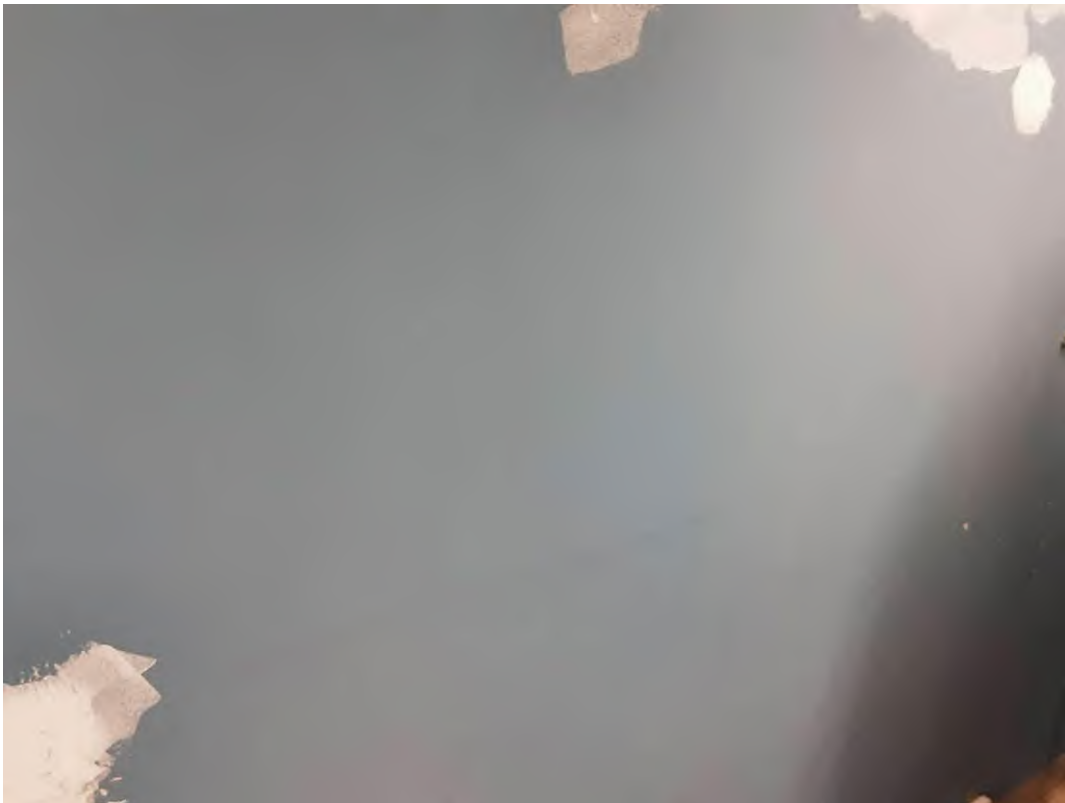
Drywall and joint compound, Blue paint on drywall, L0007, Linen Room (Location #: 27)

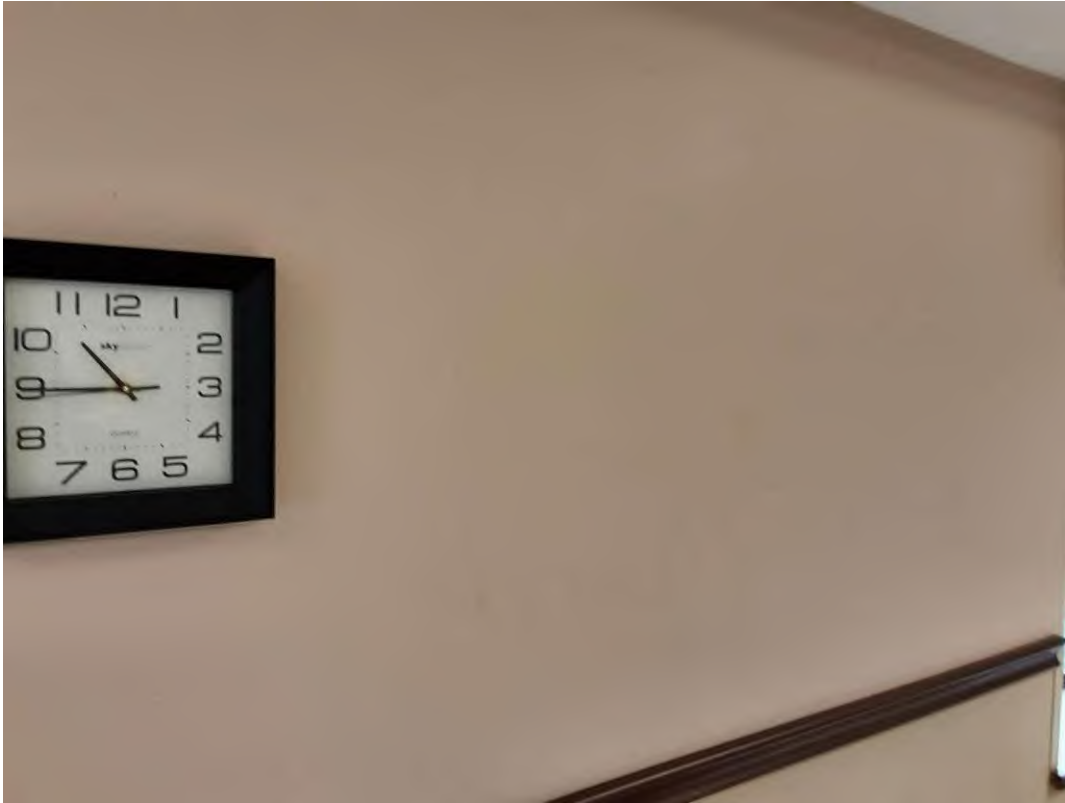
Drywall and joint compound, Pink paint, L0010, Dining Room (Location #: 58)

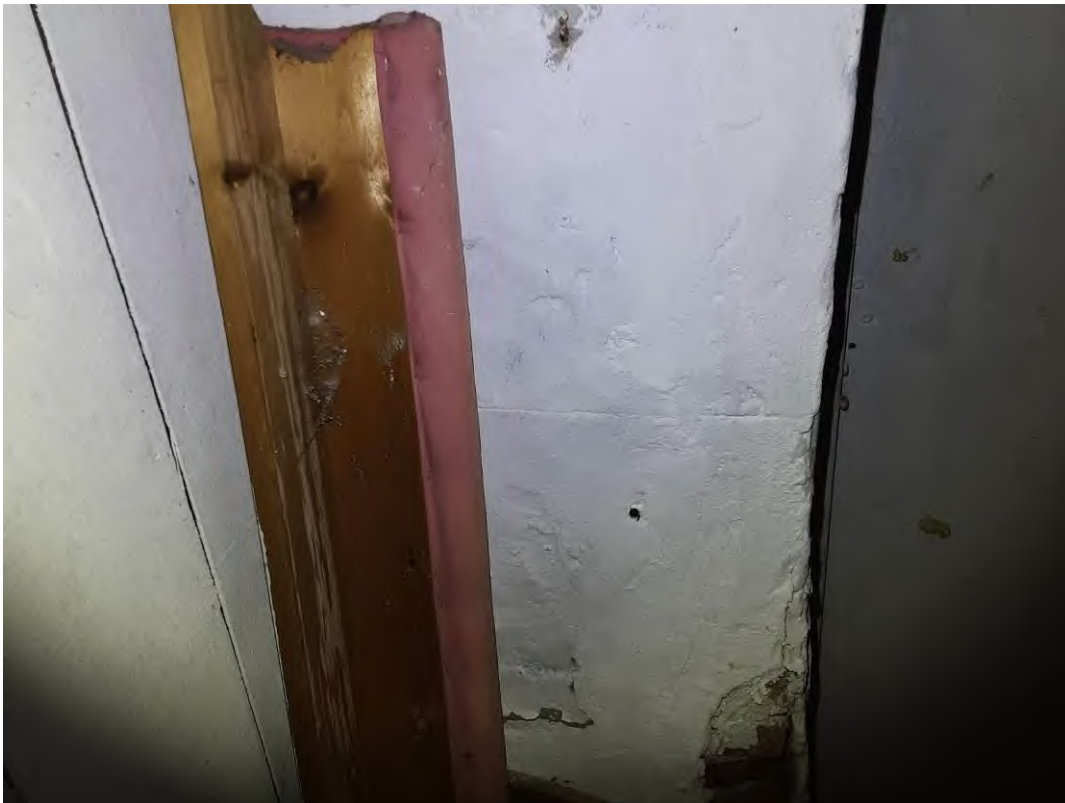
Plaster, White paint on plaster, L0012, Old House - Basement (Location #: 135)

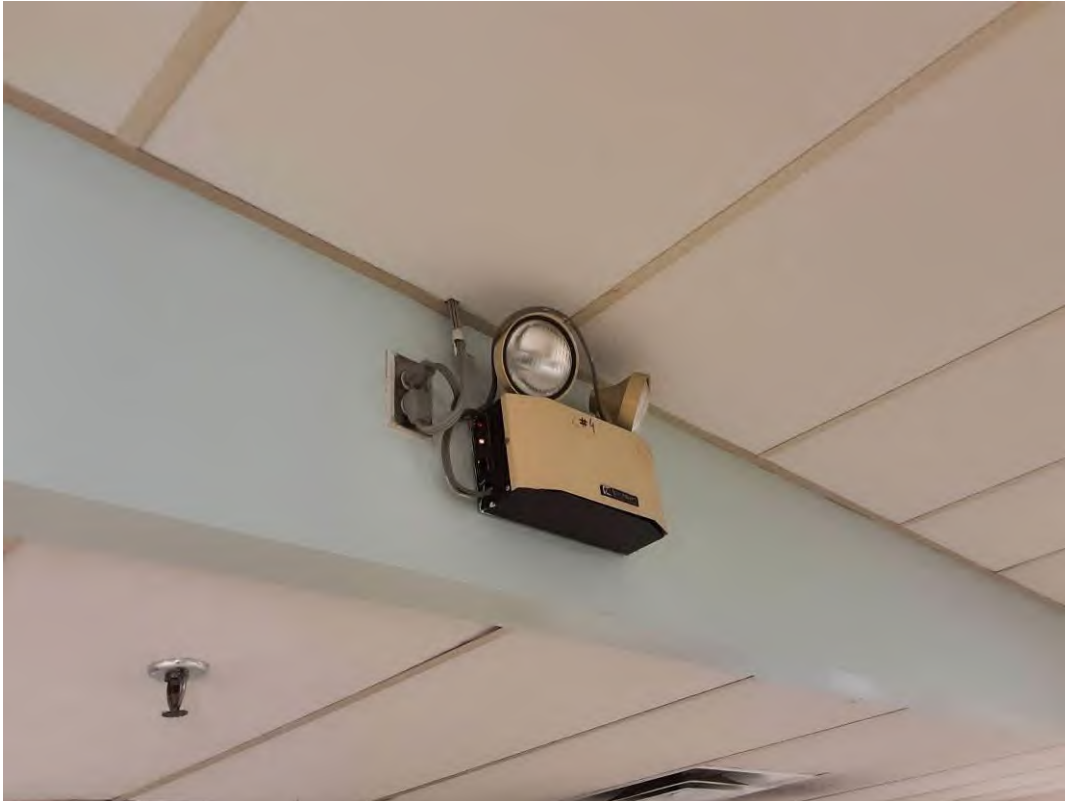
Pb Products, Lobby (Location #: 4)
