- 1. Hazardous Building Materials Assessment (Preconstruction) 1635 Dundas Street East, Whitby, Ontario**

Re: Revised Hazardous Building Materials Assessment (Preconstruction)

Region of Durham (Client) retained Pinchin Ltd. (Pinchin) to conduct a hazardous building materials assessment of Sunnycrest Nursing Home located at 1635 Dundas Street East, Whitby, Ontario.

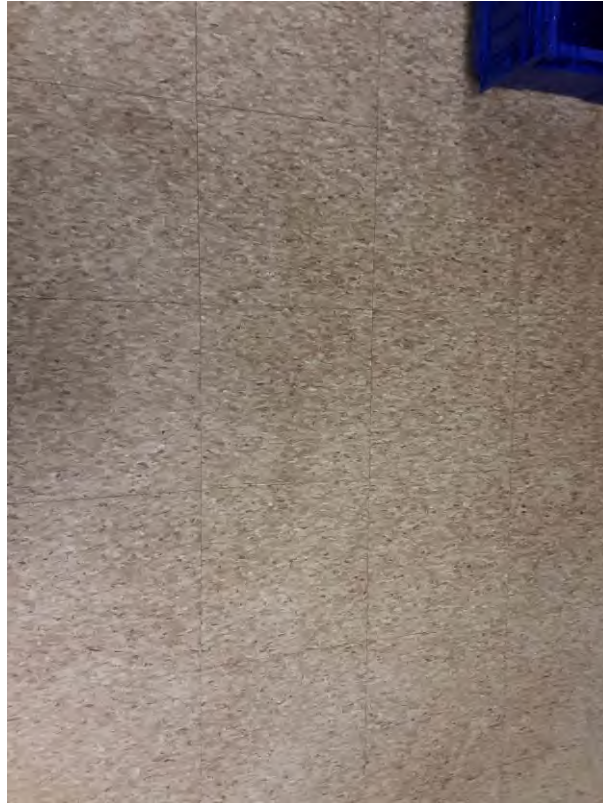
S0002A (None), Wall, Base, Adhesive/mastic, Lobby (Location #: 4)

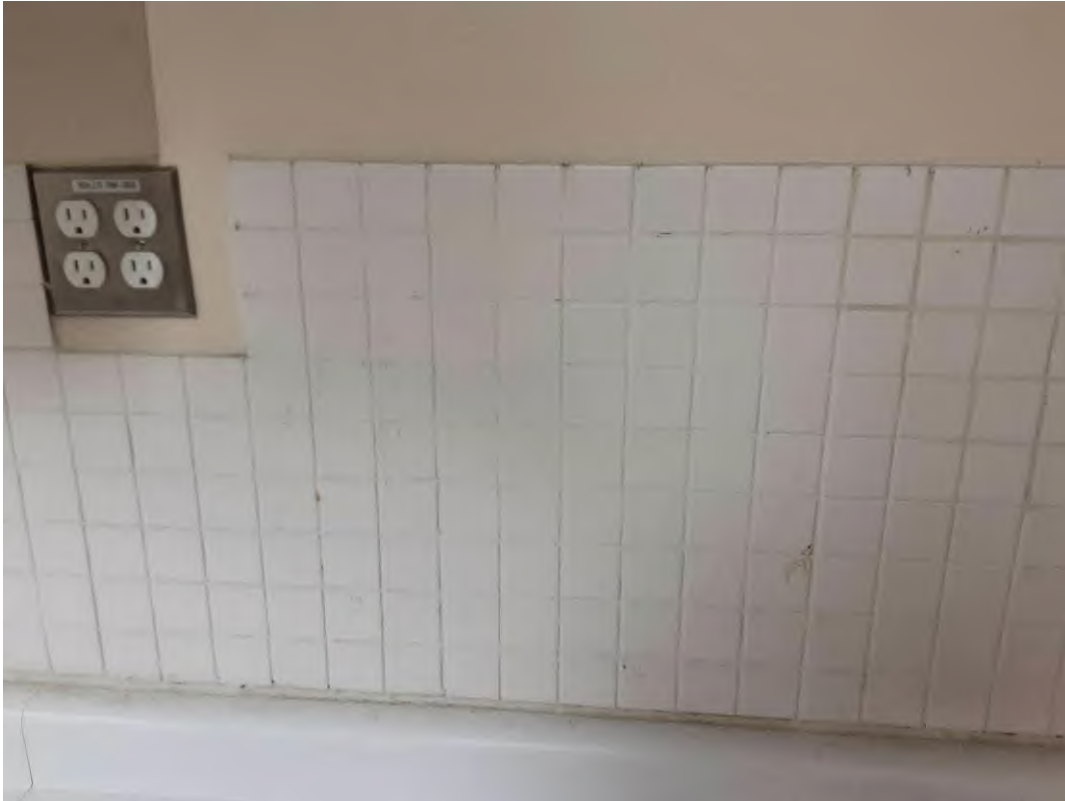
S0031A (None), Wall, Base, Wall covering, Dining Room (Location #: 58)

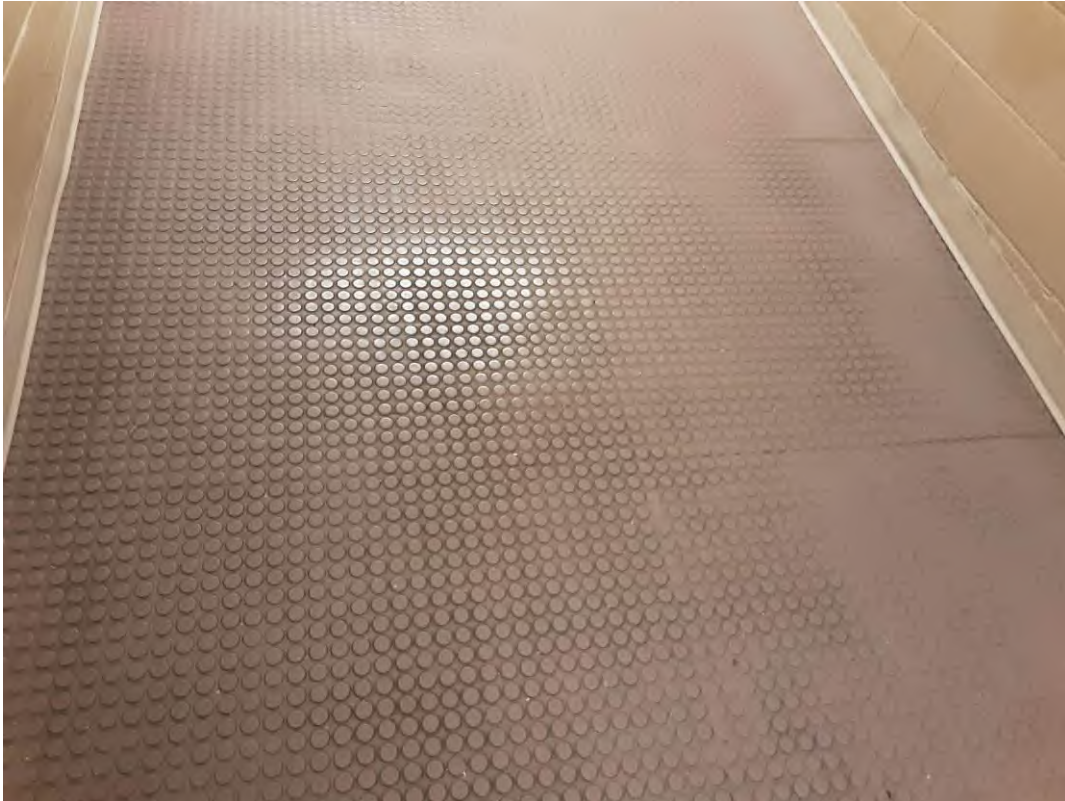
S0045A (None), Floor, All, Vinyl Sheet Flooring, Kitchen Refrigeration (Location #: 139)
Resilient flooring

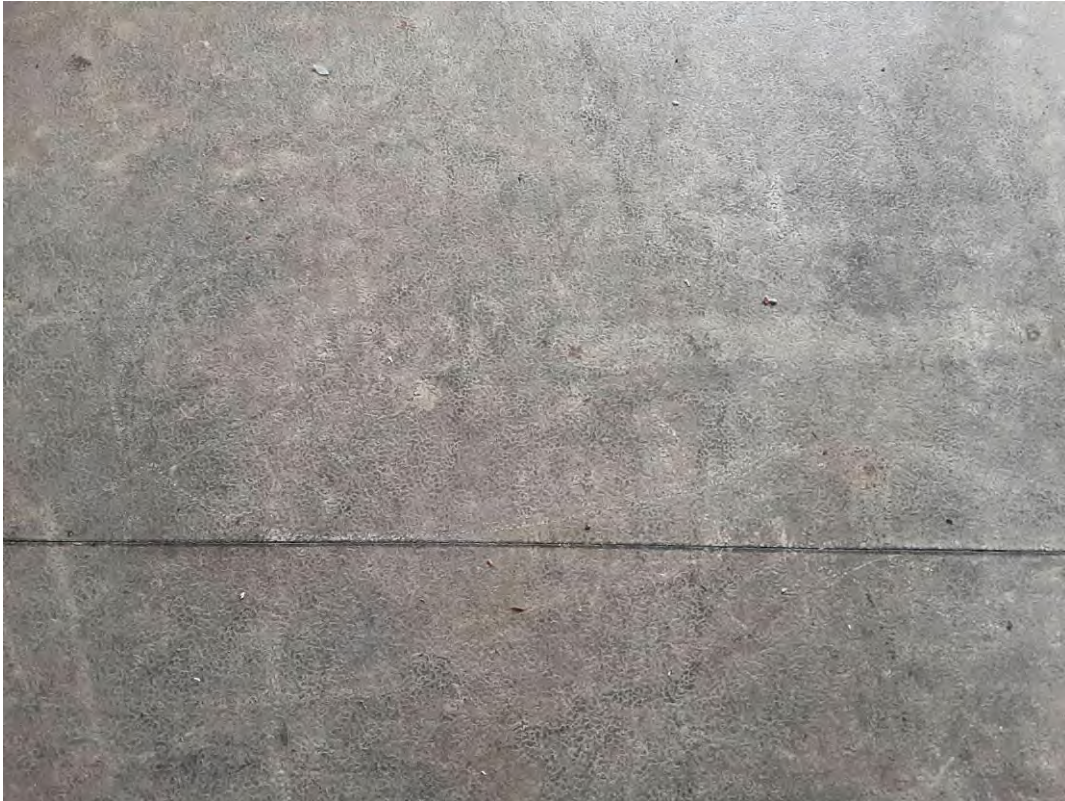
S0059C (Confirmed Asbestos), Floor, All, Vinyl Floor Tile and Mastic, Foyer (Location #: 149)

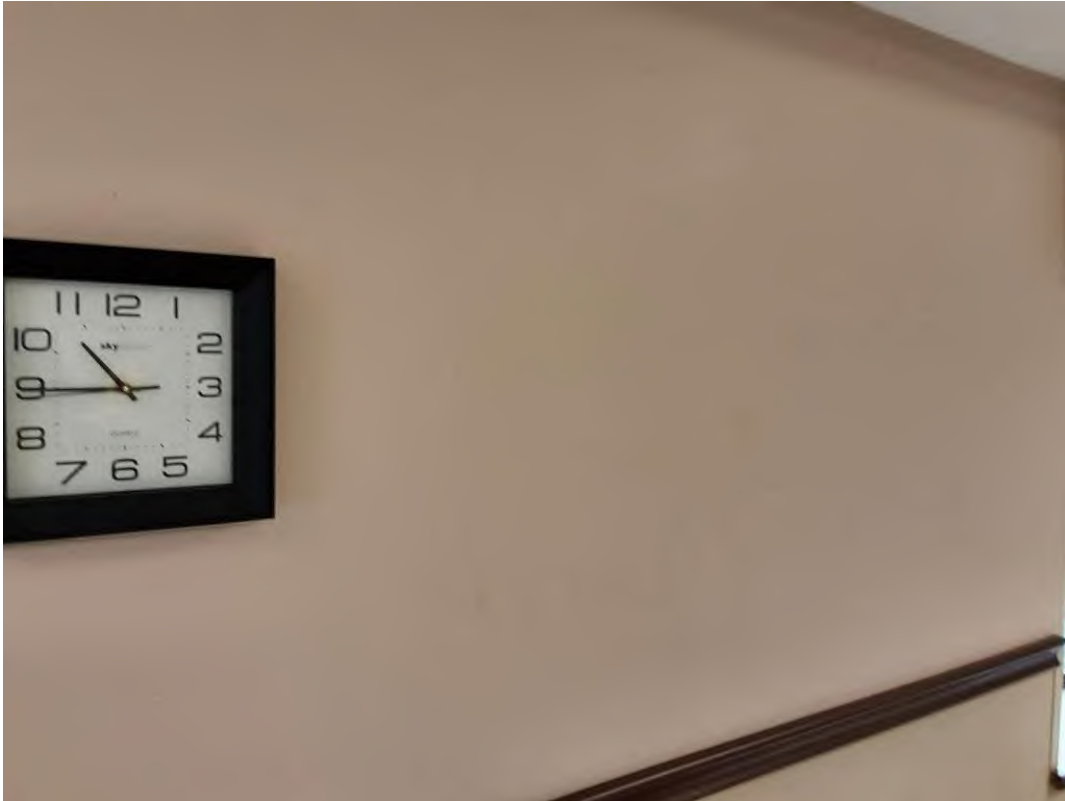
Drywall and joint compound, Blue paint on drywall, L0007, Linen Room (Location #: 27)

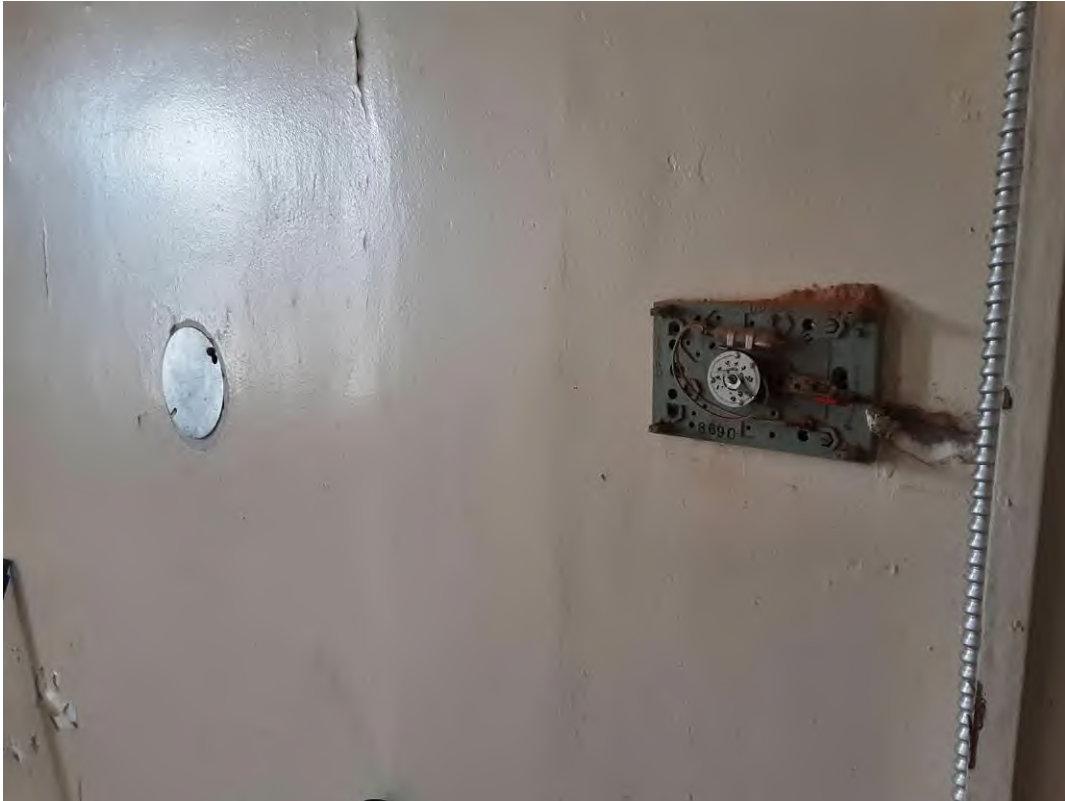
Pb Products, West Corridor (Location #: 56)
