Re: Revised Hazardous Building Materials Assessment (Preconstruction)

Sunnycrest Nursing Home, 1635 Dundas Street East, Whitby, Ontario

Pinchin File: 329911.000

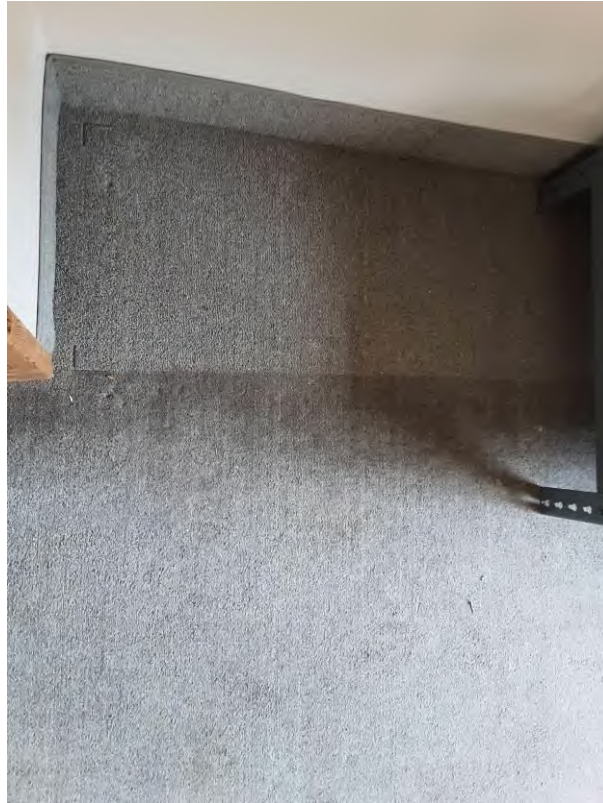
S0053A (None), Floor, Adhesive/mastic, Records (Location #: 170)

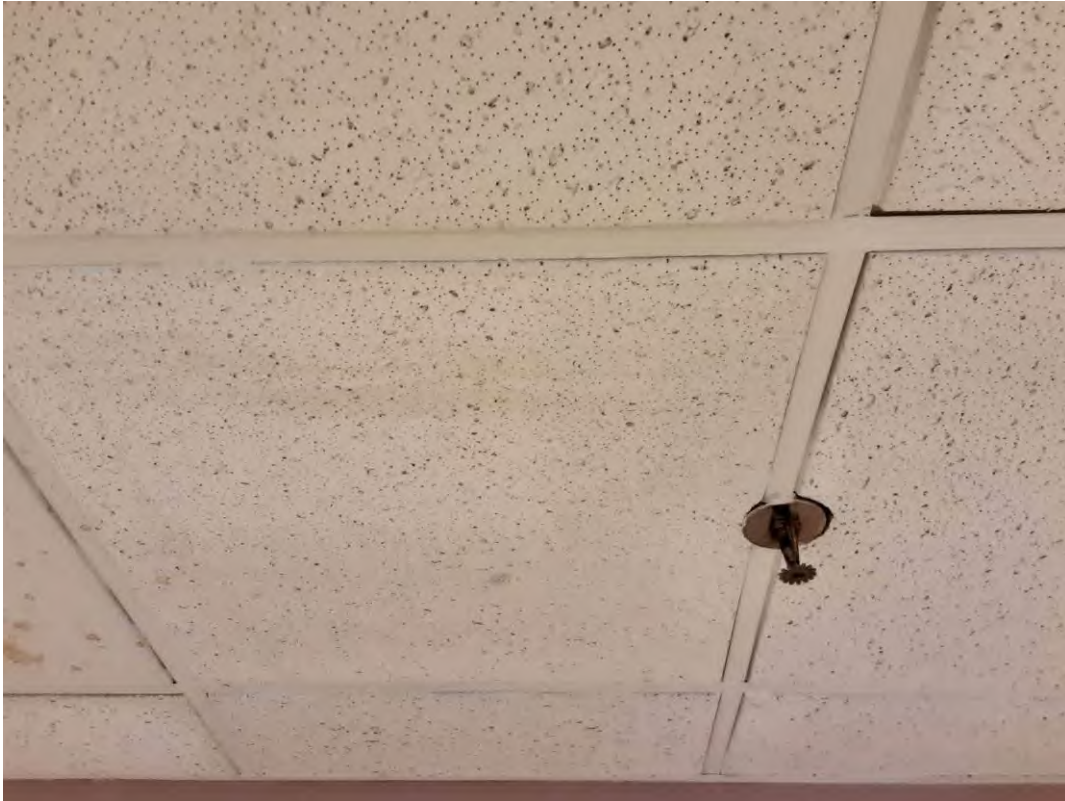
V0000 (None), Ceiling, Ceiling Tiles (lay-in), Dining Room (Location #: 113)
Date code 1994

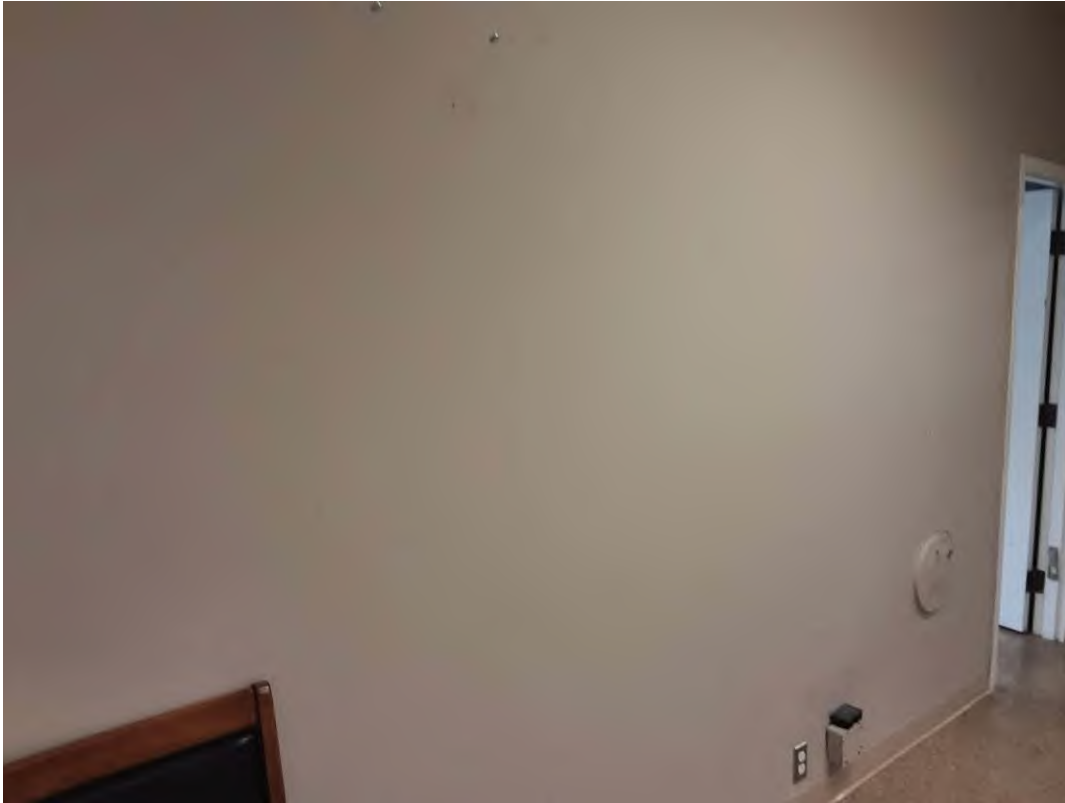
Drywall and joint compound, Light grey paint, L0002, Main Office (Location #: 5)

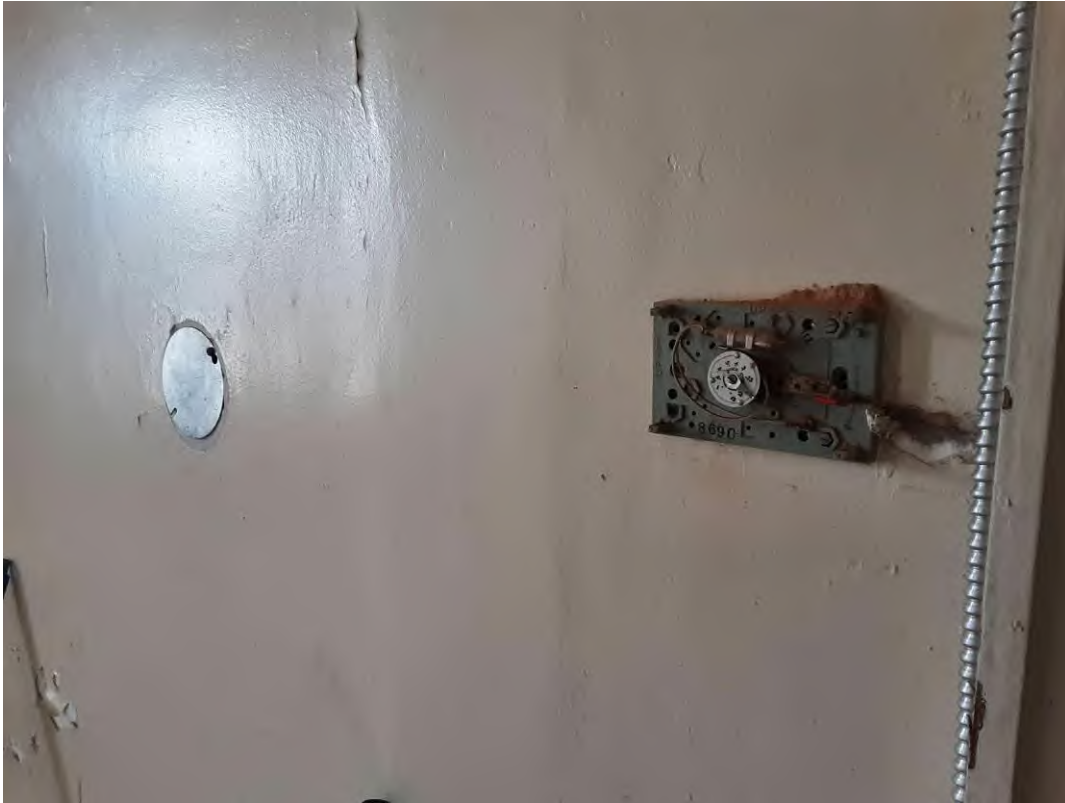
Mercury, Old House - Ground Floor (Location #: 177)

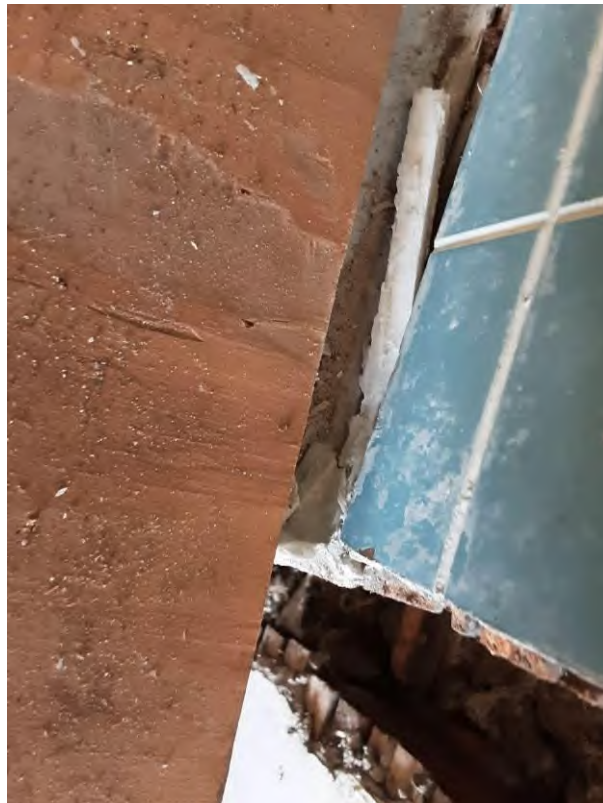
PCB, Medical Supply (Location #: 174)

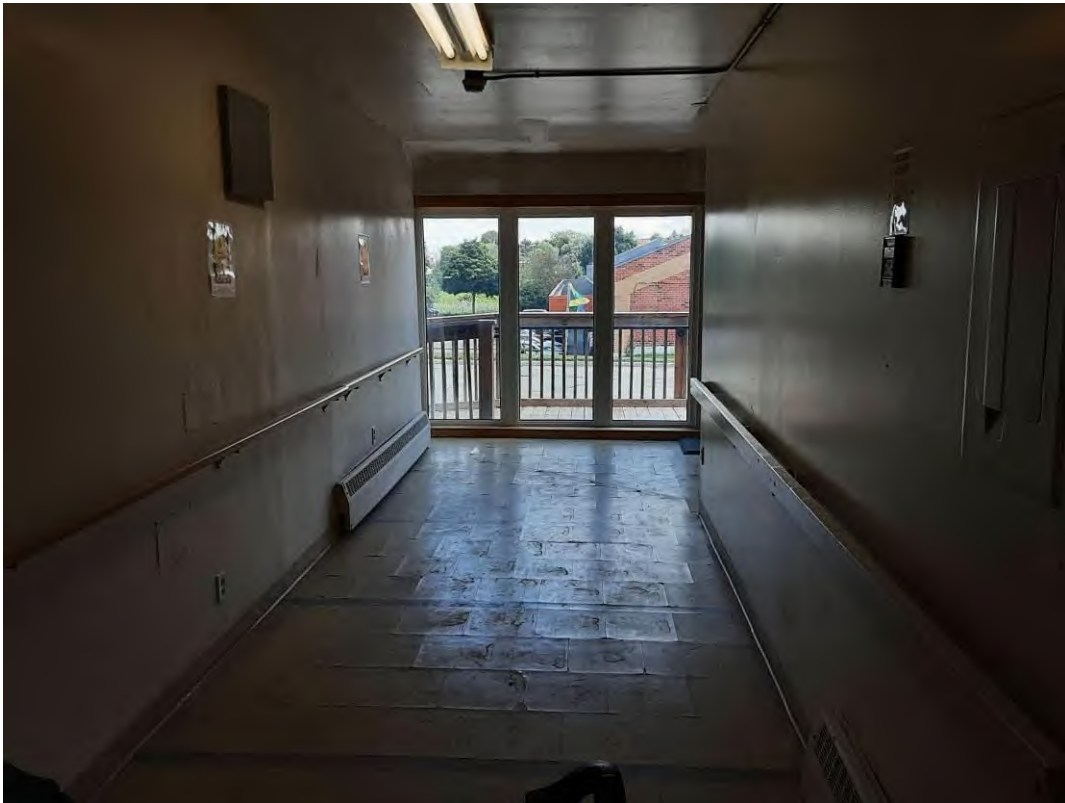
PCB, Old House - 2nd Floor (Location #: 178)
